## *MEMORANDUM*

**DATE** December 6, 2012  
**TO** Boston Region Metropolitan Planning Organization  
**FROM** Mark Abbott, Christine Bettin, and Bill Kuttner  
MPO Staff  
**RE** Safe Access to Transit for Pedestrians and Bicycles: Oak Grove Station

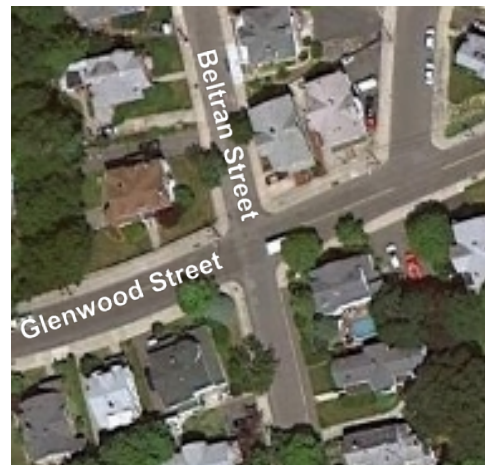
**Glenwood and Beltran streets**

There were five crashes, including one with a pedestrian, at the intersection of Glenwood Street and Beltran Street, which is located three blocks southwest of Oak Grove Station. Glenwood Street is a two-lane, east-west road with moderate traffic volumes and speeds observed during the site visit. Beltran Street has stop signs on both approaches to Glenwood Street, and low traffic volumes and speeds were observed. No trucks were observed at this intersection during the site visit.

Beltran Street rises on one approach, limiting visibility, and the word “stop” appears twice on the stop sign for emphasis. Stop bars are not painted in advance of the stop signs. A “Slow Please” traffic sign has been placed on the northwest corner of the intersection.

The sidewalks along Glenwood Street are wide and in fair condition, although a few areas are bumpy. There are pedestrian curb-cut ramps at each corner of the intersection, although one ramp is a driveway. The ramps are slightly tilted because they follow the Beltran Street grade.

A main issue at this intersection is lack of visibility, since vehicles approaching from each leg must process information regarding grade and curvature, in addition to observing traffic, pedestrians, and bicycles. There are no bicycle-specific features at this intersection.

- Stripe highly visible ladder-style crosswalks on all legs of this intersection. Ladder crosswalks are more visible than simple parallel lines, especially at night or in low light conditions.
- Install ADA-compliant detectable warning pads on all pedestrian curb-cut ramps.
- Stripe stop bars on Beltran Street in advance of the stop signs. Bicycle Improvements

- Stripe shared-lane markings (for bikes and motor vehicles) and install “Bicycles May Use Full Lane” (MUTCD R4-11) signs along Glenwood Street.
- Ensure pavement along all roadways, adjacent to curbs, is in good condition, without any potholes, bumps, or longitudinal drain grates.

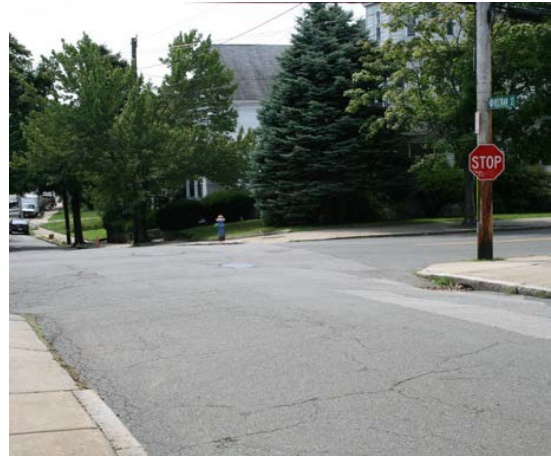
**Beltran Street: No stop bars or crosswalks**

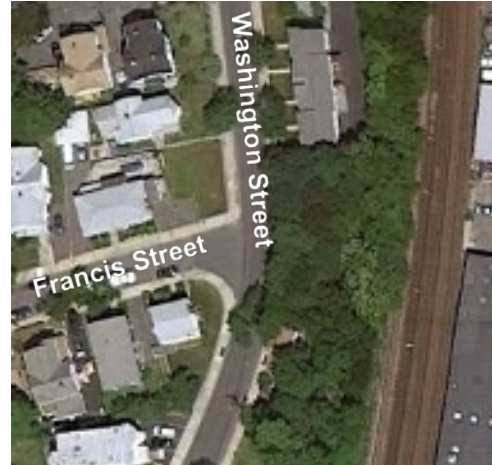
**Francis and Washington streets**

There were three crashes, including one with a pedestrian, at the intersection of Francis Street and Washington Street. Francis Street meets Washington Street at a “T” intersection two blocks south of Oak Grove Station. Washington Street approaches the station, has no center stripe, and had light traffic when observed during the site visit. No traffic was observed on Francis Street, and there is no stop sign. Traffic speeds were moderate and appropriate for the street.

The sidewalks along Washington Street are wide, and there are three pedestrian curb-cut ramps available at the corner of this intersection. A fourth ramp would be required to allow a direct crossing of Washington Street from the south side of Francis Street.

There is a large root bump under the sidewalk on the east side of Washington Street. There are no bicycle-specific features at this intersection.

Grade and curvature have a minor impact on visibility at this location. A potential impact on sight distance may be a tall, privately owned wooden fence along the property line of the residence on the northwest corner of the intersection.

- Install a stop sign and stripe a stop bar for the eastbound travel lane on Francis Street.
- Stripe yellow center line pavement markings on Washington Street in the vicinity of this intersection.

- Stripe highly visible ladder-style crosswalks at all legs of this intersection.
- Construct a pedestrian curb-cut ramp on the east side of Washington Street.
- Install ADA-compliant detectable warning pads on all pedestrian curb-cut ramps.
- Assess the impact of private property on sight distance lines.

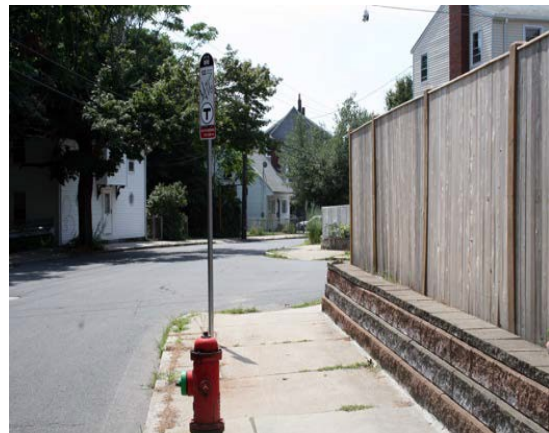
**Washington Street NW corner:  
Private fence impacts visibility**

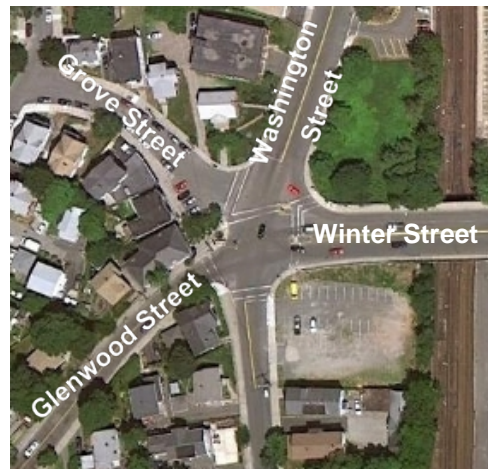
**Glenwood, Grove, Washington, and Winter streets**

Washington Street is a minor arterial roadway that meets Winter Street to the east and Grove and Glenwood streets to the west, creating a five-leg, skewed intersection. There was one bicycle crash and one pedestrian crash at this intersection between 2005 and 2009. During the site visit, traffic flows and speeds appeared to be moderate along all intersecting roadways.

All legs of the intersection, except Grove Street, which is a westbound one-way street, are signalized. There are pedestrian signals for the south and southwest legs of this intersection, where push buttons activate a dedicated pedestrian phase for all legs of the intersection at the same time. The pedestrian signal timing is 22 seconds, which is sufficient for the lengths of crossings at this intersection.

The sidewalks range from approximately 6 to 8 feet in width; some of them are old and some are newly built. All corners of the intersection have pedestrian curb-cut ramps, although the ramps do not have detectable warning pads.

There is a channelizing and pedestrian refuge island across Washington Street; however, the pedestrian crossing distance from the island to the west side of the street is approximately 60 feet. The longest uninterrupted crossing a pedestrian should encounter at a crosswalk is 50 feet.<sup>5</sup> Motorists wishing to enter Grove Street from Winter Street were observed to travel in both directions around the channelizing and pedestrian refuge island.

Grove Street intersects with Washington, Glenwood, and Winter streets at a skewed angle. It is a low-volume, westbound one-way, one-lane road that is approximately 40 feet wide at the intersection, after which its width decreases to approximately 30 feet.

Grove Street approaches the intersection between Washington Street and Glenwood Street, which creates poor visibility between motorists making right turns from Washington Street onto Glenwood Street and pedestrians standing on the northwest corner of Glenwood Street and Washington Street. Additionally, visibility at this corner is blocked by vegetation, a traffic signal post, and a utility post.

The corner radius on the northwest corner of Grove Street and Washington Street appears to be large, which increases the pedestrian crossing distance and may increase the speed of turning vehicles.

There are no bicycle-specific features within this intersection.

- Restripe pavement markings. The travel lane markings along Winter Street have completely faded and are no longer visible. Restriping these would help guide motorists approaching the intersection.
- Restripe ladder style crosswalks at all legs of this intersection.
- Stripe channelization pavement markings in order to extend the channelizing island, which would help guide motorists to stay to the left of the island when entering Grove Street. This would help to reduce conflicts between right-turning motorists and pedestrians crossing in the crosswalk.
- Upgrade to accessible pedestrian signals with countdown features.
- Trim the vegetation on the northwest corner of Glenwood and Washington streets to improve visibility between pedestrians and motorists.

- Stripe shared-lane markings (for bikes and motor vehicles) and install “Bicycles May Use Full Lane” (MUTCD R4-11) signs along Glenwood and Winter Streets.
- Stripe shared-lane markings and install “Bicycles May Use Full Lane” (MUTCD R4-11) along Washington Street north from Grove and Winter Streets.
- Install MBTA directional signage guiding bicyclists to the Pedal & Park bike cage, which is located on the east side of Oak Grove Station, with access from Banks Place.
- Install ADA-compliant detectable warning pads on all pedestrian curb-cut ramps.

- Ensure pavement along all roadways, adjacent to curbs, is in good condition, without any potholes, bumps, or longitudinal drain grates.

- Ensure adequate lighting throughout this intersection. This would also benefit pedestrians.

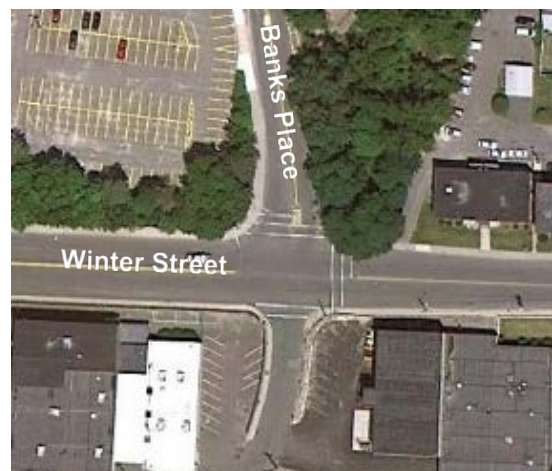
**Winter Street and Banks Place**

The Oak Grove Station has extensive parking arrayed to the east and south of the head-house and station platforms. Banks Place connects the station parking lots with Winter Street, an east-west street immediately south of the station property. Winter Street has traffic signals at both ends—where it meets Washington Street to the west and Main Street to the east. During a site visit at around noon on Friday, August 3, traffic on Winter Street was moderate and included some trucks. Speeds were appropriate for the roadway.

Banks Place has a stop sign as it approaches Winter Street. Across the street is a private way leading into a small industrial park, and this private way also has a stop sign where it meets Winter Street. During the site visit, no traffic to Oak Grove Station was observed, and a small amount of traffic was seen entering or leaving the industrial park. There appear to have been traffic signals at this intersection at one time. The masts remain, but the signal heads have been removed.

Banks Place has two generous lanes separated by a yellow line, and has a small traffic island where it meets Winter Street, where there are a crosswalk and stop-line. The road into the industrial park is narrow and has no striping. Winter Street has two wide lanes in each direction east of the intersection, but west of the intersection it widens to accommodate two narrow westbound lanes as it approaches Washington Street. Unfortunately, these lane markings are now almost invisible. There are no bicycle-specific features at this intersection.

The sidewalks at this intersection are almost entirely inadequate. Winter Street, the public way, has usable sidewalks and ramps along its north side. On the south side, the sidewalks are variously narrow, obstructed, or lacking ramps. Pedestrians going to the industrial park must walk in the street, and Banks Place, the access road to Oak Grove Station, only has a sidewalk on the west side.

- Ensure pavement along all roadways, adjacent to curbs, is in good condition, without any potholes, bumps, or longitudinal drain grates.

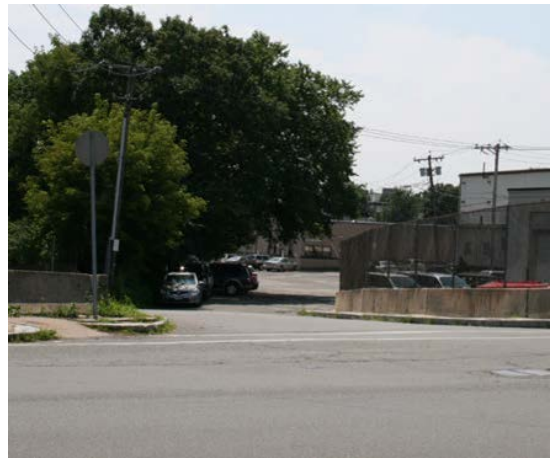
**Winter Street: Missing pedestrian ramp at SW corner**

Three approaches to this intersection have painted crosswalks. There is no crosswalk across the west leg of this intersection. There is a painted crosswalk with a Yield to Pedestrians sign on a stanchion across Winter Street on the east side of the intersection.

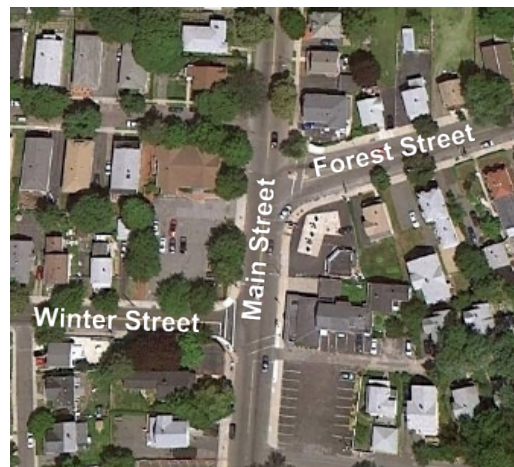
**Winter, Main, and Forest streets**

Main Street is a busy north-south arterial that meets Winter Street to the west and Forest Street to the east at a pair of "T" intersections offset by 160 feet. During the site visit, traffic was heavy on Main Street and included numerous trucks, and was moderate on Winter and Forest streets. Traffic speeds were moderate and appropriate for the intersection.

Both intersections are signalized, and the signals are timed to function as a single intersection. Traffic approaching from the west on Winter Street receives an exclusive green phase, allowing movement to the north or south on Main Street, or to the east with a second turn onto Forest Street. This is followed by a green phase for Main Street. Then

there is an exclusive green phase for westbound traffic on Forest Street that allows movement to the north or south on Main Street, or to the west with a second turn onto Winter Street. There is another green phase for Main Street before Winter Street receives its next green. Right turns on red are permitted.

There are three striped crosswalks: one each across Winter and Forest streets, and one across Main Street south of Winter Street. The lack of a crosswalk on the north leg of the intersection requires pedestrians on the northeast corner to cross three signalized crosswalks, potentially over the course of three signal cycles, to get to the northwest corner of Winter and Main streets on a path to Oak Grove Station.

Push buttons are available at each crosswalk location, and pushing a button results in a dedicated pedestrian phase over the two offset intersections. The pedestrian signal timing provides 23 seconds of crossing time for pedestrians, which is sufficient. The pedestrian signal heads on the northwest and southwest corners of Main and Winter Streets were not functioning properly, and the pedestrian signal push button on the northeast corner of Main and Forest Streets was not functioning properly. There are no bicycle-specific features.

- Restripe ladder-style crosswalks at all legs of this intersection.
- Install ADA-compliant detectable warning pads on all pedestrian curb-cut ramps.
- Repair the pedestrian signal heads on the northwest and southwest corners of Main Street and Winter Street.
- Repair the pedestrian signal push button on the northeast corner of Main Street and Forest Street.

- Install bicycle racks in the public right-of-way adjacent to businesses and/or encourage businesses to install bicycle racks for their customers.
- Ensure pavement along all roadways, adjacent to curbs, is in good condition, without any potholes, bumps, or longitudinal drain grates.

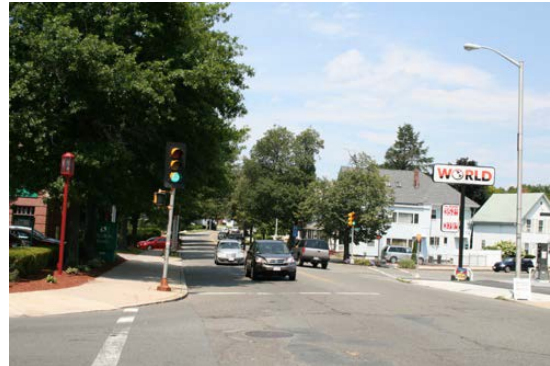
**Main Street, NB: Offset "T" intersection**

The sidewalks are wide; some are old and some are newly built. One corner lacks a pedestrian curb-cut ramp, requiring the use of a nearby driveway. The sidewalks along the 160-foot offset section have curb cuts that allow vehicle access to a bank branch on the west and a gas station on the east side of the intersection.
