Station Area Characteristics

Station Amenities

Station Access by Pedestrians and Bicyclists

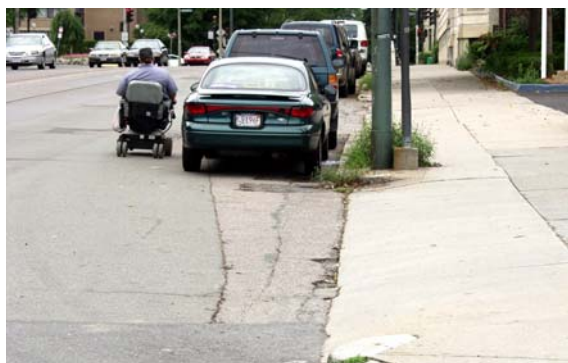
Chestnut Hill Avenue North

The pavement condition on Chestnut Hill Avenue at and north of Cleveland Circle is rough. Rail tracks are also present, adding to the uneven surface. Sidewalks either lack wheelchair ramp/curb cuts at the street corners or have inadequate ones.

- Repair sidewalks, install curb cuts (particularly in the north-south direction), and repair the road surface pavement, especially at crossings
- Eliminate overgrown weeds and foliage along the sidewalk on the west side of Chestnut Hill Avenue
- Install trailblazing signs along Chestnut Hill Avenue (and at the B, C, D branch station/stops) that inform riders of the connection between the different Green Line branches

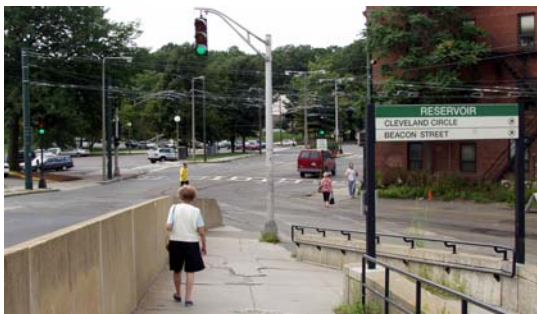
Passengers walking from Reservoir Station to Cleveland Circle must cross the entrance to the MBTA service facility, used by authorized vehicles and trains. The pavement at the MBTA driveway, between the Reservoir walkways and the sidewalk to the north at Cleveland Circle, is in poor condition, and a crosswalk is not provided. The pavement condition of the sidewalk leading to the top of Reservoir on the east side of Chestnut Hill Avenue shows signs of deterioration.

- Repave and stripe the crossing of the MBTA service facility entrance between the Reservoir walkways and the sidewalk to the north at Cleveland Circle
- Repave the eastside concrete sidewalk/ramp along Chestnut Hill Avenue at Reservoir Station

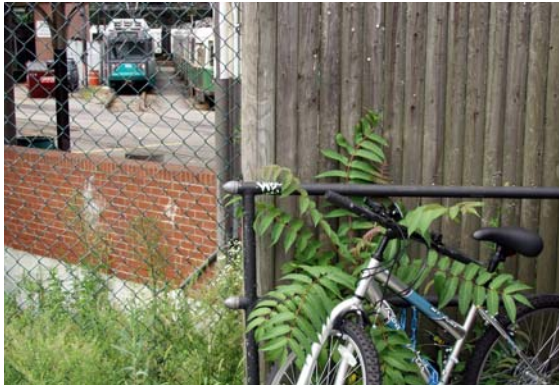
Bicycle Parking at Boston College Station

No bicycle parking is provided at Boston College Station. A demand for bicycle parking exists, as demonstrated by the locked bicycle observed along a chain-link fence at the station.

Recommendation: Install a bicycle rack at Boston College Station. A rack with four inverted-U racks elements should be added. An appropriate location for the rack is just to the right of the MBTA information panel. The proposed bicycle rack location is visible to station patrons and personnel, provides shelter, and the platform width can accommodate bicycles while not interfering with the circulation of passengers. (However, a bench is presently located here; the bench can be relocated to the empty space to the right of its current location, where the platform is too narrow for a bicycle rack.)

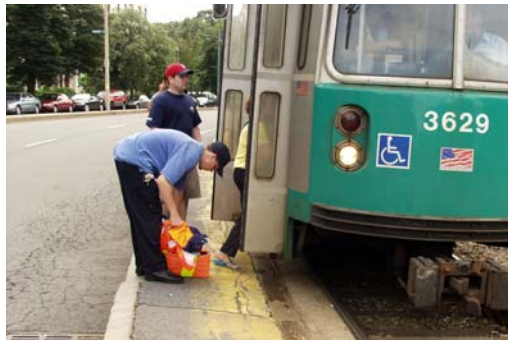
Passenger Waiting Area at Chestnut Hill Avenue Stop

At the Chestnut Hill Avenue stop, the passenger waiting area consists of a narrow (four-foot wide), blacktop median between the inbound tracks and the curving eastbound lanes of Commonwealth Avenue. No crosswalk is provided across Commonwealth Avenue at the head-of-the-train area. The wide inside traffic lane on Commonwealth Avenue does not have a striped shoulder separating traffic from the curb along the median.

Recommendation: Consider measures to increase passenger safety for Green Line riders on the median platform on Commonwealth Avenue. The MBTA's Design and Construction Department should identify appropriate improvements, which may include:

- Restriping the Commonwealth Avenue lanes, particularly in the stretch adjacent to the transit stop, with the intent of narrowing the lanes by one foot each and adding a shoulder to the inside lane. This should slow down traffic and would provide an extra buffer between vehicular traffic and passengers. The inside shoulder solid line should visibly stand out—it could be yellow and light-reflective.
- Installing a fence along the road-side perimeter of the passenger wait area.
- Extending the platform width, in conjunction with the recommendations above.

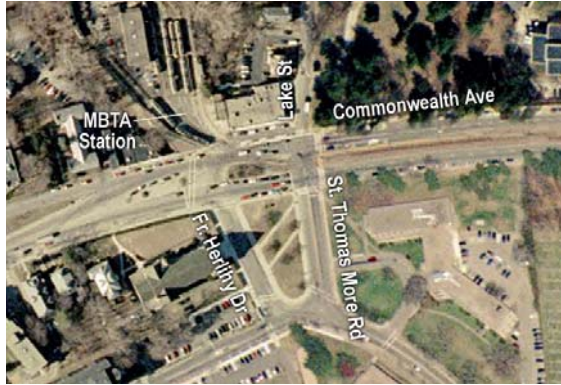
A pedestrian-crossing signal is located at the striped crosswalk at Boston College Station across Commonwealth Avenue from the Boston College campus (and the campus entrance at Fr. Herlihy Drive). Four signal posts, each with a pedestrian-crossing button and signals, make up the signalized portion of this crosswalk; two are located in the median of Commonwealth Avenue and the other two at the north and southbound sides of the crosswalk. The pedestrian-crossing button on the north side of the crosswalk, at Boston College Station, did not trigger the pedestrian crossing signal on the day of the field observation. Also noted was that the “Walk” light displayed properly at all four signals, but the “Don’t Walk” lights only worked on the median post that faces the station. The pedestrian-crossing signal is coordinated with the nearby traffic signal at Lake Street/St. Thomas More Road (Boston College campus). The field observation noted two vehicles ignoring the red signal and making a right turn from Commonwealth Avenue to Boston College without stopping.

Recommendation: General maintenance of the crosswalk and pedestrian-crossing signal is needed, consisting of the following improvements:

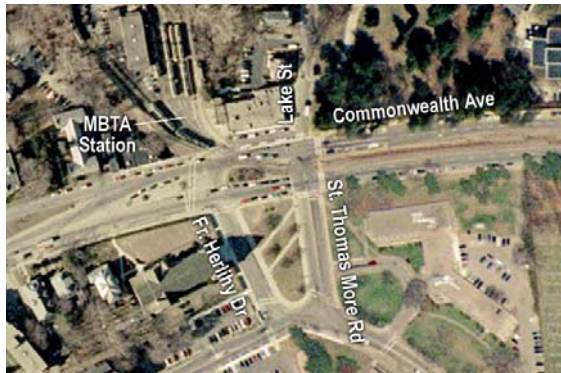
Commonwealth Avenue at Lake Street/St. Thomas More Road (Boston College)

A traffic signal with pedestrian-crossing signals is located on Commonwealth Avenue at Lake Street (to the north) and St. Thomas More Road (to the south, at the Boston College campus). The intersection features many movements, requiring close attention by those traversing this location: westbound and eastbound Commonwealth Avenue traffic is split with a median on which the Green Line trains operate; Lake Street handles one-way traffic heading north from the intersection; St. Thomas More Road is two-way, two-lane street. Right turns are permitted on red at all

approaches. Vehicle loop detectors on Commonwealth Avenue are located in the pavement on which the pedestrian crosswalk is located; not only does this placement of loop detectors create cracks in the crosswalk's pavement, but reduces the efficiency of traffic signal operation as well.

Recommendation: In addition to restriping the crosswalks, the signalized intersection should receive an upgrade of the signals and design, consisting of the following improvements:

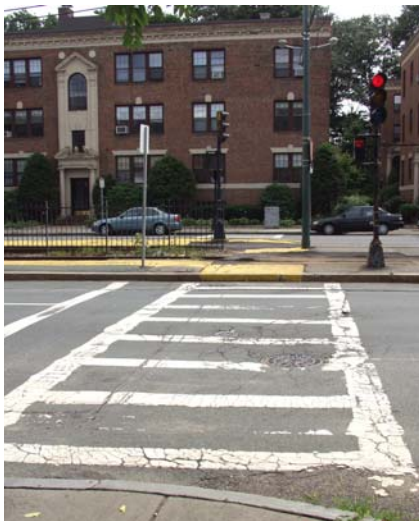
Greycliff Road and South Street Stops

The Greycliff Road and South Street stops are in the median of Commonwealth Avenue—a typical characteristic of this light-rail branch. Pedestrian crosswalks between the Commonwealth Avenue sidewalks and the median station platforms at the South Street and at the Greycliff Road stops are in poor condition. Although these crosswalks have white, ladder-striped pavement markings, the pavement condition is cracked and ramps/curb cuts are nonexistent. Plus, on the north sidewalk along Commonwealth Avenue, the grass buffer that separates the paved sidewalk and the curb—a recommended design feature of sidewalks—does not contain paved breaks/cuts at the crosswalks.

Recommendation: Add ramps/curb cuts to the pedestrian crossings and perform general rehabilitation of the crosswalk, including restriping and improving pavement condition.

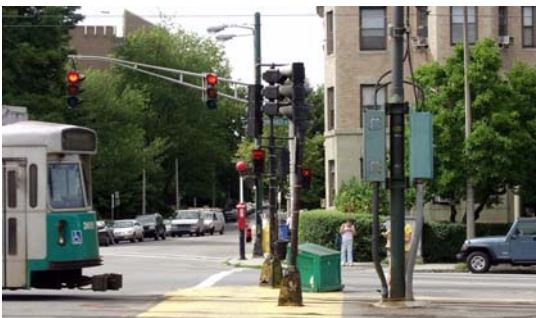
The condition of the pedestrian crosswalks is marginal, particularly across Commonwealth Avenue. The pavement has visible signs of pothole patchwork, and railroad tracks cut across the pedestrian crosswalks. The street corners and the medians lack curb cuts for wheelchair access. The median crosswalks on Commonwealth Avenue have obstructions (signal posts) in the pathway of pedestrians. The painted crosswalks have fading paint.

Recommendations: Add ramps/curb cuts to the pedestrian crossings and perform general maintenance of the crosswalks, including restriping and improving pavement condition. Consider adding curb extensions or bulb-outs to protect pedestrians and enhance their use of the intersection.

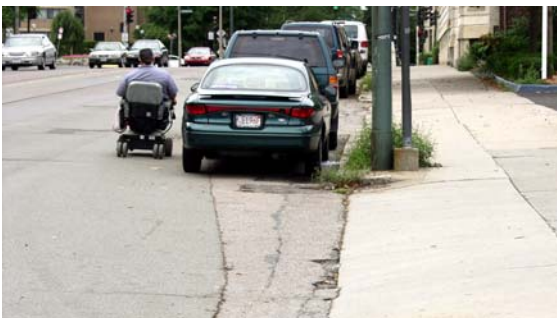
Chestnut Hill Avenue between Commonwealth Avenue and Cleveland Circle

To the south of Commonwealth Avenue, Chestnut Hill Avenue is a busy, wide, four-lane, undivided road with on-street parking and sidewalks on both sides. The pavement condition on this stretch is rough. Rail tracks are also present, adding to the unevenness of the surface. Sidewalks either lack curb cuts at the street corners or have inadequate ones.

- Repair sidewalks, install curb cuts at street corners (particularly in the north-south direction), and repair the roadway surface, especially at crossings.
- Eliminate overgrown weeds and foliage along the sidewalk on the west side of Chestnut Hill Avenue.
- Install trailblazing signs along Chestnut Hill Avenue, particularly at Commonwealth Avenue, that direct Green Line riders to the stations at Cleveland Circle and Reservoir, just two blocks to the south. Some passengers may find different transfer and travel opportunities if they are aware of the ease of accessing one of the neighboring stations.

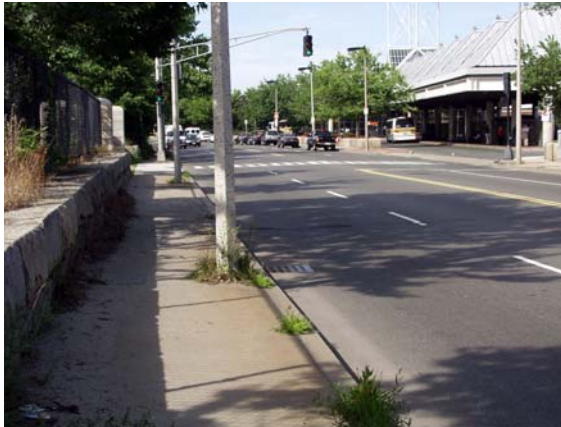
Washington Street South

Washington Street to the south is a four-lane arterial roadway with narrow shoulders and heavy traffic. Bicyclists were observed using this road heading north and south between South Street and points south off of Washington Street; some bicyclists were observed using the sidewalk. Sidewalks are provided on both sides, with no buffer separation between the road and pedestrian traffic. The sidewalk on the west side is of adequate width, but weeds and dirt/debris accumulation are contributing to reducing the practical width. The midblock pedestrian crossing signal at the Arboretum entrance (on the west side, across from the bus bay at the station) does not function well: the signal takes too

long to activate (two minutes); the field audit also noted that the signal is not coordinated with the signal at South Street to the north or Ukraine Way to the south. The traffic signal at Ukraine Way has pedestrian crossing signals; they are not pedestrian activated and turn on at appropriate signal phases.

Recommendations: Improve pedestrian and bicyclist safety and comfort by implementing the following:

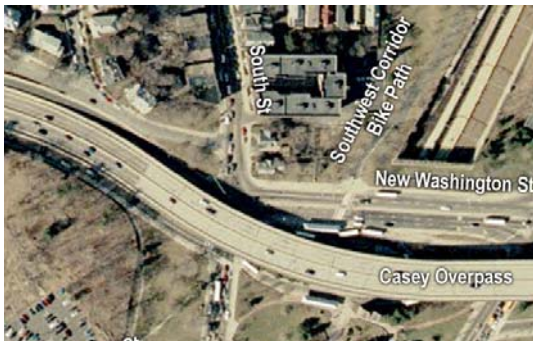
Vehicle queues can extend back from the New Washington Street intersection at South Street. These queues are far enough to block the crosswalk at the Southwest Corridor Park.

The design of the New Washington Street crossing of the Southwest Corridor and the north entrance of the station fails to make a good connection between these transportation facilities. The crosswalk (and median curb cut) angle away from the station's north entrance; the crosswalk does not follow desire lines of users of the Southwest Corridor Park to the station entrance. Furthermore, no signs are posted directing station users exiting the station to the Southwest Corridor Park and Bike Path; and from the southbound perspective heading toward the station, the north entrance location is not easily visible.

- Restripe the existing crosswalk.
 - Install pedestrian-crossing signs for vehicular traffic.
 - Fix the broken streetlight on north side of the pedestrian crossing of New Washington Street at Southwest Corridor.

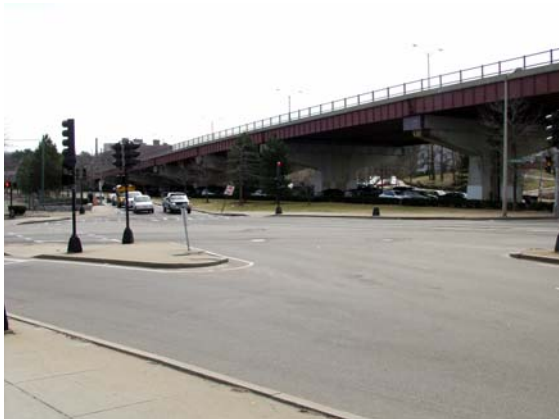
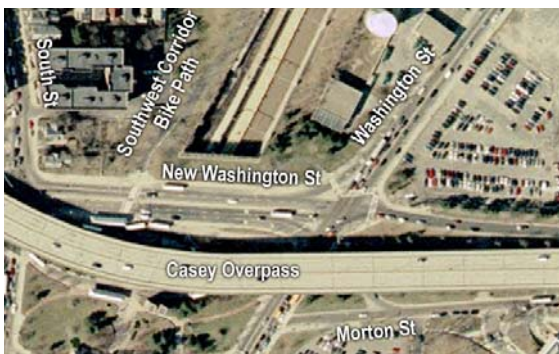
Washington Street at New Washington Street and Hyde Park Avenue

Five roadway legs intersect just northeast of Forest Hills Station: Washington Street to the north, Hyde Park Avenue to the south, New Washington Street to the west, plus Morton Street to the southeast and the Arborway exit ramp to the east. The intersection is wide and intimidating for pedestrians and bicyclists. Many of the approaches carry two lanes of through and/or turning traffic, which is channeled by medians and islands. Pavement conditions are rough and uneven, old railroad tracks cross the intersection, and the striping of the pedestrian crossings is fading. North-south pedestrian crossing along the west side is not encouraged, as shown by the absence of pedestrian crosswalks and walk signals; such a crossing should take place farther west at the pedestrian crossing signal at Southwest Corridor Park. Not many pedestrians were observed crossing this intersection during busy periods.

Recommendations: Improve the intersection design and operation to increase the comfort and safety of pedestrian crossings and bicycle navigation.

- Restripe pedestrian crosswalks
- Narrow the turning lanes to slow traffic
- Redesign traffic islands and pavement striping, in order to reduce the expanse of the intersection, giving it a less intimidating appearance
- Paint the corner curbs yellow, especially those of the traffic islands, in order to increase visibility
- Repair the pavement surface
- Install additional street lighting
