Improving Pedestrian and Bicyclist Access to Selected Transit Stations

A report produced by the Central Transportation Planning Staff for the Massachusetts Highway Department and the Massachusetts Bay Transportation Authority

September 2005

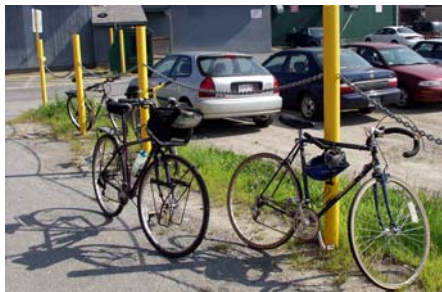
Bicycle Parking at the Station

On the south (inbound) side of the station platform, a dish-style bicycle rack is located in an open area beside the benches and shelter for the station. No bicycles were parked there on the day of the observation; bicycles were chained to posts on the north side of the station.

Recommendation: Move the existing bike rack to the north side of the station (not MBTA property), between the commuter parking lot and the outbound platform. This spot is more visible, on a hard surface, and in an area where bicyclists have been observed to lock their bicycles. Consider a location next to or behind the building, which may facilitate adding a shelter over the racks. Alternatively, there seems to be enough room between the parking lot and the railroad tracks to comfortably add a rack.

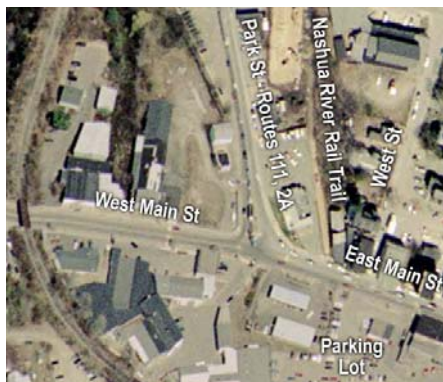
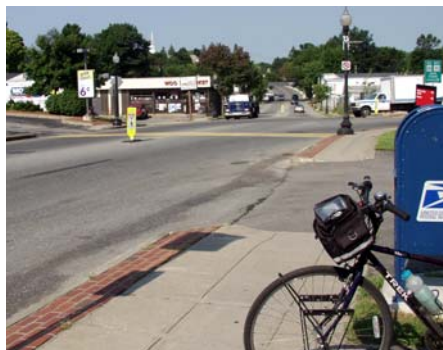
The intersection of Park Street and Main Street is unsignalized. Traffic tends to mostly travel along Route 2A/111, turning between Park Street and E. Main Street. Much truck traffic passes through this intersection; as with most of the traffic here, the primary movement includes the turns. During the peak morning commute hour, a traffic control officer was observed directing traffic. Red stop signs are in place for traffic approaching from the north (Park) and south (driveway).

Recommendations: Increase the safety of the intersection of Main Street at Park Street by implementing the following improvements:

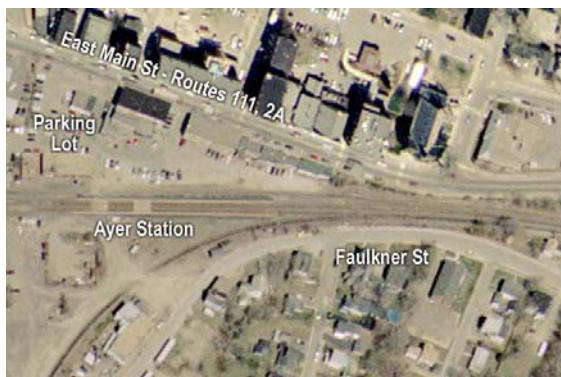
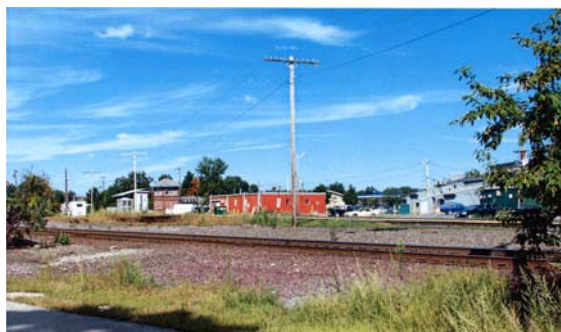
The residential neighborhood to the southeast of the Ayer commuter rail station lacks a connection to the station platform. Weeds, brush, gravel, and a freight railroad are uninviting elements to pedestrians who may want to approach the station platform from this neighborhood. CTPS staff observed that pedestrians handled these impediments to reach the station by walking through the brush and crossing the gravel and tracks. The alternative path for pedestrians and bicyclists to reach the station is to head east to Main Street and then head west to the station—a half-mile route.

Recommendation: Work with the railroad company to either (1) create a safe connection between the station and the residential neighborhood to the southeast, or (2) take appropriate measures to prevent or discourage such crossings.

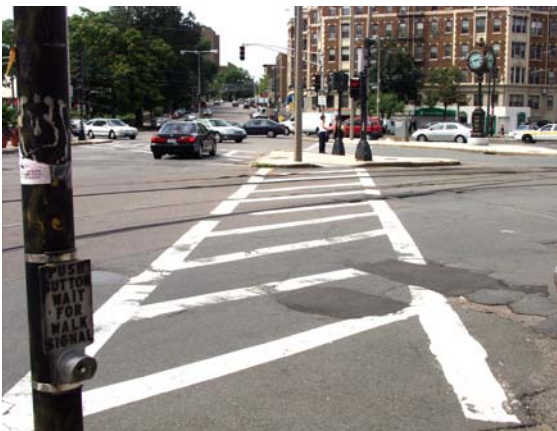
Cleveland Circle—the signalized intersection of Beacon Street and Chestnut Hill Avenue—is a challenging area to negotiate for both pedestrians and bicyclists. The intersection’s design and operation are more complex than usual for a four-leg intersection, which Cleveland Circle is essentially. Its expansive footprint handles busy, two-lane traffic approaches in each direction, in addition to the turning movements of the Green Line light-rail trains. Medians and traffic islands help break up the movements and offer refuge for crossing pedestrians.

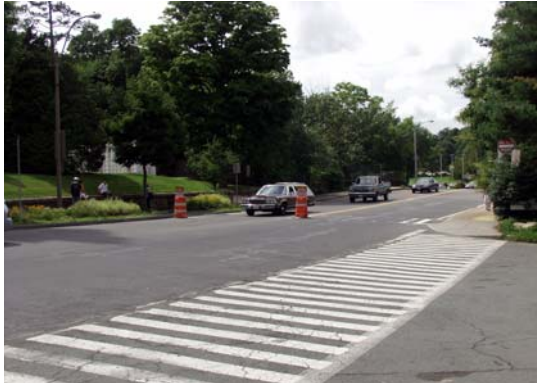
Chestnut Hill Avenue south of Reservoir Station is a two-lane roadway. Concrete sidewalks are found along both sides, and they have a grass-and-tree buffer separating them from the roadway lanes.

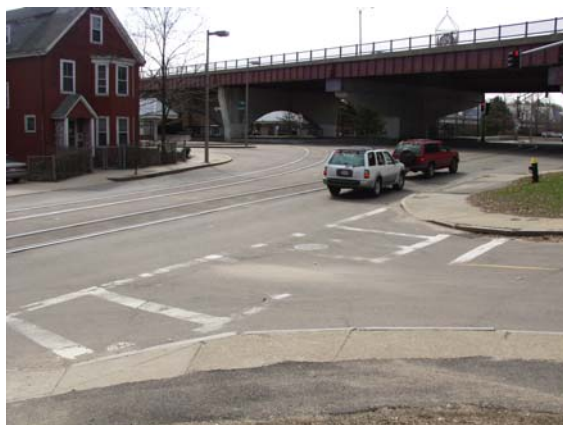
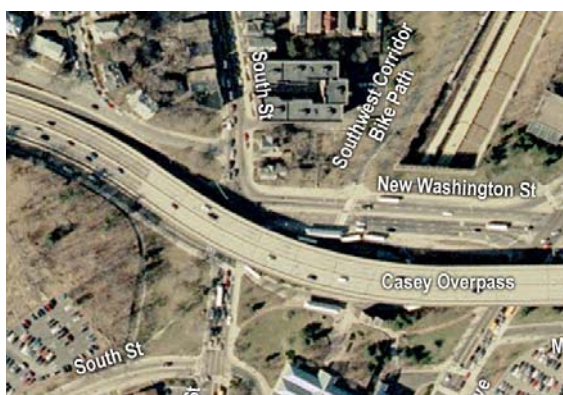
The intersection of South Street at New Washington Street and the Arborway eastbound on-ramp is signalized. South Street at the intersection is wide enough for four lanes of traffic, although no striping is present other than the middle-of-the-road yellow stripe. No pedestrian crossing is marked across South Street north of the intersection with New Washington Street.

Recommendation: Install a crosswalk across South Street, to guide pedestrians from South Street and Park Lane in the direction of the station's north entrance. Since the intersection with New Washington Street is wide, consider the following when installing this crosswalk:

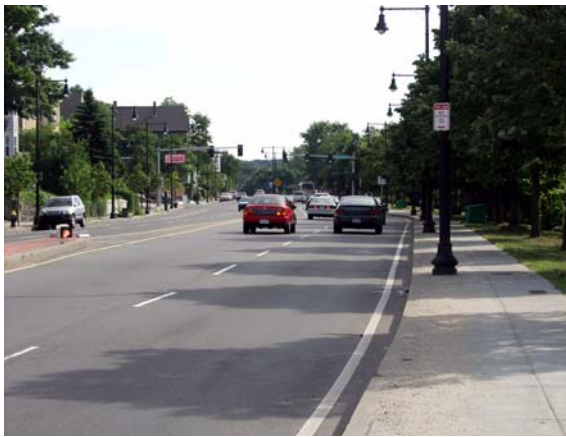
To the south of the station, and south of Ukraine Way, Hyde Park Avenue continues as a four-lane road with narrow shoulders. On-street parking is allowed on the northbound side of the street. The sidewalks on both sides are in good condition but are not buffer-separated from the street curb. However, the decorative streetlights, closely spaced along this stretch of road, act as a physical separation of traffic and pedestrian activity. Although pedestrians do not have any challenges using this corridor to reach the station, bicyclists have to deal with a challenging road, particularly northbound. Street sweeping and removal of debris should be done frequently in order to reduce hazards for bicyclists.

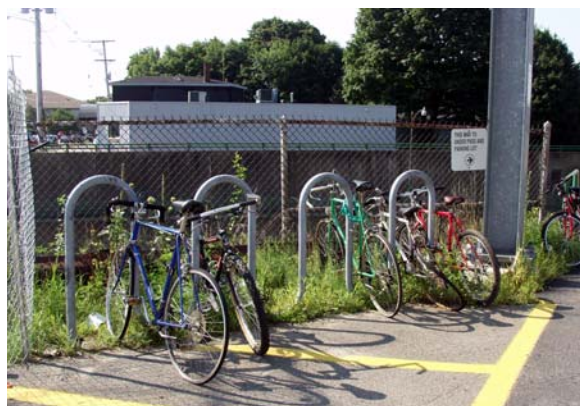
Only one bicycle rack is installed at the station, a ribbon rack on the south side of the station on the east (inbound) side of the tracks. On the day of the field audit and passenger observation, the rack was used by eight bicycles. In addition, two bicycles were locked to the chain-link fence.
