ROUTE 203

(Gallivan Boulevard and Morton Street)

**Safety, Mobility, and
Access Management**

Draft – November 2012

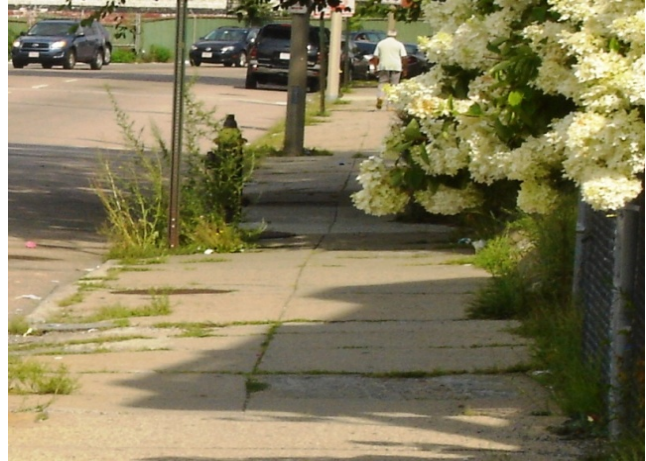
Morton Street, west of Norfolk Street: Sidewalk broken and vegetation has reduced the effective width of the sidewalk

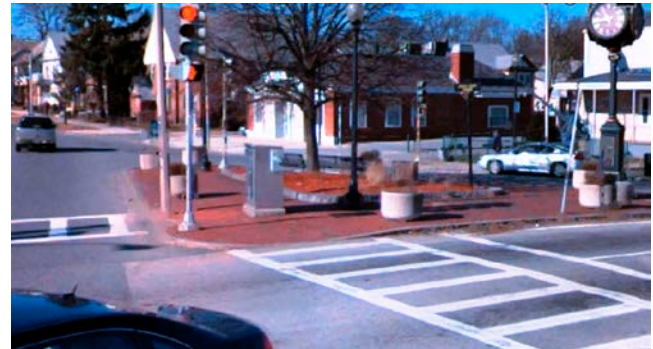
Gallivan Boulevard and Granite Street/Adams Street: Choke points that narrow the effective sidewalk width, such as mailboxes, utility poles and equipment, and landscaping.

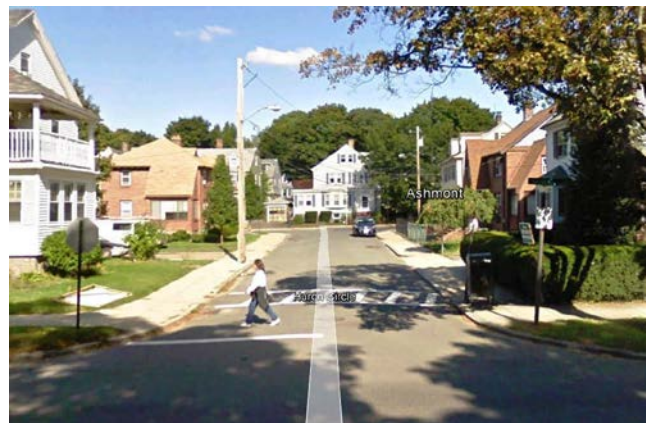
Gallivan Boulevard at Huron Circle: Curb ramps and crosswalk are not aligned to allow pedestrians to stay within the bounds of the sidewalk and the pedestrian desire line.

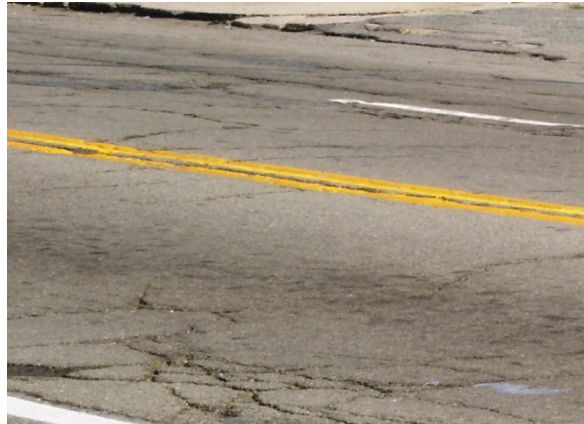
The pavement conditions for Gallivan Boulevard and Morton Street are shown in Figure 3-3. The pavement condition is generally good in the Gallivan Boulevard segment, except for the stretch between Pleasant Hill Avenue and Morton Street, where the pavement condition is poor. In the Morton Street segment, the pavement condition is generally poor. In addition, recent field observations indicate that there are extensive pavement cracking and rutting in the Morton Street segment due to drainage problems and lack of maintenance over the years.

Morton Street, west of Blue Hill Avenue: pavement is broken.

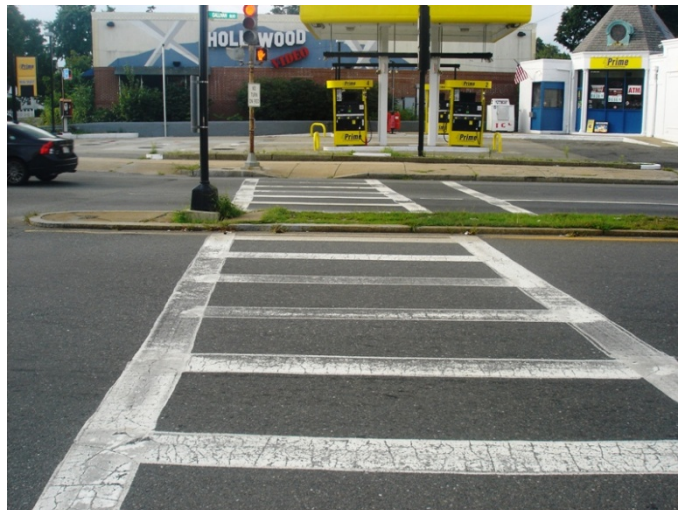
Gallivan Boulevard at Granite Avenue/Adams Street:
No opening in the median to connect the crosswalks

- Construct an opening in the median on the west leg of Gallivan Boulevard to connect the crosswalks and provide a refuge for pedestrians.

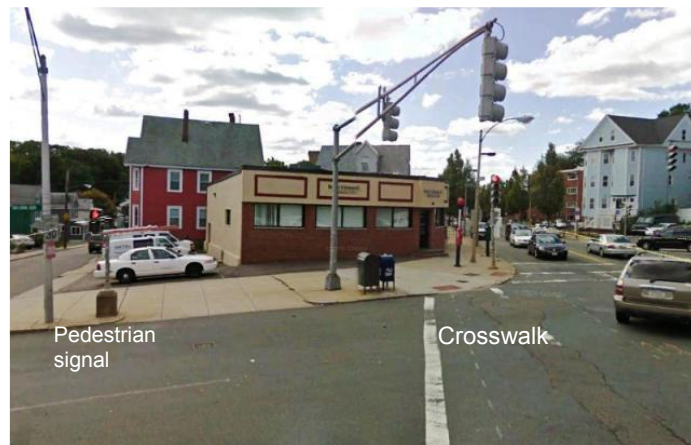
Pedestrian signal not aligned with crosswalk

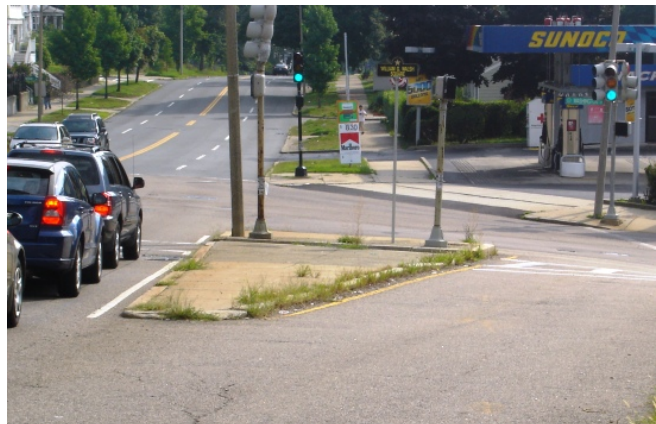
No object marker (OM1-2) installed at the approach of the triangular island

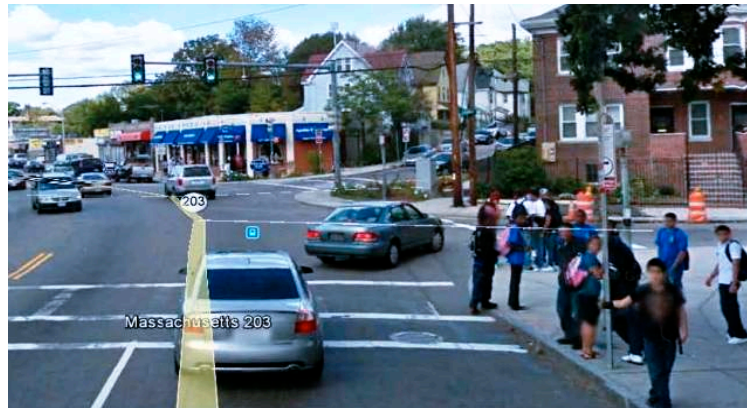
MBTA bus Routes 21 and 26 have stops at the intersection; the stop at Selden Street has 246 total daily boardings and the stop at West Selden Street has 140 total boardings. The MBTA has installed bus stop signs at the intersection. There are no bus shelters or benches at any of the stops in the vicinity of the intersection even though the total daily boardings meet the MBTA criteria for bus shelter installation.

Morton Street at West Selden Street and Corbet Street:
Students and passengers waiting for a school bus or MBTA bus.
