# Route 126 Corridor: Transportation Improvement Study

*Bellingham to Framingham*

Draft – December 2010

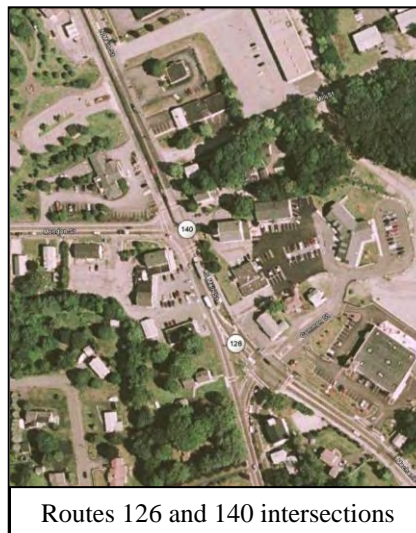
South Main Street, Mechanic Street, North Main Street, and Mendon Street form two closely spaced signalized intersections, shown in the insert at the right. The existing AM and PM peak-hour turning-movement counts are shown in Figure 3-3. Four pedestrians were observed at this intersection during the AM peak period and two pedestrians during the PM peak period. Analysis of the AM and PM peak-hour traffic presented in Table 3-1 indicated that some movements at the approaches of South Main Street and Mechanic Street operate at LOS E or F during the AM or PM peak hours, confirming field observations of queues on these approaches during peak hours.

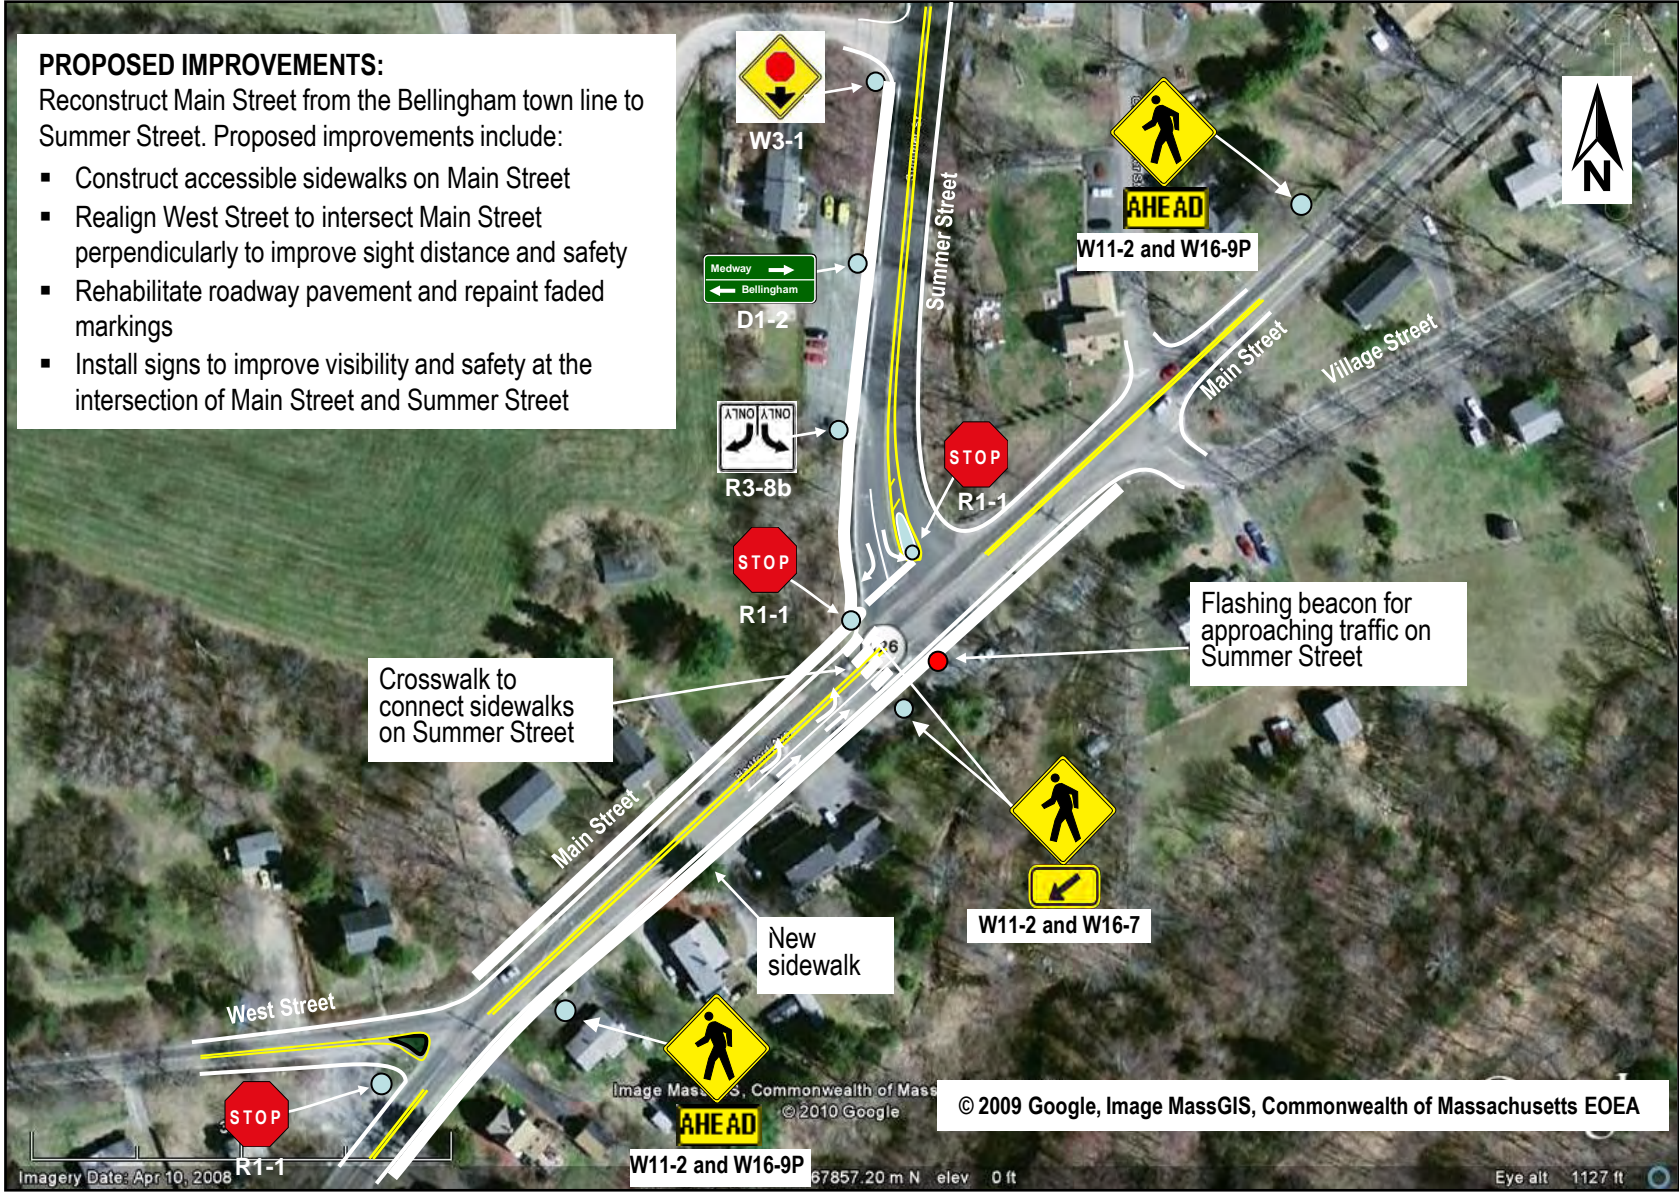
**FIGURE 4-3**  
**Main Street: From the Bellingham Town**  
**Line to Summer Street: Proposed Improvements**

In addition, staff recommend that the Main Street and Summer Street intersection be studied together with the Main Street and Village Street intersection to examine the possibility of installing coordinated signals at both intersections to improve safety and traffic flow.
