Route 1 Priority Corridor Study

Norwood, Massachusetts

December 2022

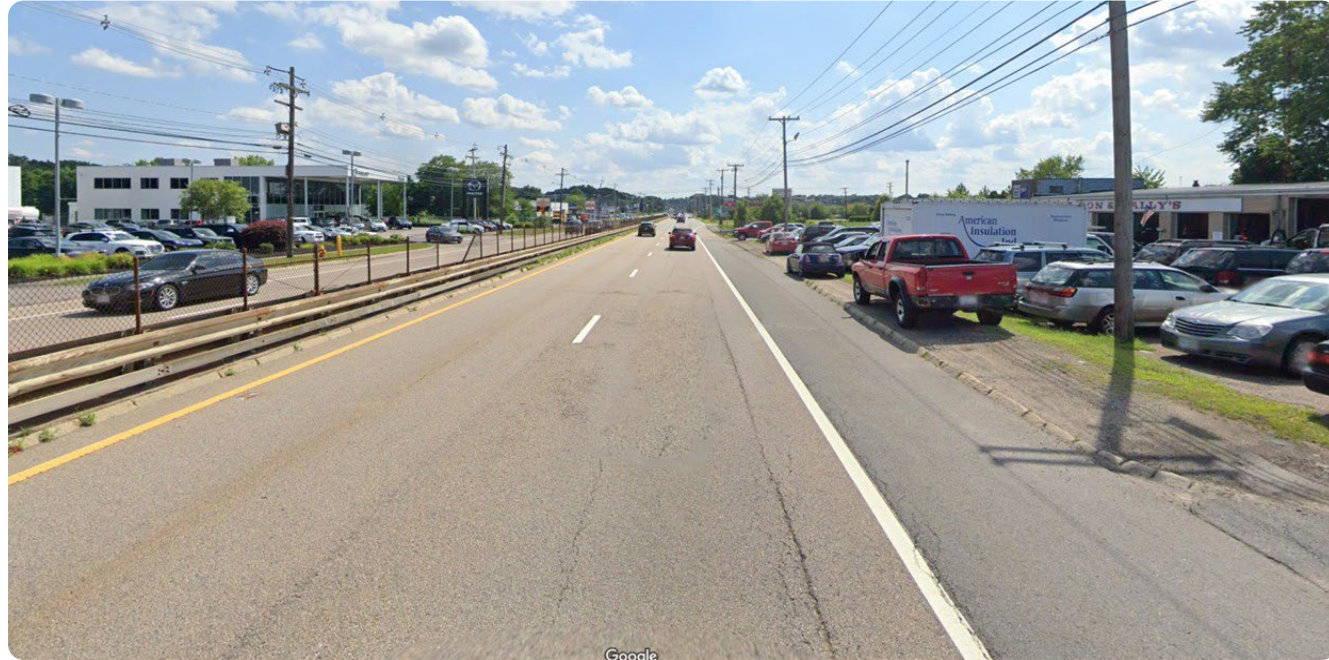
Vehicle parked on sidewalk at 905 Boston Providence Highway

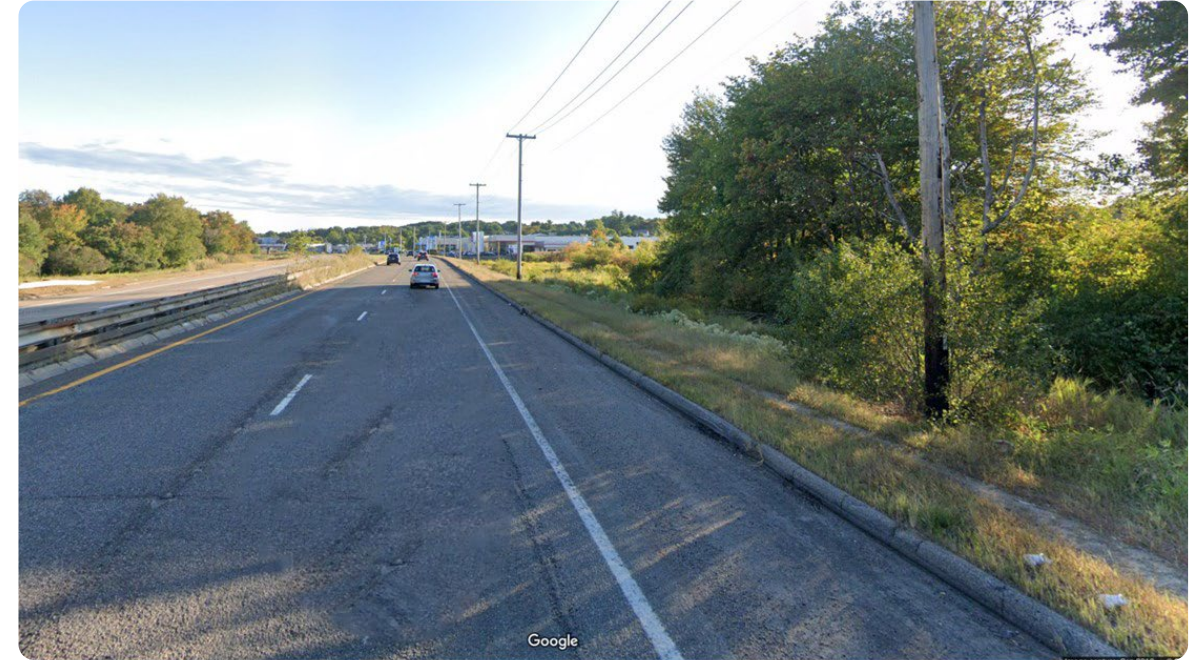
Gap in sidewalk network near Everett Street

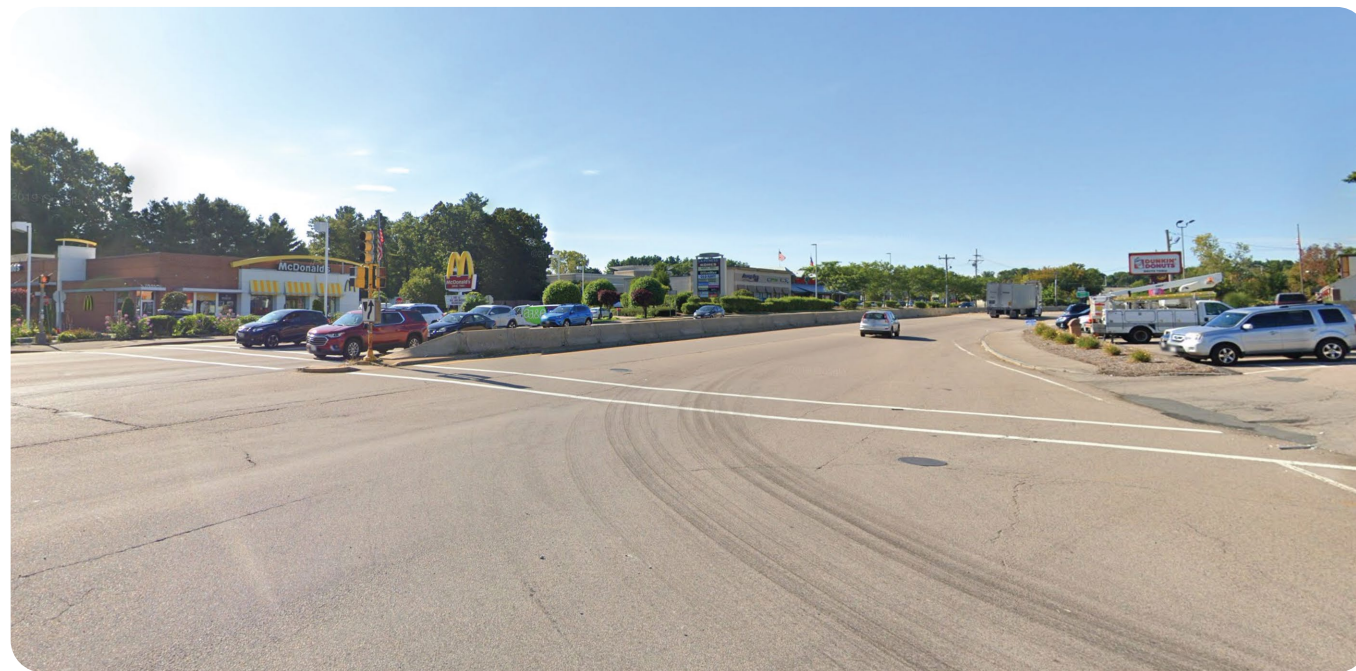
Long crosswalk with single-stage crossing at Union Street

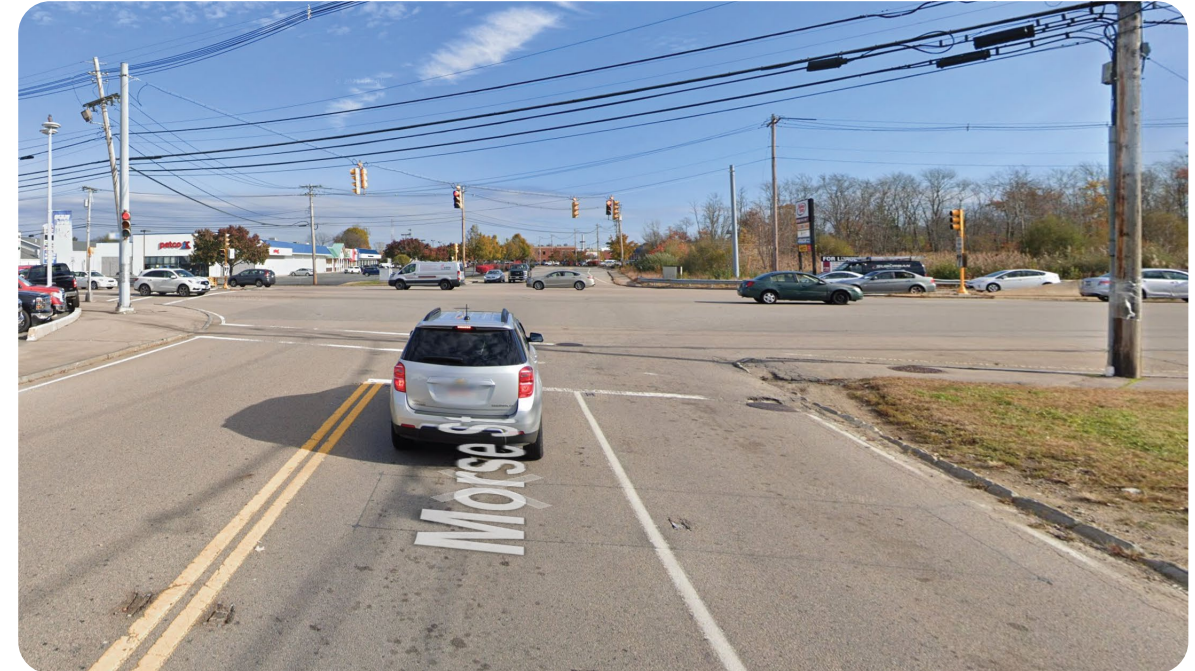
Lack of pedestrian signals and pushbuttons on Morse Street

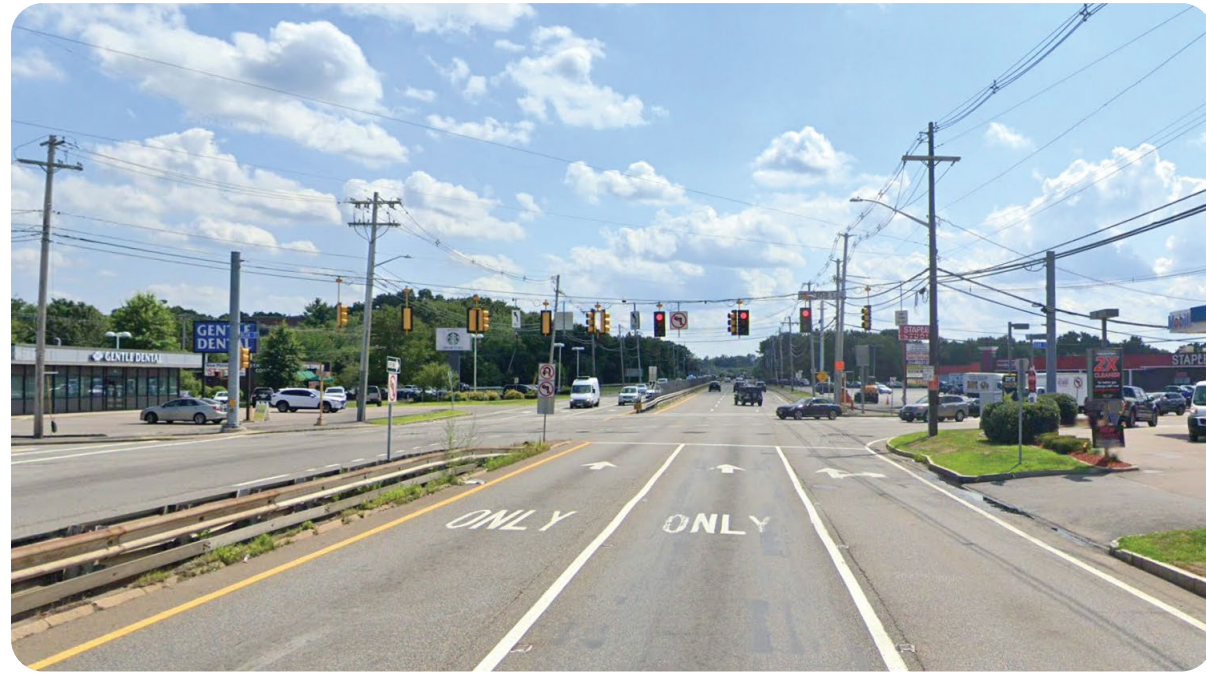
Shoulders on Route 1 end at signalized intersection because of turn lanes

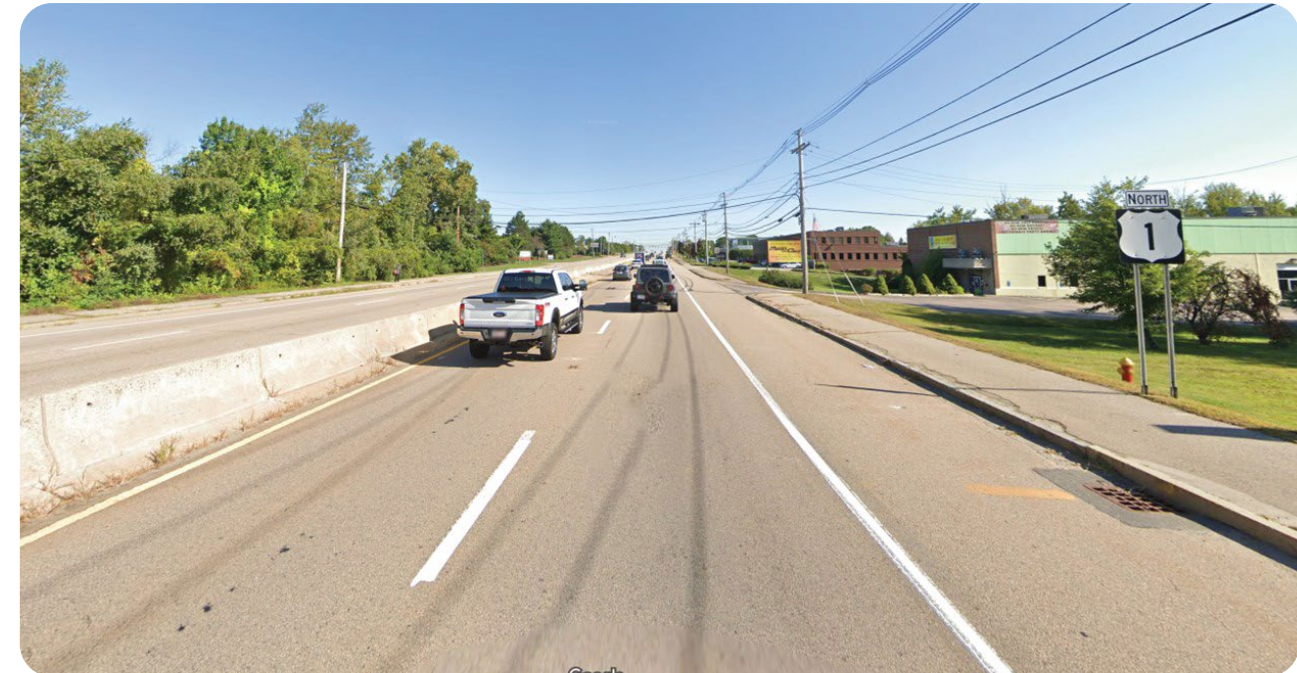
No buffer and protection for people biking on the shoulder on Route 1

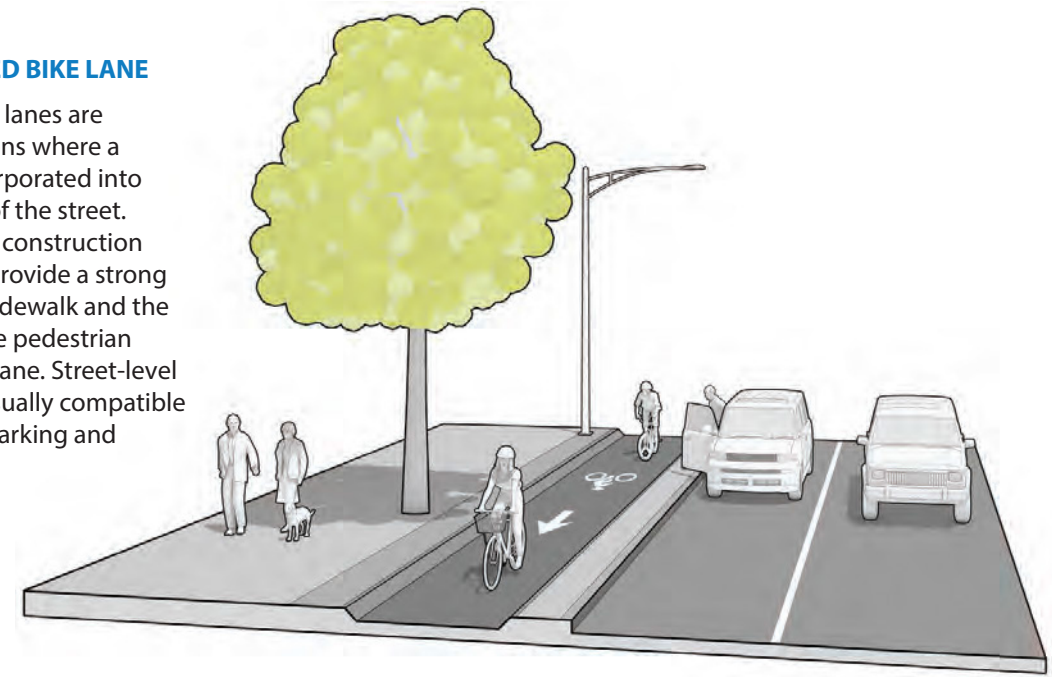
STREET-LEVEL SEPARATED BIKE LANE

Street-level separated bike lanes are common in retrofit situations where a separated bike lane is incorporated into the existing cross section of the street. They are also used for new construction where there is a desire to provide a strong delineation between the sidewalk and the bike lane in order to reduce pedestrian encroachment in the bike lane. Street-level separated bike lanes are usually compatible with accessible on-street parking and loading zones.
