## *MEMORANDUM*

**DATE** December 6, 2012  
**TO** Boston Region Metropolitan Planning Organization  
**FROM** Mark Abbott, Christine Bettin, and Bill Kuttner  
MPO Staff  
**RE** Safe Access to Transit for Pedestrians and Bicycles: Oak Grove Station

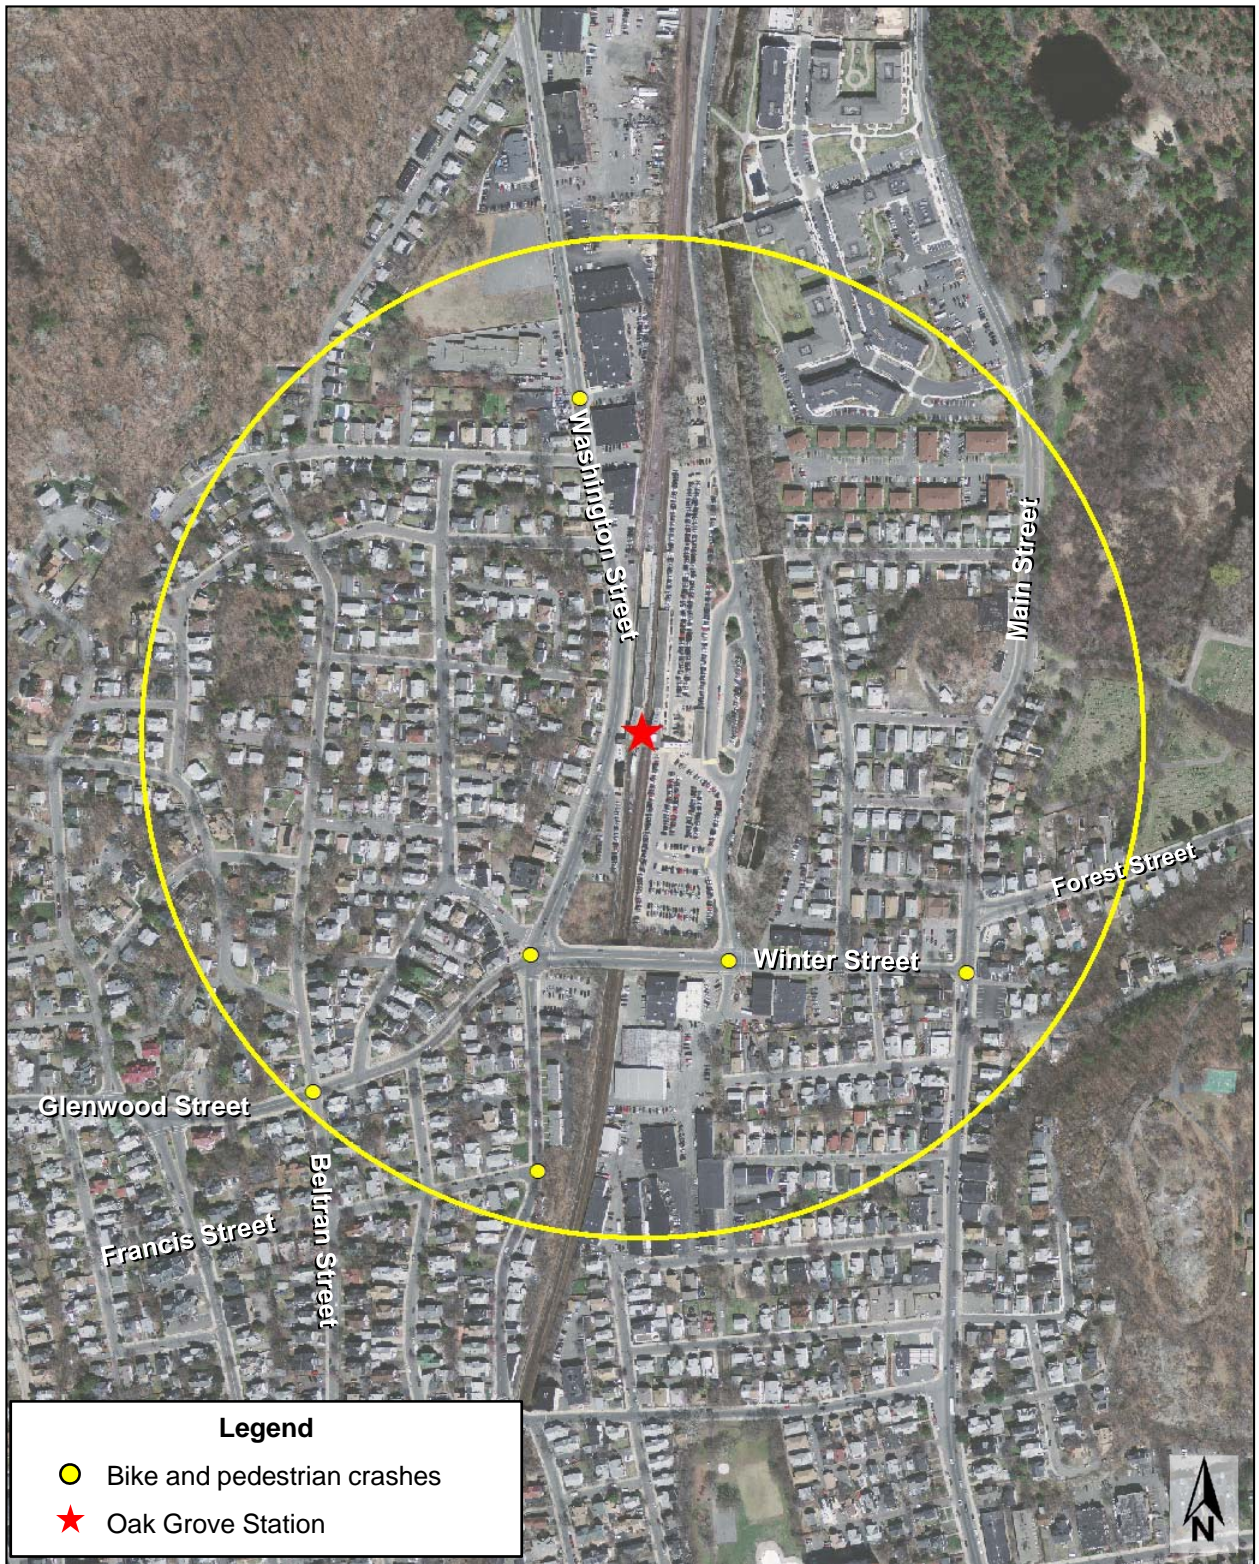
**FIGURE 1**  
**Bike and Pedestrian Crashes**  
**within One-Half Mile of Oak Grove Station**

Records available to Boston Region MPO staff show that there have been a total of seven bicycle or pedestrian crashes from 2005 to 2009 at six locations within a half-mile of Oak Grove Station (Table 2). Of the seven crashes involving a bicycle or pedestrian, two were at the same intersection and one was at a location best characterized as a driveway (Glen Rock Road). Figure 1 illustrates the locations of the bicycle and pedestrian crashes in proximity to Oak Grove Station.

<b>Intersection</b>	<b>City/Town</b>	<b>Vehicle Crashes</b>	<b>Pedestrian Crashes</b>	<b>Bicycle Crashes</b>	<b>Total Crashes</b>
Glen Rock Road/ Washington Street (Driveway)	Malden	2	0	1	3
Glenwood Street/Beltran Street	Malden	4	1	0	13
Francis Street/Washington Street	Malden	2	1	0	1
Glenwood Street/Grove Street/ Washington Street/Winter Street	Malden	11	1	1	10
Banks Place/Winter Street	Malden	0	1	0	5
Main Street/Forest Street/ Winter Street	Malden	9	1	0	3

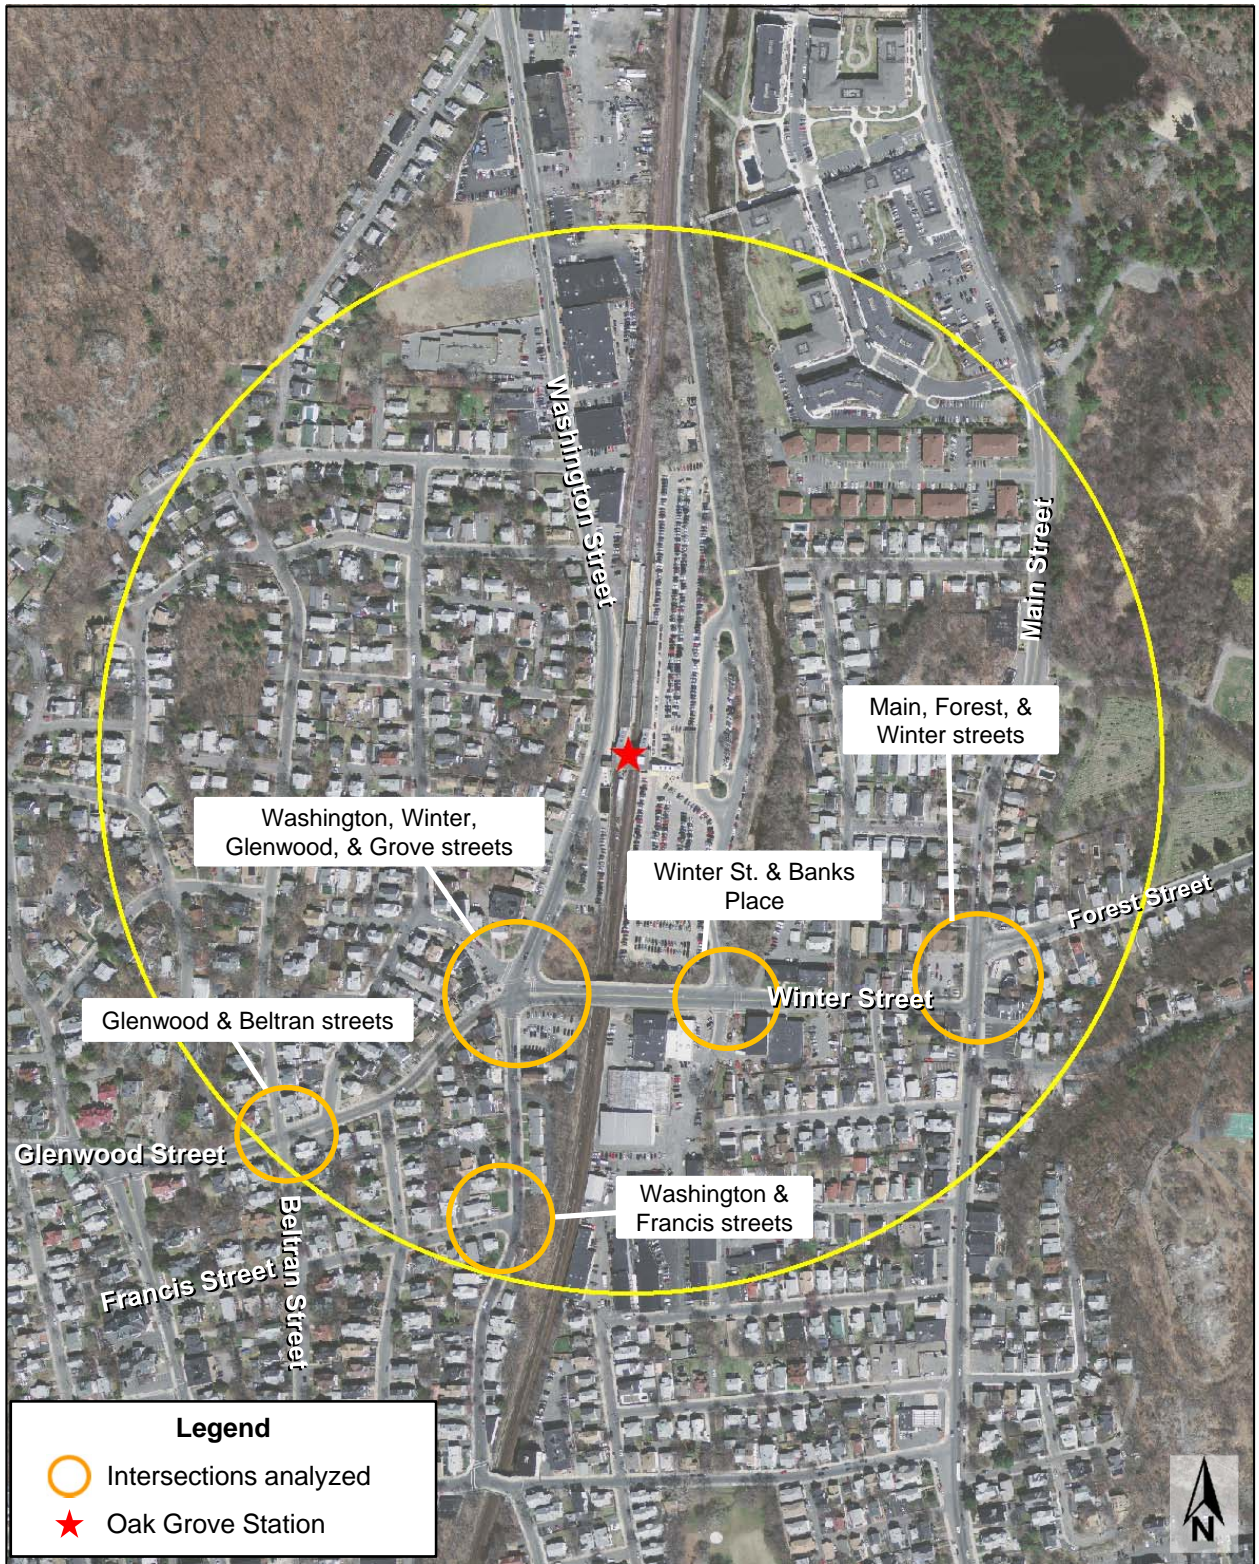
**FIGURE 2**  
**Intersections Analyzed**  
**within One-Half Mile of Oak Grove Station**

Five of those six locations, excluding Glen Rock Road at Washington Street, were selected for further analysis (see Figure 2). The five intersections are:

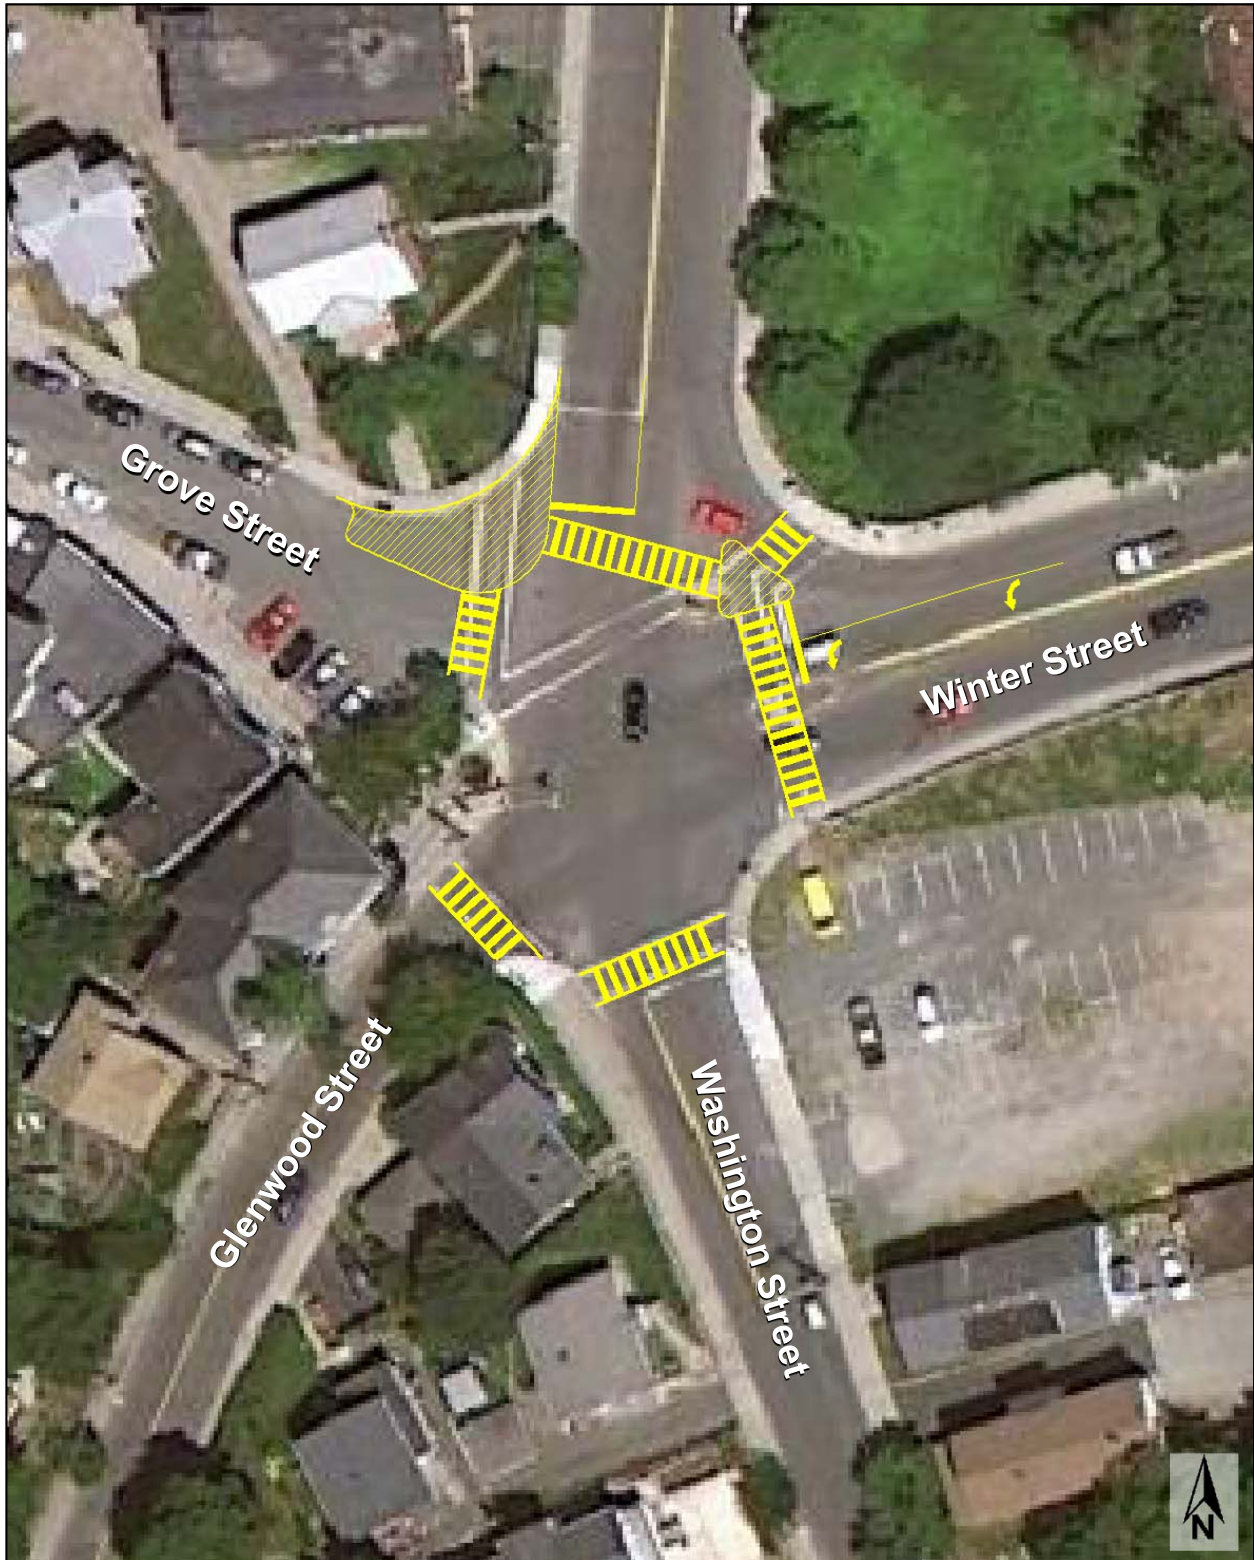
**FIGURE 3**  
**Proposed Pedestrian Improvements at**  
**Winter, Grove, Glenwood, and Washington Streets**

There is a channelizing and pedestrian refuge island across Washington Street; however, the pedestrian crossing distance from the island to the west side of the street is approximately 60 feet. The longest uninterrupted crossing a pedestrian should encounter at a crosswalk is 50 feet.<sup>5</sup> Motorists wishing to enter Grove Street from Winter Street were observed to travel in both directions around the channelizing and pedestrian refuge island.

- Construct curb extensions on the northwest corner of Grove Street and Washington Street and on the northeast corner of Winter Street and Washington Street. These curb extensions would reduce the length of the corner radii, which would help reduce the pedestrian crossing distances, reduce the speed of vehicles entering Grove Street and turning right onto Washington Street, and allow additional space for landscaping, benches, a garbage can, and bike racks to help beautify the intersection and provide bicycle and pedestrian amenities. Figure 3 provides a conceptual plan for these curb extensions.
- Install accessible pedestrian signals with countdown features for the crosswalks along the north and east legs of this intersection.
