Station Area Characteristics

Station Amenities

Station Access by Pedestrians and Bicyclists

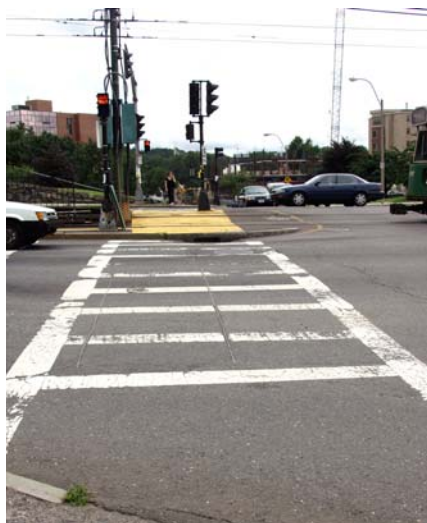
A ladder-striped crosswalk is painted across Commonwealth Avenue on the east side only, and both Lake Street and St. Thomas More Road also have crosswalks. The crosswalk paint is visible; across the median, the crosswalk is painted solid yellow. The median, however, does not have curb cuts for the pedestrian crossing. Pedestrians crossed Commonwealth Avenue at a rate corresponding to 180 pedestrian crossings per hour during the afternoon peak period.⁴

Recommendation: In addition to restriping the crosswalks, the signalized intersection should receive an upgrade of the signals and design, consisting of the following improvements:

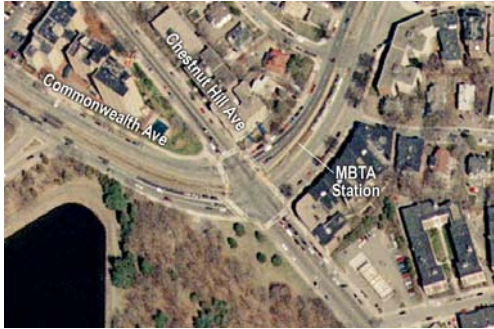
Commonwealth Avenue at Chestnut Hill Avenue

The condition of the pedestrian crosswalks is marginal, particularly across Commonwealth Avenue. The pavement has visible signs of pothole patchwork, and railroad tracks cut across the pedestrian crosswalks. The street corners and the medians lack curb cuts for wheelchair access. The median crosswalks on Commonwealth Avenue have obstructions (signal posts) in the pathway of pedestrians. The painted crosswalks have fading paint.

Recommendations: Add ramps/curb cuts to the pedestrian crossings and perform general maintenance of the crosswalks, including restriping and improving pavement condition. Consider adding curb extensions or bulb-outs to protect pedestrians and enhance their use of the intersection.

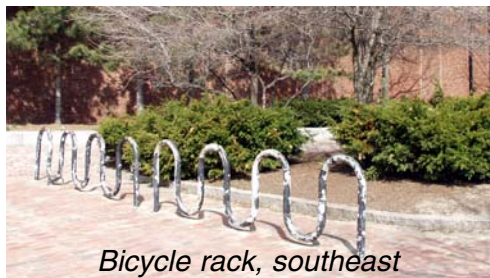
Bicycle rack, southeast

Bicycle racks are located on the north side and southeast side of the station. At the north entrance, toward the South Street side, two ribbon racks (8 spaces each) are situated just under the station roof overhang. On the southeast side of the station platform (Hyde Park Avenue entrance), two ribbon bicycle racks are located in an open area (unsheltered) just north of the parking lot. The spaces at the north entrance's bicycle racks were nearly all occupied, while most spaces were available at the bicycle racks on the southeast side.

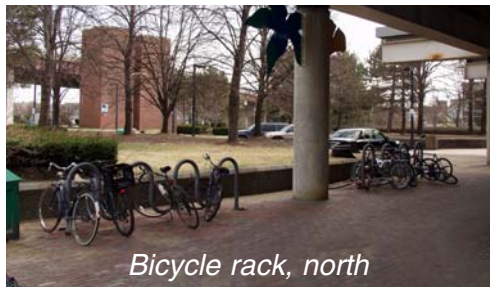
Bicycle rack, north

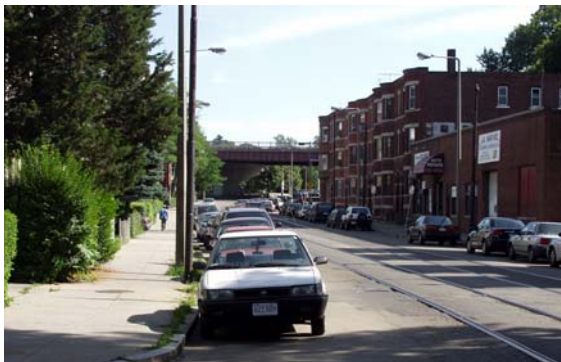
South Street approaching from the north side of the station area is a two-lane road with parked vehicles on both sides of the street. In addition, along the middle of the roadway are two sets of inactive trolley railroad tracks. The condition of the pavement is bumpy and poor. Although this street connects a heavily residential neighborhood to the station area, bicyclists are better off not riding along this street. The Southwest Corridor should be used instead, if possible.

The sidewalk along South Street seems adequate: it is wide and in good condition. However, ramp/curb cuts for wheelchairs are absent on many nearby intersections at side streets. Streetlights are present on both sides of the street.

Recommendation: Install a crosswalk across South Street, to guide pedestrians from South Street and Park Lane in the direction of the station's north entrance. Since the intersection with New Washington Street is wide, consider the following when installing this crosswalk:

- Place the crosswalk farther north, between St. Marks Street on the east and Park Lane on the west. This would discourage pedestrians from crossing South Street at the intersection, which does not have a pedestrian crossing signal or crosswalk.
- The crosswalk should be striped and have a pedestrian signpost or barrel in the center of the roadway as an added caution to drivers.
- Alternatively, or in addition, South Street could be narrowed at the intersection of New Washington Street to slow down through and turning traffic. A bulb-out at the northeast corner of the intersection, for instance, would slow down the right-turning vehicles from New Washington Street to South Street.

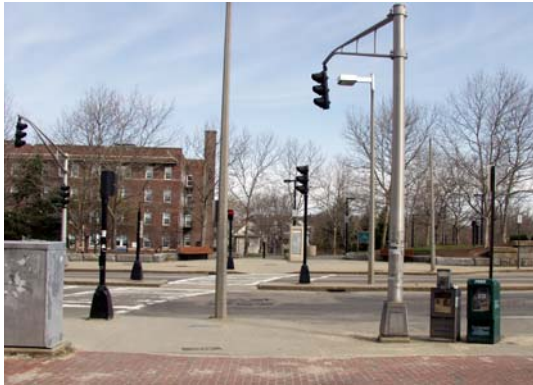
Southwest Corridor Park at New Washington Street

The Southwest Corridor Park (and Bike Path) approaches Forest Hills Station from the north. Leaving it at New Washington Street, across from the station, bicyclists and pedestrians can cross midblock using a signalized (pedestrian actuated) and striped pedestrian crossing.

The design of the New Washington Street crossing of the Southwest Corridor and the north entrance of the station fails to make a good connection between these transportation facilities. The crosswalk (and median curb cut) angle away from the station's north entrance; the crosswalk does not follow desire lines of users of the Southwest Corridor Park to the station entrance. Furthermore, no signs are posted directing station users exiting the station to the Southwest Corridor Park and Bike Path; and from the southbound perspective heading toward the station, the north entrance location is not easily visible.

- Restripe the existing crosswalk.
 - Install pedestrian-crossing signs for vehicular traffic.
 - Fix the broken streetlight on north side of the pedestrian crossing of New Washington Street at Southwest Corridor.

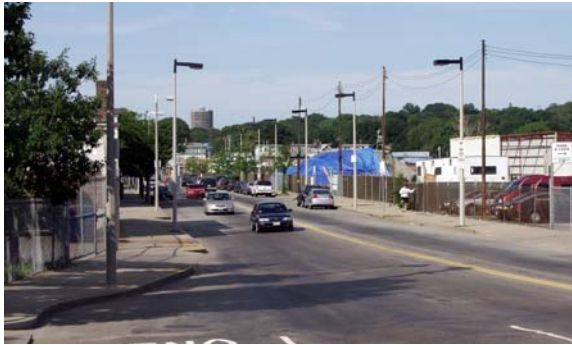
Washington Street North

Washington Street to the north of the station is a busy two-lane roadway. The street allows for parking on both sides of the road. A school located farther north on Washington Street generates pedestrian activity toward the station. Sidewalks between the school and the station area seem adequate. Bicycle conditions are not favorable due to on-street parking and the high traffic volumes along Washington Street.

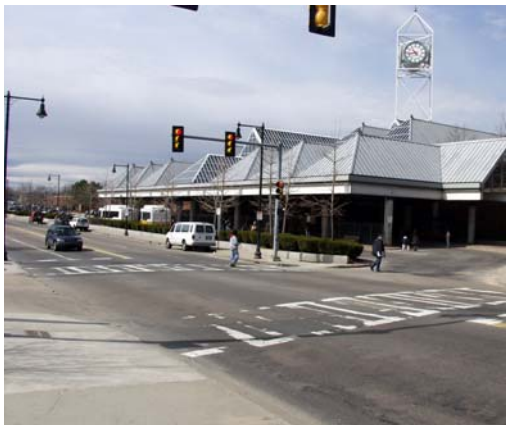
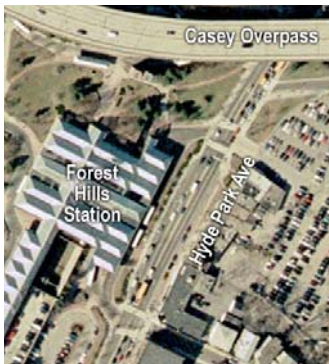
Hyde Park Avenue between New Washington Street and Ukraine Way

Hyde Park Avenue, which runs along the east side of the station, is a busy four-lane road. The avenue lies between a residential neighborhood to the east and the station to the west. A series of closely spaced driveways create the need for two signalized intersections (for access to the bus bays, Tower Street, and Woodlawn Street), and one unsignalized intersection (at the southeast parking lot), all of which handle many turning vehicles and pedestrian crossings. The street sign at Tower Street indicates that the north–south avenue is called “Washington St.” not “Hyde Park Ave.”

Recommendations: Improvements along Hyde Park Avenue between Ukraine Way and New Washington Street should facilitate driver awareness and visibility of pedestrian activity at the intersections along this stretch of road. Basic improvements should consist of the following:

- Restripe the pedestrian crosswalks.
- Add pedestrian crossing signs.
- Move all stop lines 10 feet back from crosswalks, and add “Stop Here on Red” sign.
- Consider posting “No Turn on Red” signs, but not before analyzing their impact on traffic operations. Alternatively, add “Yield to Pedestrians on Turns” signs.
- Consider signs for pedestrians to encourage street crossing only during the “Walk” signal.
- Correct the street name sign at Tower Street, to indicate that the roadway heading north is “Washington St.” and the roadway heading south is “Hyde Park Ave.”

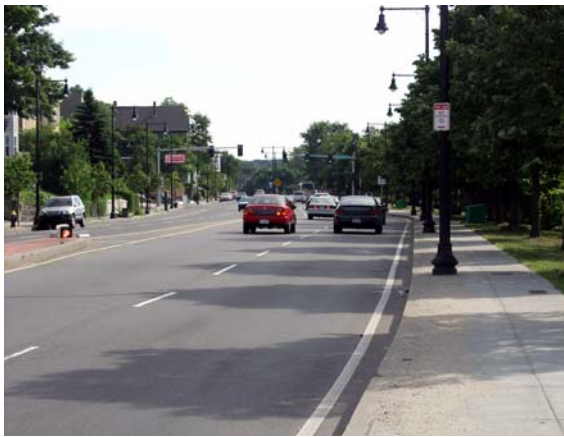
Hyde Park Avenue South

To the south of the station, and south of Ukraine Way, Hyde Park Avenue continues as a four-lane road with narrow shoulders. On-street parking is allowed on the northbound side of the street. The sidewalks on both sides are in good condition but are not buffer-separated from the street curb. However, the decorative streetlights, closely spaced along this stretch of road, act as a physical separation of traffic and pedestrian activity. Although pedestrians do not have any challenges using this corridor to reach the station, bicyclists have to deal with a challenging road, particularly northbound. Street sweeping and removal of debris should be done frequently in order to reduce hazards for bicyclists.
