Improving Pedestrian and Bicyclist Access to Selected Transit Stations

A report produced by the Central Transportation Planning Staff for the Massachusetts Highway Department and the Massachusetts Bay Transportation Authority

September 2005

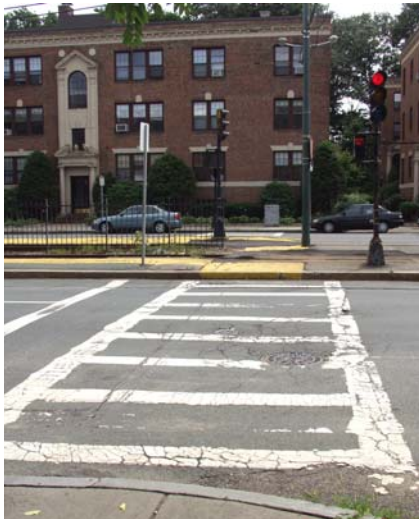
Greycliff Road and South Street Stops

The Greycliff Road and South Street stops are in the median of Commonwealth Avenue—a typical characteristic of this light-rail branch. Pedestrian crosswalks between the Commonwealth Avenue sidewalks and the median station platforms at the South Street and at the Greycliff Road stops are in poor condition. Although these crosswalks have white, ladder-striped pavement markings, the pavement condition is cracked and ramps/curb cuts are nonexistent. Plus, on the north sidewalk along Commonwealth Avenue, the grass buffer that separates the paved sidewalk and the curb—a recommended design feature of sidewalks—does not contain paved breaks/cuts at the crosswalks.

Recommendation: Add ramps/curb cuts to the pedestrian crossings and perform general rehabilitation of the crosswalk, including restriping and improving pavement condition.

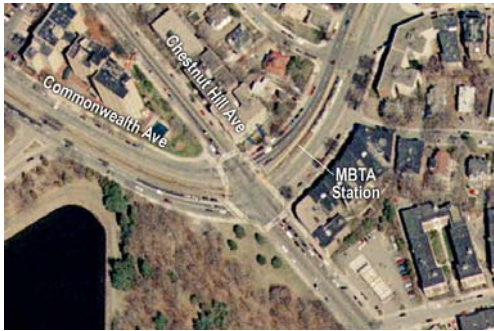
Commonwealth Avenue at Chestnut Hill Avenue

The four-approach, signalized intersection of Chestnut Hill Avenue at Commonwealth Avenue features two lanes in each direction of east-west through traffic, two railroad tracks for the Green Line light-rail trains, and the north-south lanes of vehicle traffic (two to the north, four to the south). Pedestrian walk signals are present at all four corners of the intersection and at the median on Commonwealth Avenue.

The pedestrian signals seem to function in an appropriate manner. A brief all-red traffic signal (all-walk for pedestrians) coupled with a “No Turn on Red” restriction for vehicular traffic gives pedestrians a chance to cross these streets without turning-vehicle conflicts. Furthermore, partial pedestrian crossing (to the median) of Commonwealth Avenue is permitted depending on the vehicular movement.

The condition of the pedestrian crosswalks is marginal, particularly across Commonwealth Avenue. The pavement has visible signs of pothole patchwork, and railroad tracks cut across the pedestrian crosswalks. The street corners and the medians lack curb cuts for wheelchair access. The median crosswalks on Commonwealth Avenue have obstructions (signal posts) in the pathway of pedestrians. The painted crosswalks have fading paint.

Recommendations: Add ramps/curb cuts to the pedestrian crossings and perform general maintenance of the crosswalks, including restriping and improving pavement condition. Consider adding curb extensions or bulb-outs to protect pedestrians and enhance their use of the intersection.

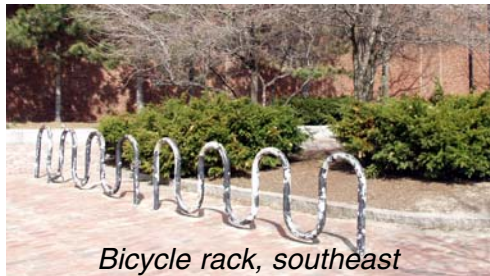
Bicycle rack, southeast

Bicycle racks are located on the north side and southeast side of the station. At the north entrance, toward the South Street side, two ribbon racks (8 spaces each) are situated just under the station roof overhang. On the southeast side of the station platform (Hyde Park Avenue entrance), two ribbon bicycle racks are located in an open area (unsheltered) just north of the parking lot. The spaces at the north entrance's bicycle racks were nearly all occupied, while most spaces were available at the bicycle racks on the southeast side.

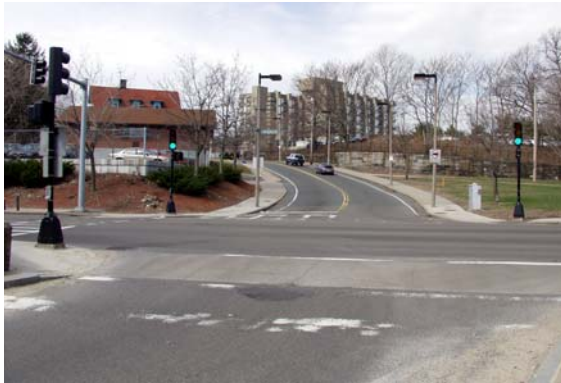
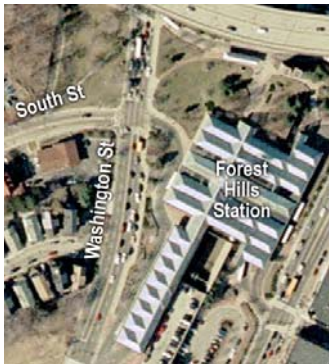
Washington Street at South Street West

The intersection of South Street at Washington Street at the west side of the station is signalized (cycle length is 80 seconds). Pedestrian walk signals activate when concurrent traffic has a green phase. Pedestrian crosswalks are marked only for the north–south movements (across South Street and across the bus exit) and for the southeast–west movement (across Washington Street). This design discourages pedestrians from crossing Washington Street at the north side of the intersection, which handles most of the turning traffic. South Street traffic onto Washington Street in the

evening has a predominant left-turning movement. Since traffic has a “Yield to Pedestrians on Turns” sign, pedestrians can cross Washington Street to the station (east) side along the south crosswalk while most of South Street traffic has a green phase. Significant southbound traffic from Washington Street turns right onto South Street heading west.

CTPS staff observed over 170 pedestrians and 40 bicyclists traversing this intersection during a two-hour afternoon period.³ Half of the crossing pedestrians observed crossed Washington Street from South Street heading toward the Forest Hills Station side. (Presumably, the generator of this pedestrian traffic is the University of Massachusetts Medical Center–Jamaica Plain campus on South Street.) As noted earlier, the design of the intersection leads pedestrians to cross Washington Street along the south side of the intersection. However, many pedestrians from South Street happen to arrive at the intersection on the north side of the intersection; similarly, from the station side, pedestrians who have walked along the busway’s northside sidewalk (the only one available) also arrive at the intersection on the north side. In both cases, pedestrians who wish to cross Washington Street must first cross the street southbound to reach the Washington Street crosswalk. Pedestrians, however, were observed crossing along the north side of the intersection, despite the lack of a marked crosswalk.

Recommendations:

- Improve visibility of the pedestrian crossings by restriping the crosswalks, which are faded
- Install pedestrian-crossing signs, as further warning to vehicles
- Consider installing pedestrian-crossing signals with animated-eyes displays, as a reminder to pedestrians to watch for turning vehicles

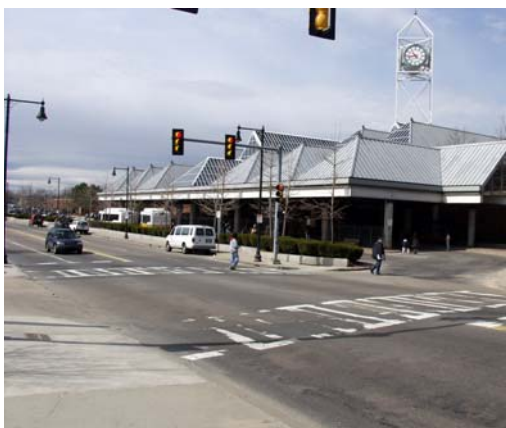
Hyde Park Avenue between New Washington Street and Ukraine Way

Hyde Park Avenue, which runs along the east side of the station, is a busy four-lane road. The avenue lies between a residential neighborhood to the east and the station to the west. A series of closely spaced driveways create the need for two signalized intersections (for access to the bus bays, Tower Street, and Woodlawn Street), and one unsignalized intersection (at the southeast parking lot), all of which handle many turning vehicles and pedestrian crossings. The street sign at Tower Street indicates that the north-south avenue is called “Washington St.” not “Hyde Park Ave.”

Recommendations: Improvements along Hyde Park Avenue between Ukraine Way and New Washington Street should facilitate driver awareness and visibility of pedestrian activity at the intersections along this stretch of road. Basic improvements should consist of the following:

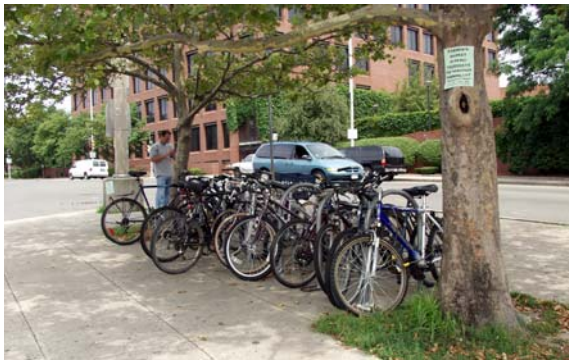
Bicycle Parking

On the west side, the bicycle rack (containing eight inverted-U rack elements) is located adjacent to the station building near the entrance. A short roof overhang provides partial cover for the parked bicycles.

On the east side, where most of the bicycle parking is provided, the bicycle racks were located in the open square, just northeast of the station entrance. During the recent construction period, eight inverted-U racks were relocated to the outside sidewalk of the bus/vehicle passenger drop-off area, along Commercial Street. These provide fewer bicycle parking spaces than the previous location. These racks were being used; additional bicycles were found locked to the fence along bus platform #2, on the east side of the station.

Recommendations:

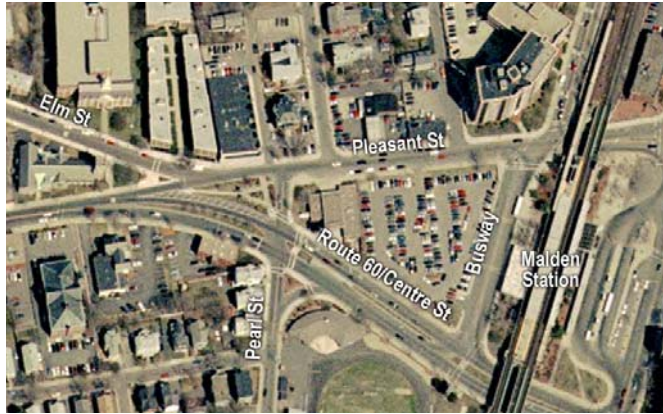
Pleasant Street and Elm Street

The main approach to Malden Center Station from the west is along Pleasant Street. Abutting the north side of the station property, Pleasant Street is a two-lane road between Commercial Street and Pearl Street. Sidewalks are available on both sides, and appear adequate, except for the sidewalk adjacent to the MBTA commuter parking lot.

Recommendations:

- Repair the sidewalk on the south side of Pleasant Street adjacent to the commuter parking lot. Consider reducing the roadway width by two feet in order to provide a landscaped buffer between the sidewalk and the roadway.
- Extend the sidewalk and curb at the gore of the Elm Street–Pleasant Street split to reduce the lane width for vehicles and provide additional refuge for pedestrians. Pavement striping, particularly for lane shoulders for vehicles, should clearly delineate the roadway split. The curb at the gore point should be clearly marked, possibly with yellow paint on the curb and/or reflective or nonreflective pavement markers.

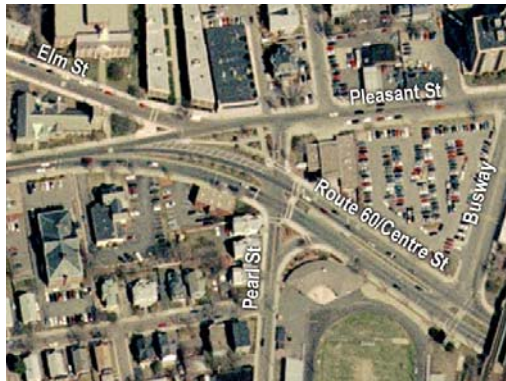
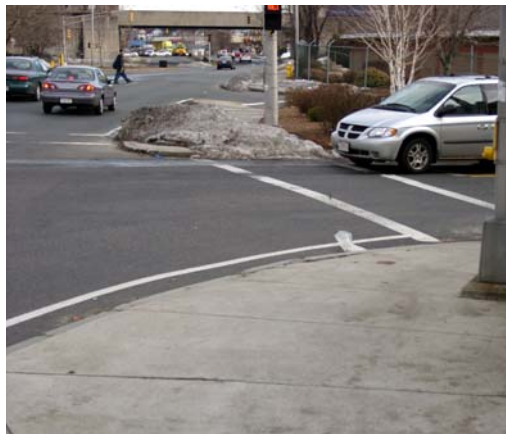
Pearl Street and Centre Street (West)

The intersection of Pearl Street at Centre Street (Route 60) is signalized. Northbound-to-eastbound right-turning traffic has its own lane, which is channel-separated from the northbound through and left-turning traffic. The design of the sidewalk curb cuts and crosswalks does not favor pedestrian movement in the direction of the nearby station. This may explain why pedestrians were observed crossing Pearl and Centre Streets outside of the crosswalks.

The traffic signal cycle has an all-red/all-walk phase for pedestrians, which is activated by push buttons. Vehicles are allowed to turn on a red light. Not all of the pedestrian-activated buttons seem to function, though, and the east-facing pedestrian “walk” signal on the south side does not turn on. A pedestrian crossing signal is missing for those pedestrians crossing Centre Street from the northeast side to Pearl Street.

Recommendations: The intersection of Pearl Street at Centre Street should be redesigned to improve pedestrian flow; the following actions should be implemented:

- Align the ramps/curb cuts and the corresponding crosswalks in the direction of pedestrian flow, parallel to Centre Street
- Paint the crosswalks with ladder-style stripes
- Fix the malfunctioning pedestrian-activated push buttons and install the missing pedestrian crossing signal
- Add a “Yield to Pedestrians” sign to all traffic approaches

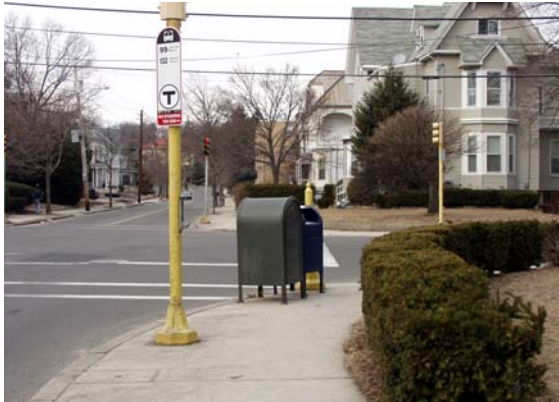
Summer Street approaches Malden Center Station from the north, linking a large residential area to Pleasant Street on the northwest side of the station. Summer Street is a two-lane road with on-street parking and concrete sidewalks on both sides. The sidewalks are paved to the curb and have trees, posts, and signs along their extent. The intersections, such as those with Maple Street, Mountain Avenue, Chestnut/Lincoln Street, and Clifton Street, all have a similar crosswalk design: two parallel, solid white lines delineating the crosswalk with ramps/curb cuts placed back from the intersection. In general, the sidewalks along Summer Street are in good

condition. However, at some street corners, obstructions (such as mailboxes, streetlights, and sign posts) are in the pathway of pedestrians and the crosswalk/curb cuts.

Recommendations: In order to enhance pedestrian safety and comfort at the intersections along Summer Street, implement the following improvements:

- Add ladder-style striping to the crosswalks, in order to increase visibility
- Relocate mailboxes and other obstructions from the path of pedestrians
- Add “Yield to Pedestrians” signs at the intersections, particularly at Pleasant Street
- Redo the corner curbs at Mountain Avenue and at Clifton Street to add perpendicular wheelchair ramps
- Consider adding bulb-outs at the intersection with Mountain Avenue

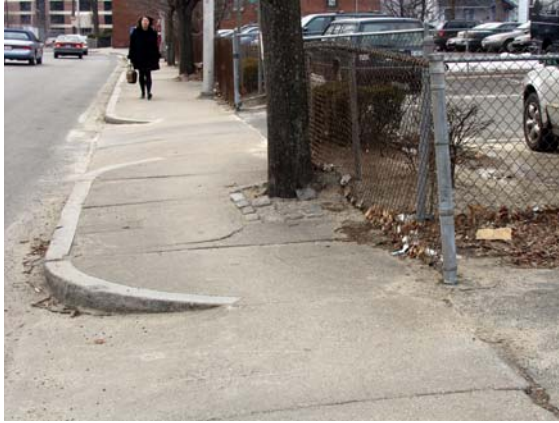
The intersection of Florence Street at Washington Street is signalized. The crosswalks at the intersection are striped with two parallel, solid white lines. The traffic signal cycle has a pedestrian-activated all-red/all-walk phase. However, not all the buttons are functioning. Turns on a red light are allowed.

The sidewalks on both sides of Florence Street west of Washington Street are in poor condition: street curb cuts are present that lead to a fence, no buffer separates vehicle traffic from the sidewalk, significant cracks are found in the concrete, and debris was found along both the street curb and the fence that lines the sidewalk. (Please note that the City of Malden is currently selecting proposals for redeveloping property along Florence Street. Changes could occur within the next three years.)

Recommendations:

- Improve the sidewalk condition and design along Florence Street by implementing the following:
 - Reconstruct the sidewalk in order to correct for unnecessary street curb cuts and improve surface condition. Consider narrowing the traffic lanes in order to increase the sidewalk width or even add a landscaped buffer to further separate vehicle traffic from pedestrian activity.
 - Stripe shoulder lanes to provide a buffer between vehicle traffic and the sidewalk
- Increase pedestrian safety at the intersection of Florence Street at Washington Street by implementing the following:
 - Add ladder-style striping to the crosswalks
 - Extend the median closer into the intersection in order to create a midcrossing refuge for pedestrians using the crosswalk
 - Fix malfunctioning pedestrian-activated push buttons
 - Add a “Yield to Pedestrians” sign to all traffic approaches

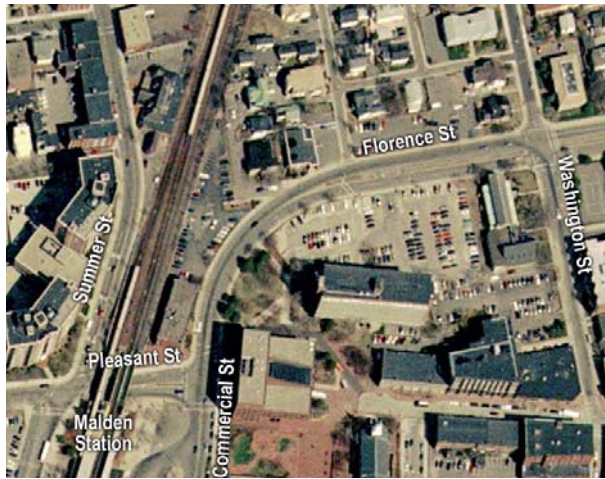
Just northeast of the station is the signalized intersection of Florence Street at Pleasant Street and Commercial Street. This three-legged intersection features many turning vehicles, particularly right turns from southbound Florence Street, right turns from eastbound Pleasant Street, and left turns from northbound Commercial Street; right turns are permitted on red. Crosswalk signal buttons activate an all-walk pedestrian phase. Crosswalks on all three approaches are simply two parallel white lines, which are fading. During recent observations in the morning peak hour, 360 pedestrians crossed Pleasant Street, over 168 pedestrians crossed Commercial Street, and 106 pedestrians crossed

Recommendations: Increase pedestrian safety at the intersection of Florence Street at Pleasant Street and Commercial Street by implementing the following:

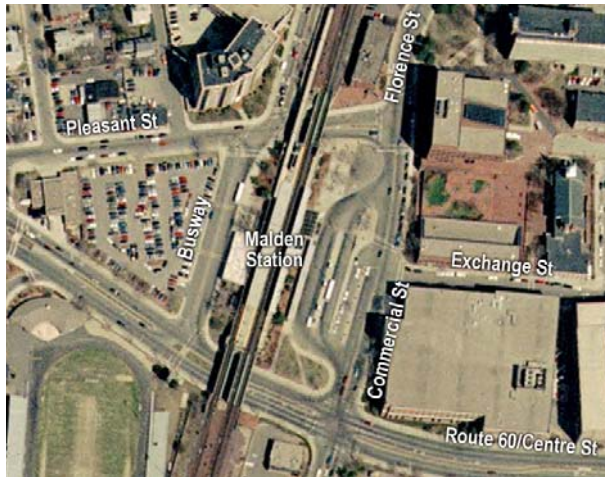
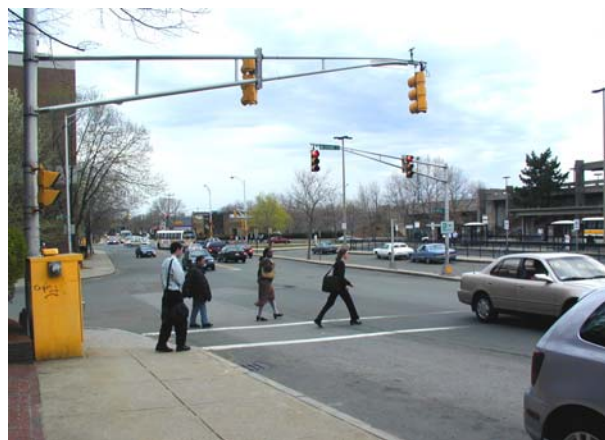
Exchange Street at Commercial Street, on the east side of Malden Center Station, is a signalized intersection. Traffic at this intersection also enters the station's eastside passenger drop-off bay. The northbound and southbound lanes have unlimited green signal time (Exchange Street is a one-way, eastbound street), except when triggered by an all-way pedestrian-actuated walk signal. Crosswalks are simply striped with two parallel white lines, on the north side of the intersection (leading toward the station entrance) and across Exchange Street.

As part of the Malden Center Station accessibility construction, the crosswalk and curbs across Commercial Street at Exchange Street have been reconfigured. The MBTA is replacing the existing sidewalk and wheelchair ramp at the crosswalk ends with new wheelchair ramps. New white thermoplastic striping will be added to the crosswalk, including ladder stripes. The MBTA is also removing and resetting the northern-end curb of the drop-off bay back by eight feet.

Recommendations: The following amenities should be provided to increase pedestrian safety at the intersection of Exchange Street and Commercial Street:

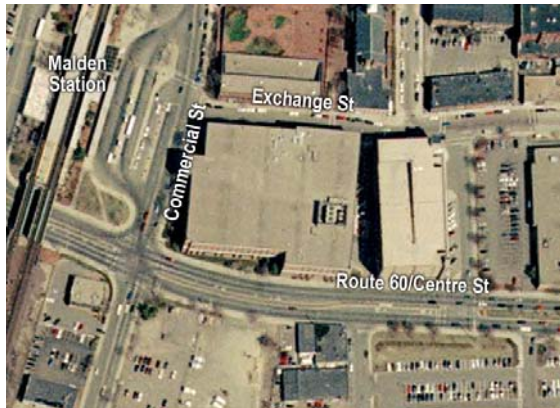
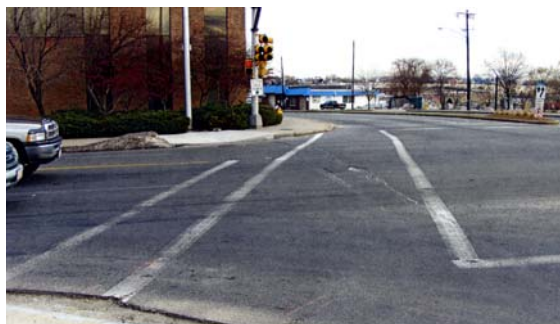
Centre Street (Route 60) at Commercial Street is a busy, signalized intersection. Each approach of the intersection has two lanes, and Centre Street is divided by a landscaped median. Pedestrian crossings are striped across all four approaches, with only simple, parallel white stripes; each corner features only one sidewalk curb cut for wheelchair ramps. Pedestrian walk signals turn on concurrently with the two-way through traffic, during which left turns are permitted. A sign is posted for pedestrians with the warning, “Watch for Turning Vehicles on Walk Signal.” However, the concurrent pedestrian walk signal does not activate during the phase that includes one-way through traffic and a protected left.

As part of the Malden Center Station accessibility construction, the corner curbs on the northeast and northwest corners of the intersection of Commercial Street and Centre Street have been reconfigured. The MBTA is replacing the existing sidewalk and wheelchair ramp on the northwest corner with two new wheelchair ramps. These two new ramps will line up with the

Recommendation: Increase pedestrian safety at the intersection of Centre Street (Route 60) at Commercial Street by implementing the following:

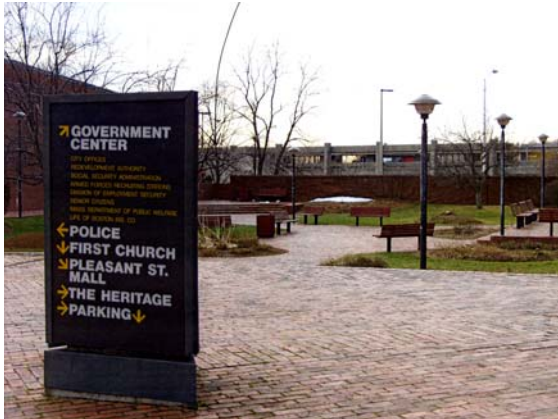
Malden Center and Pleasant Street East

Currently, Pleasant Street at the Malden Center business district is cut off from Commercial Street and Malden Center Station by the Malden Government Center buildings and plaza. This eastern extension of Pleasant Street itself offers a favorable pedestrian environment: the wide, brick sidewalks with street-level shops are buffered from the low traffic volumes by on-street parking.

In order to access the station from the commercial center of Malden, travelers must either walk through the Government Center plaza and down stairs (or a long ramp) to Commercial Street, or take a side street to

Exchange Street, which connects to Commercial Street and the station. The station is not clearly visible from the west end of Pleasant Street (the T “lollipop” sign is not visible at all), and trailblazing signs at Government Center do not direct people to the station.

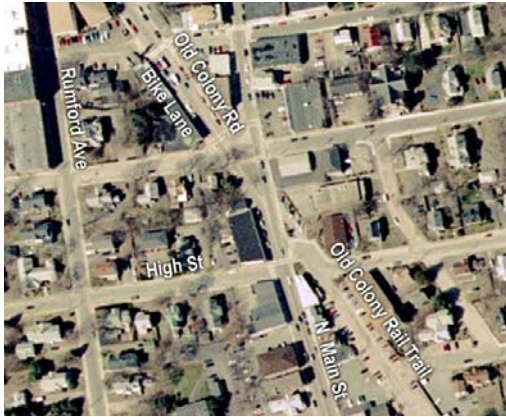
Rail-Trail-to-Station Connection

In 2003, a new paved, off-road shared-use path was constructed in Mansfield. Called the Old Colony Rail Trail, this path extends north from the Mansfield-Norton town line to North Main Street in downtown Mansfield at Old Colony Road/High Street. The terminus is just four blocks south of the commuter rail station. On-street signs and even a short on-street bike lane are in place to guide bicyclists to and from the commuter rail station. Our field audit found that some modifications are called for to the trailblazing signs that direct bicyclists to and from the commuter rail station; these recommendations, along with others related to the path are described below.

Recommendation: Install raised pavement markers along the sides of the bicycle path. These will provide a physical delineation of the bicycle path, while not interfering with bicycle and motor vehicle operations.

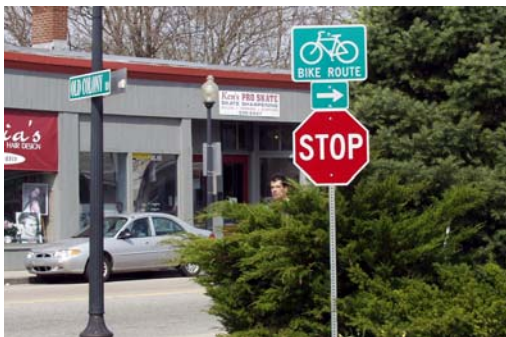
Signs at Northern Terminus of Off-Street Bike Path at N. Main Street

At the north end of the off-street path at N. Main Street, a sign directs bicycle traffic to head north along Main Street. Taking this route, a cyclist heading to the station would encounter the traffic of Main Street and have to navigate the intersection with Route 106/Chauncy Street. However, a signed on-street route is in place to lead cyclists from the end of the bicycle path, through a residential neighborhood along High Street and Rumford Avenue, straight to a pedestrian/bicyclist crossing of Route 106 to Mansfield Station.

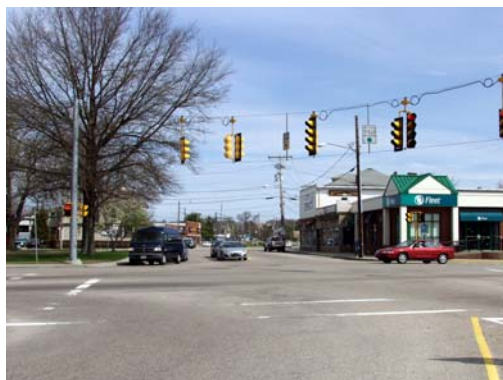
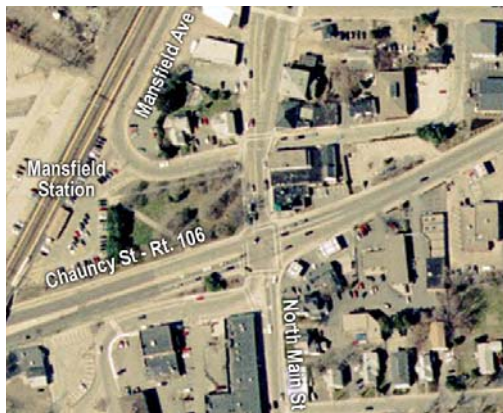
N. Main Street at Route 106/Chauncy Street

Pedestrians approaching from the east must cross N. Main Street to get to the station. If coming from along Route 106/Chauncy Street or from points south of Chauncy Street, the safest and easiest crossing is at the signalized intersection of these two streets. The pedestrian phase is actuated by pedestrian-crossing buttons; this triggers an all-walk phase for pedestrians. The time seems adequate, with a total of 26 seconds of “Walk” and flashing “Don’t Walk” signals. However, pedestrians must wait until the all-walk phase enters the cycle, which lasts 135 seconds. Also, the red “Don’t Walk” signals did not work at some signal posts.

- Add ladder-style stripes to the crosswalks, in addition to the existing horizontal lines
- Fix malfunctioning and broken pedestrian crossing signals
- Add additional lighting to the sidewalks on the public common at the northwest corner of N. Main Street and Route 106

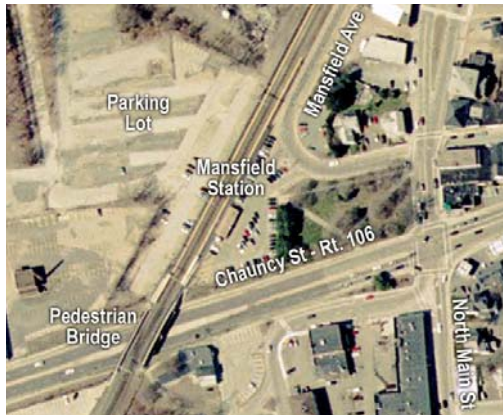
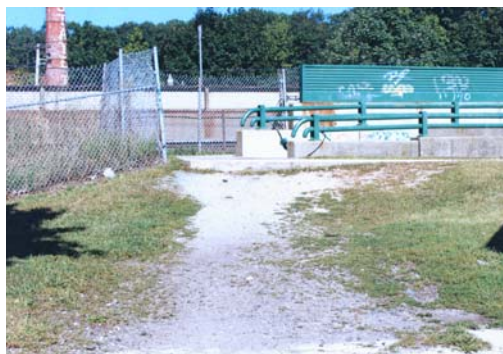
Pedestrian Bridge over Route 106

Route 106 (Chauncy Street) separates the commuter rail station from the parking and residential areas to the south. The roadway is divided and below grade where its four lanes cross under the railroad tracks. Both sides of the road have sidewalks, which are elevated from the street level and separated from the vehicle lanes by metal railing. In order to cross to the south side from the station, pedestrians and bicyclists must use the pedestrian overpass, which is adjacent to the railroad right-of-way.

The pedestrian overpass, to the south and east of the station, leads pedestrians and bicyclists across Route 106 to an area behind a commercial building. There is a paved sidewalk that heads east, parallel to Route 106 and along the building, to a commuter parking area and commercial establishments in the Thomas Street and N. Main Street area. The field audit noted desire lines in the hard ground leading around the other (south) side of the commercial building toward Rumford Street, where there is additional commuter parking and the beginning/end of the on-street bike lane and route. An often-used access point to the station, the pathway to the pedestrian bridge is unmarked (no signs), hidden from view, and uninviting.

Neither the pedestrian bridge nor the paved and unpaved pathways on the southeast side have direct lighting. Nearby street lamps do provide some illumination, but this light does not even illuminate the surface of the bridge walkway.

Recommendation: Pedestrian and bicyclist access to the pedestrian bridge should be enhanced by implementing the following:

- Install trailblazing signs that direct station users to the pedestrian bridge behind the commercial building; these signs could be MBTA-issued signs
- Improve bridge, staircase, and pathway lighting conditions, for visibility and safety of users at night; light should shine directly onto the walking surfaces
- Pave the dirt pathway on the south side of the commercial building, where desire lines currently exist, for bicyclist and pedestrian use

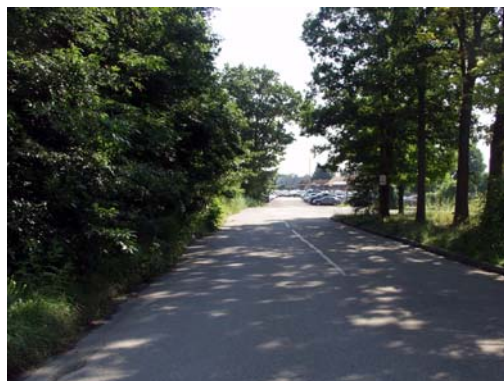
Access from the West

People from the residential areas to the immediate west of the station have to walk on the street in order to reach the commuter parking lot and west side of the station. However, most of these streets (such as River Street) lead to cul-de-sacs within a small residential area (approximately 60 houses), and thus do not carry much traffic. The only exception is Allen Street, which leads traffic to the commuter rail lot from Route 106 (via Highland Avenue). No sidewalks or streetlights are present on these roads.

Residents from the neighborhood even farther west have a natural barrier—a brook—and, thus, must first walk south to Route 106 in order to head east toward the station. A sidewalk follows Route 106 to the pedestrian under/overpass at the south entrance to the station.

Recommendations: Install simple safety improvements that visually connect drivers with pedestrians or that keep vehicle speeds low. These improvements should include:

- Install street lighting
- Post low-speed-limit signs or pedestrian activity signs
- Add speed humps along the approach to the commuter parking lot
- Cut back the foliage at street corners to provide visibility for turning vehicles

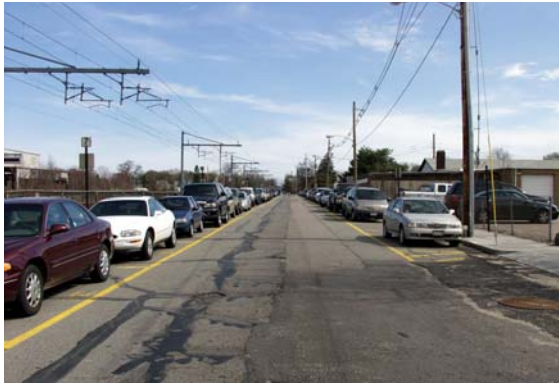
From the north, pedestrians and cyclists can approach the station along Mansfield Avenue. Both Oakland Street and N. Main Street connect to Mansfield Avenue. Mansfield Avenue has a sidewalk only on the east side; this is adequate for the pedestrian volume observed. The west side of Mansfield Avenue, which is adjacent to the railroad right-of-way, offers vehicle parking for commuters.

The most defining characteristic of Mansfield Avenue is the considerable traffic volume, especially in such proximity to the station house. The stretch of Oakland

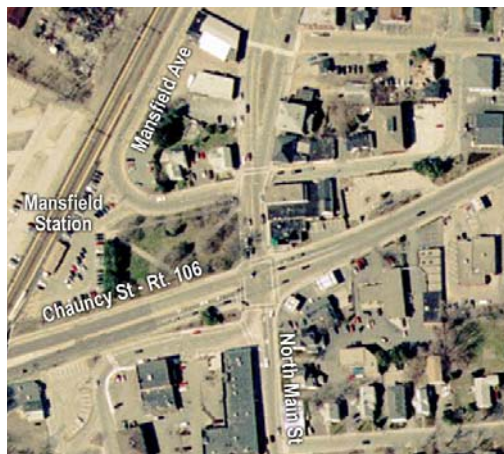
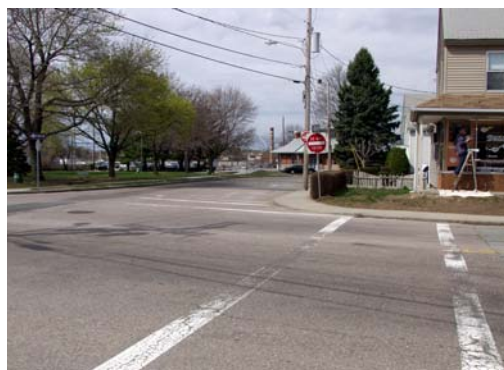
N. Main Street at Mansfield Avenue

Approaching the station from east of N. Main Street and north of Chauncy Street, pedestrians do not have any signalized locations to cross. A pedestrian crosswalk is striped on the north side of Mansfield Avenue to cross N. Main Street; this crosswalk is a short distance north of the signalized intersection with Chauncy Street. The crosswalk leads pedestrians to a sidewalk on the north side of Mansfield Avenue, just east of the station. This sidewalk has just been rebuilt as part of the station area improvements. It remains without a buffer separation from the road but has a yellow-painted curb. Across the street, a wide, grass-buffer-separated sidewalk is located on the south side of Mansfield Avenue along the common.

The current configuration of the crosswalks at Mansfield Avenue at N. Main Street encourages pedestrians to cross N. Main Street to the north side of Mansfield Avenue using the striped crosswalk, or alternatively, walk down to Chauncy Street and cross using the signalized intersection. In other words, a crosswalk across N. Main Street to the south side of Mansfield Avenue is absent. Such a crosswalk would create conflicts with the numerous right-turning vehicles from Mansfield Avenue to southbound N. Main Street.
