**Randolph-Quincy
Replacement and Rehabilitation of Highway
Lighting System at I-93/Route 24**

Project File No. 608611

Presentation to Boston MPO

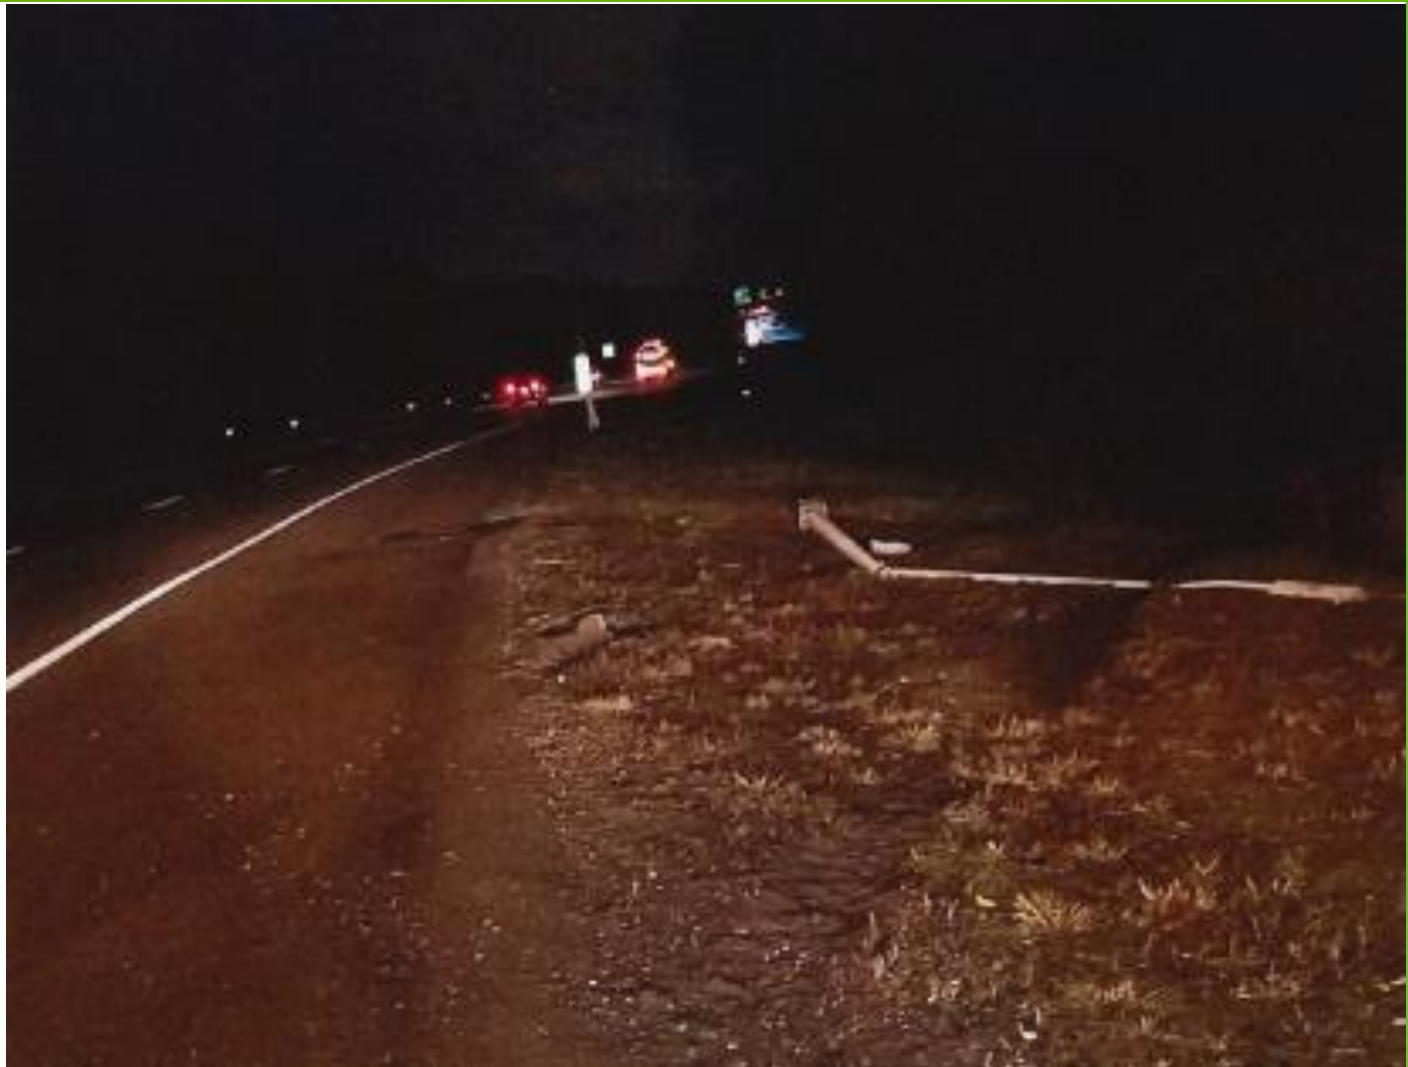
Light pole
knocked down on
May 11, 2020 on
Route 24 NB
Entrance to
I-93 NB

- **High crash location:**
 - Over 500 crashes in 5 years
 - One fatality
 - 155 crashes occurred during low traffic volume under dark conditions
 - Another 48 crashes occurred at dawn or dusk
 - Of 203 crashes during low lighting conditions 56 crashes involved personal injuries and one fatality
 - Multiple crashes striking light poles
- **Loss of light poles due to vehicle hits worsens lighting conditions and requires increased maintenance**
- **Due to loss of poles illumination levels are below minimum**
- **Lack of light uniformity (bright areas and dark areas)**
- **Replacing light poles requires lane closures further reducing safety of motorists and putting maintenance crews at risk**

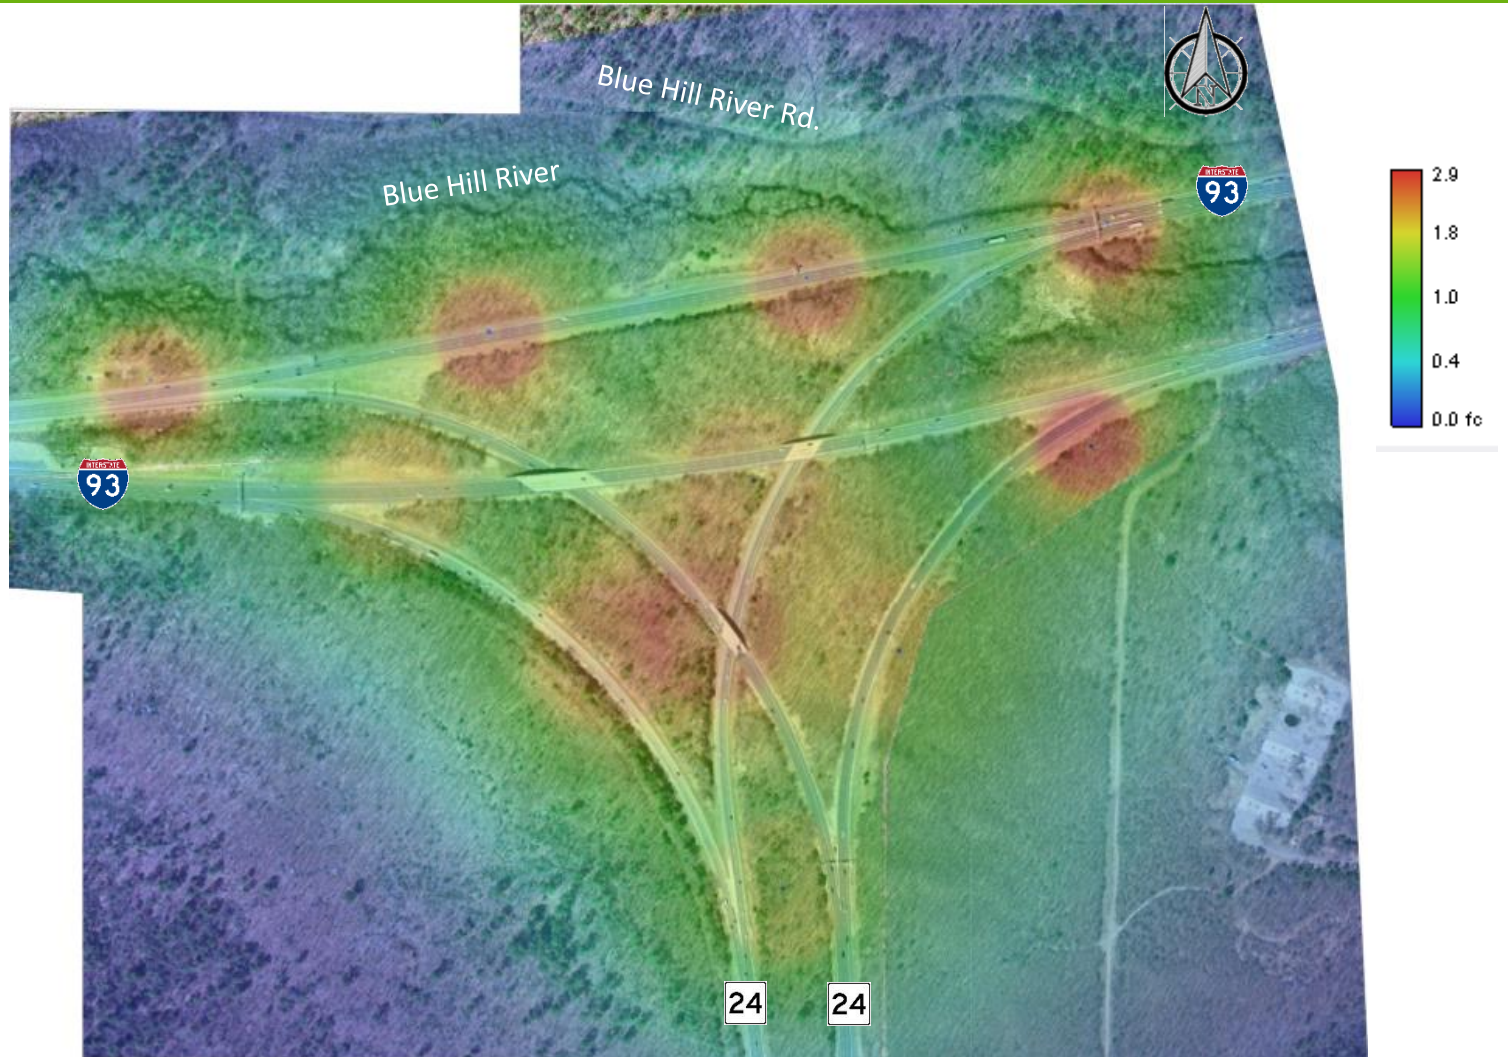
Proposed Illuminance Heat Map

Roadway Illuminance Statistics					
Description	Avg	Max	Min	Max/Min	Avg/Min
I-93 SB	1.1 fc	2.5 fc	0.3 fc	8.3:1	3.7:1
I-93 NB	1.0 fc	2.5 fc	0.3 fc	8.3:1	4.0:1
I-93 NB TO RT 24 SB RAMP	1.0 fc	2.5 fc	0.2 fc	12.5:1	5.0:1
I-93 SB TO RT 24 SB RAMP	1.1 fc	2.1 fc	0.2 fc	10.5:1	5.5:1
RT 24 NB TO I-93 SB RAMP	1.1 fc	2.8 fc	0.3 fc	9.3:1	3.7:1
RT 24 NB TO I-93 NB RAMP	1.1 fc	2.2 fc	0.3 fc	7.3:1	3.7:1

Recommended average roadway illuminance for major interchange: 1.8 FC (*Source: IES; MassDOT agreed to lower illuminance level to 1.0 FC*)

Recommended illuminance for Lighting Zone 0 (environmentally sensitive area): 0.05 FC

- Reduced height of six high mast towers to 135 feet
- Reduced light color temperature to 2700 K
- Introduced “dummy” fixtures facing environmentally sensitive areas
- Updated Categorical Exclusion Checklist
