4 SELECTED TRANSPORTATION ISSUES: ANALYSES AND PROPOSED IMPROVEMENTS

4.1 Riley Plaza Traffic Circulation

Downtown Salem
Transportation
Improvement Study

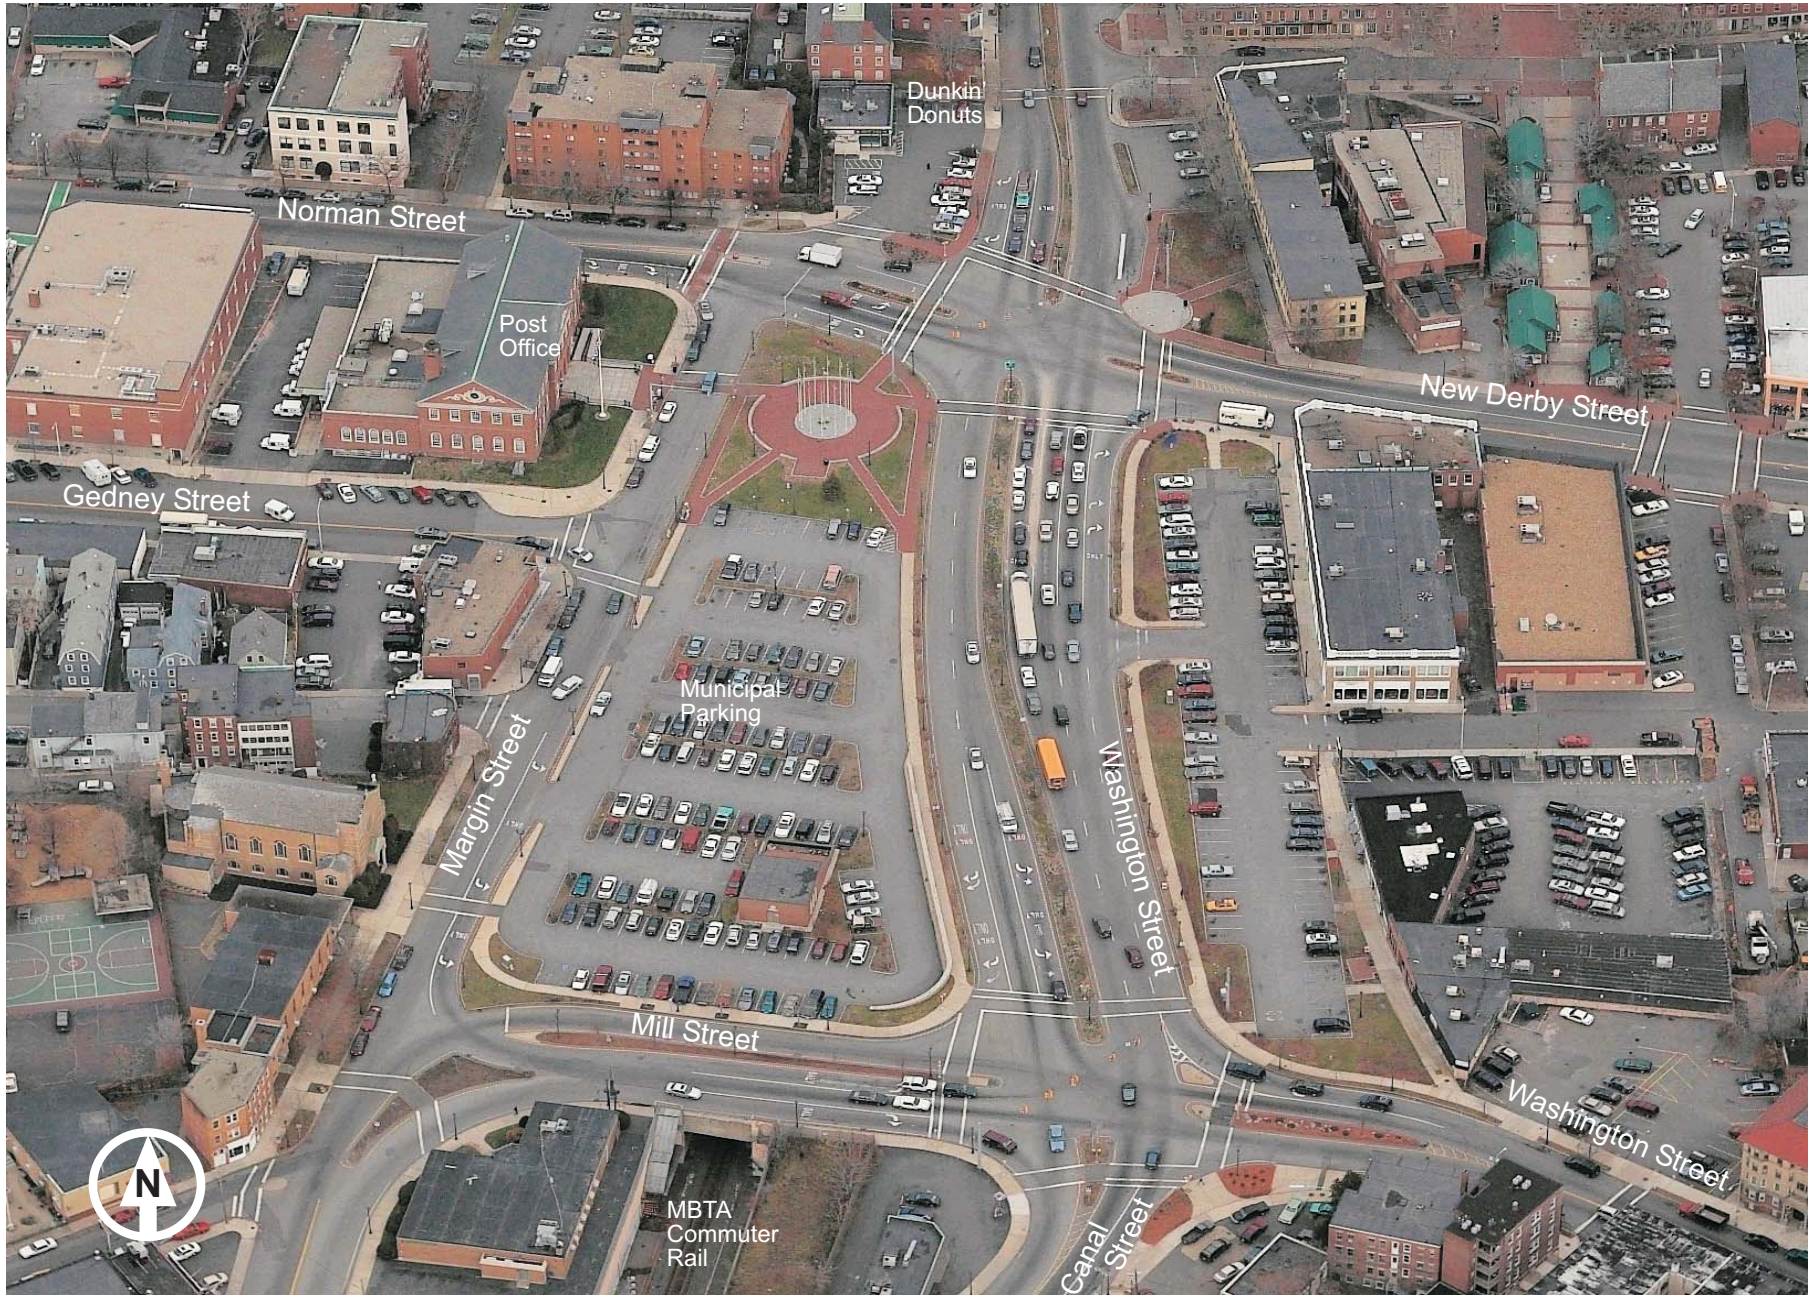
Figure 4-1 Riley Plaza

Riley Plaza is a key location in downtown Salem where a number of major roadways meet. The area is encircled by Washington Street, Norman Street, Margin Street, and Mill Street, which once formed a large traffic rotary with counterclockwise traffic rotation and no control. In 1995–1996, the rotary was reconstructed to allow two-way traffic flow (except on Margin Street), and traffic signals were installed at the intersections of Washington Street at Norman/New Derby Street and at Canal Street/Mill Street. Figure 4-1 is an aerial view of the area.

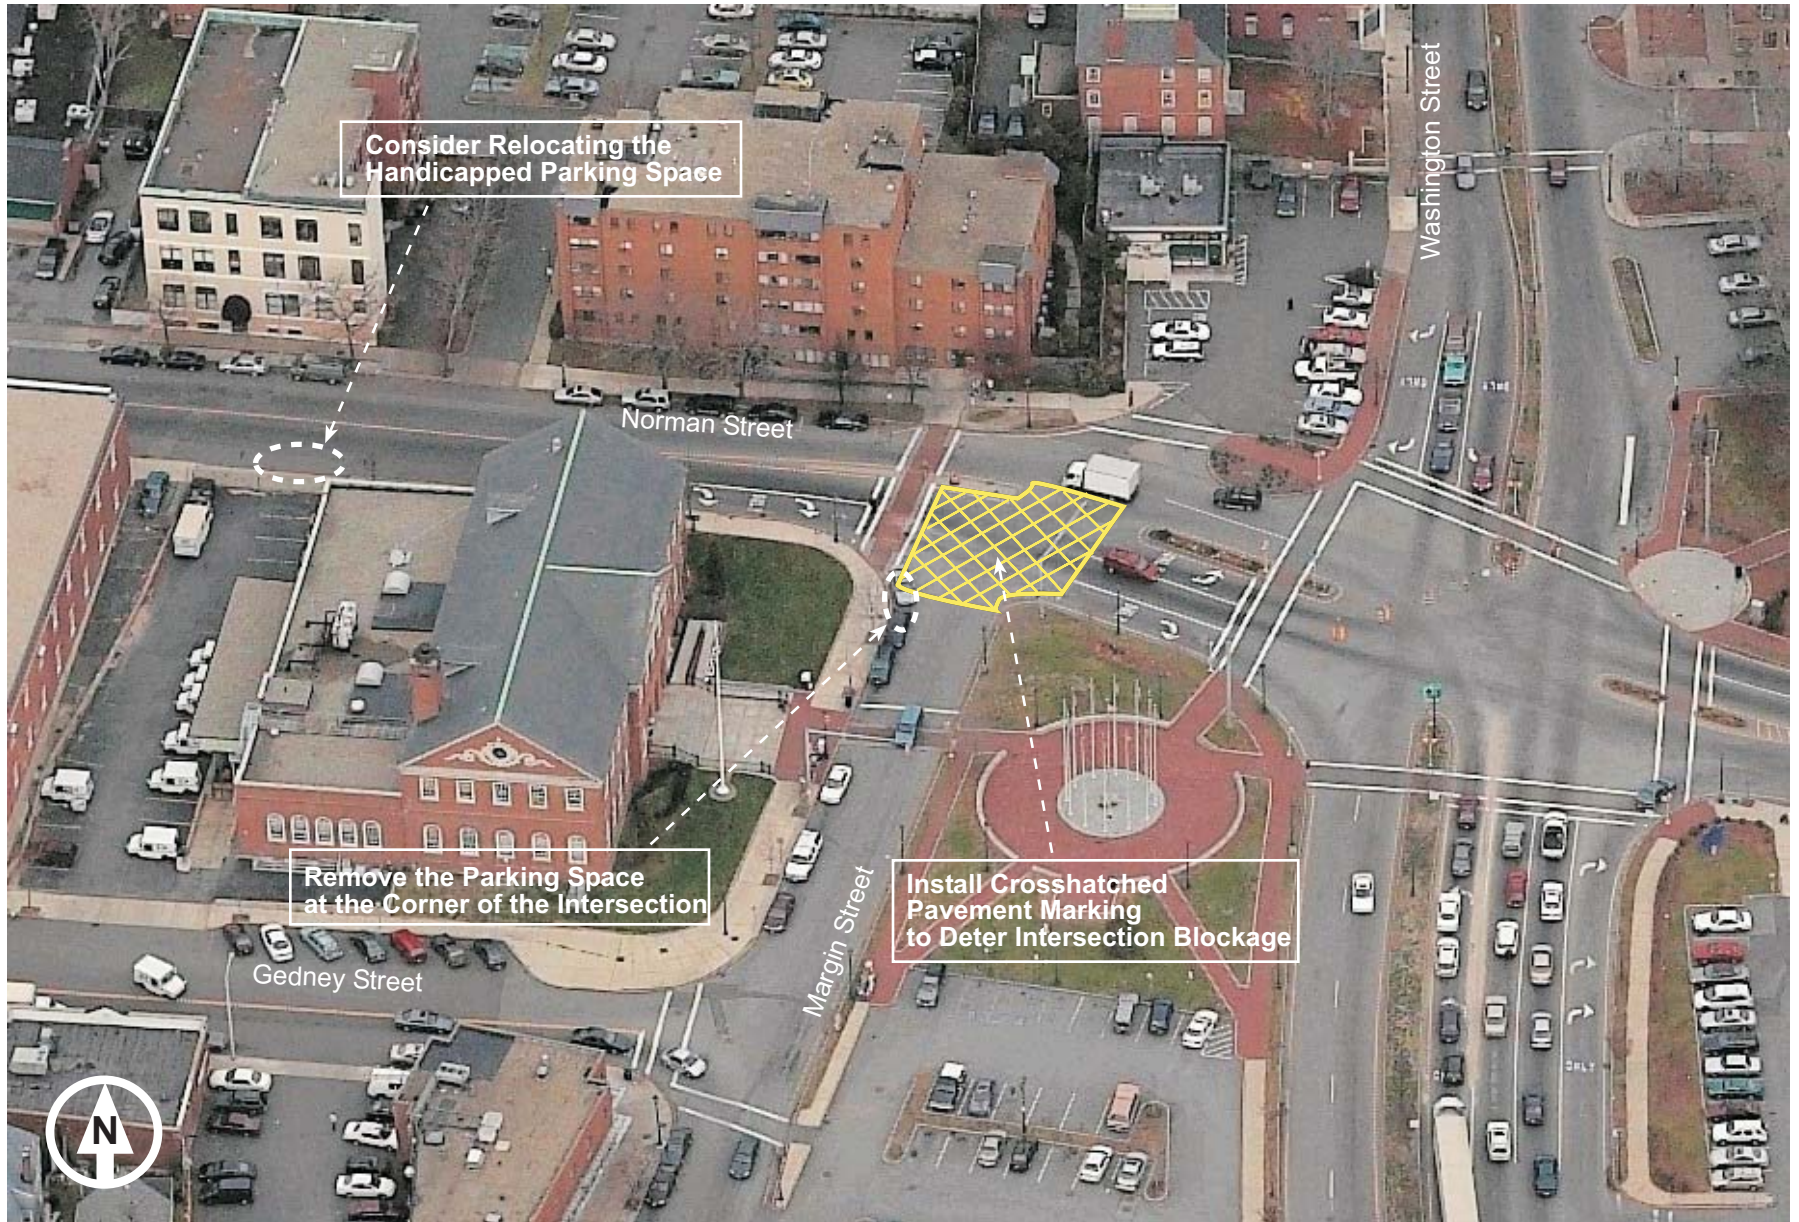
**Figure 4-5 Proposed Intersection Improvements:
Norman Street at Margin Street**

To improve traffic operations and pedestrian safety at this intersection, three short-term improvements are proposed (see Figure 4-5):

The intersection is highly congested during peak periods. The congestion is due to heavy traffic and intersection geometry deficiencies. The northbound approach contains only two lanes: an inside lane shared by left-turn and through movements and an outside lane (a flared area near the intersection less than 150 feet in length) shared by through and right-turn movements. The intersection is tight and the northbound lanes are slanted to the east due to surrounding developments. Therefore, the northbound left-turn and the southbound left-turn traffic flows are in each other’s path and sometimes interlocked at the middle of the intersection. This and the lack of an exclusive signal phase for the northbound left-turn traffic

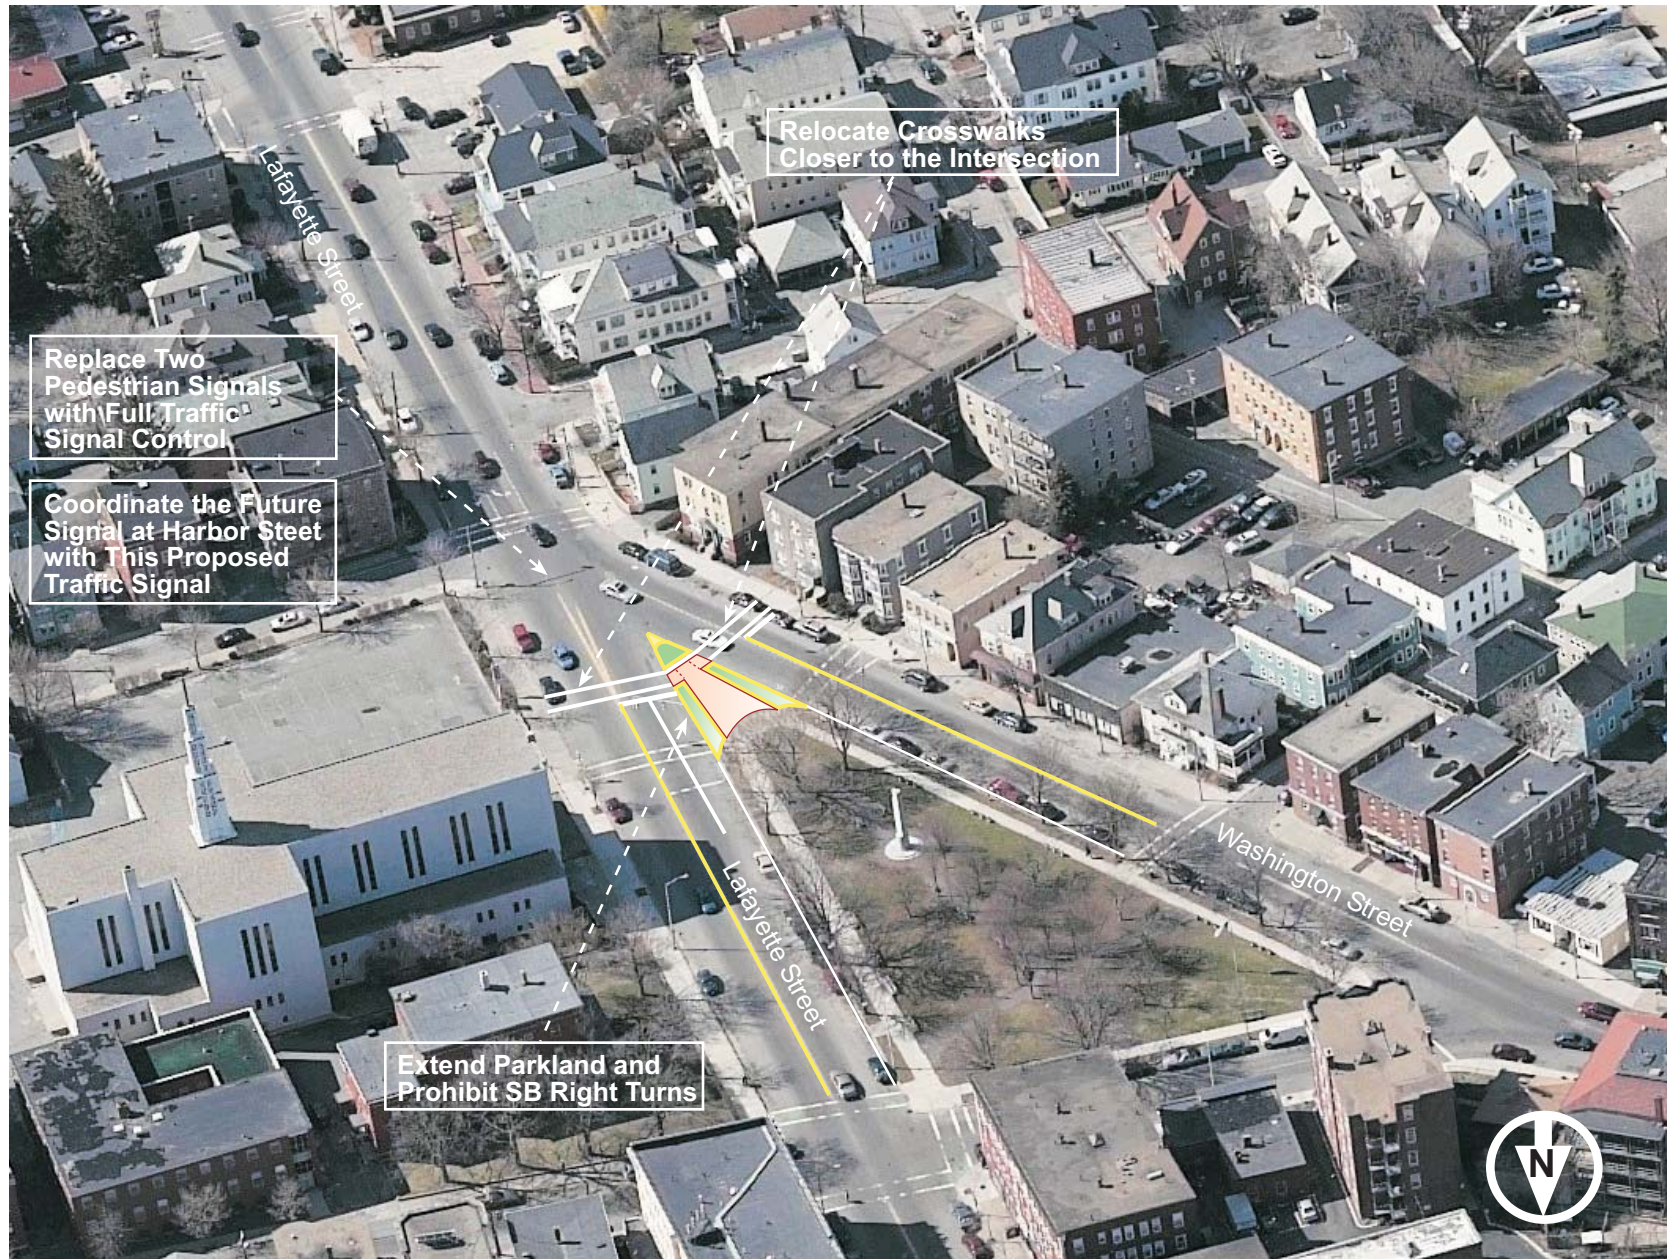
**Figure 4-12 Proposed Intersection Reconfiguration:
Lafayette Street at Washington Street**

It is suggested that the intersection layout be tightened and the pedestrian signals be replaced by full traffic signal control. A preliminary analysis of signal warrants indicates that signalization of this intersection is justified (see Table 4-4).

- Extend the triangular parkland further into the intersection. The added parkland can be made into a small open space that connects the sidewalks on the parkland and the crosswalks at the intersection. This extension will require closing the southbound right-turn traffic movement, which has a very low traffic volume (about five vehicles per hour).
- Relocate the two crosswalks adjacent to the parkland southward, closer to the intersection. This will shorten the distance for pedestrians whose trips include crossing both Washington Street and Lafayette Street.
- Replace the pedestrian crossing signals with a fully functional traffic signal that controls all the traffic and pedestrian movements at the intersection. The signal can have a simple two-phase traffic operation with an exclusive pedestrian phase.

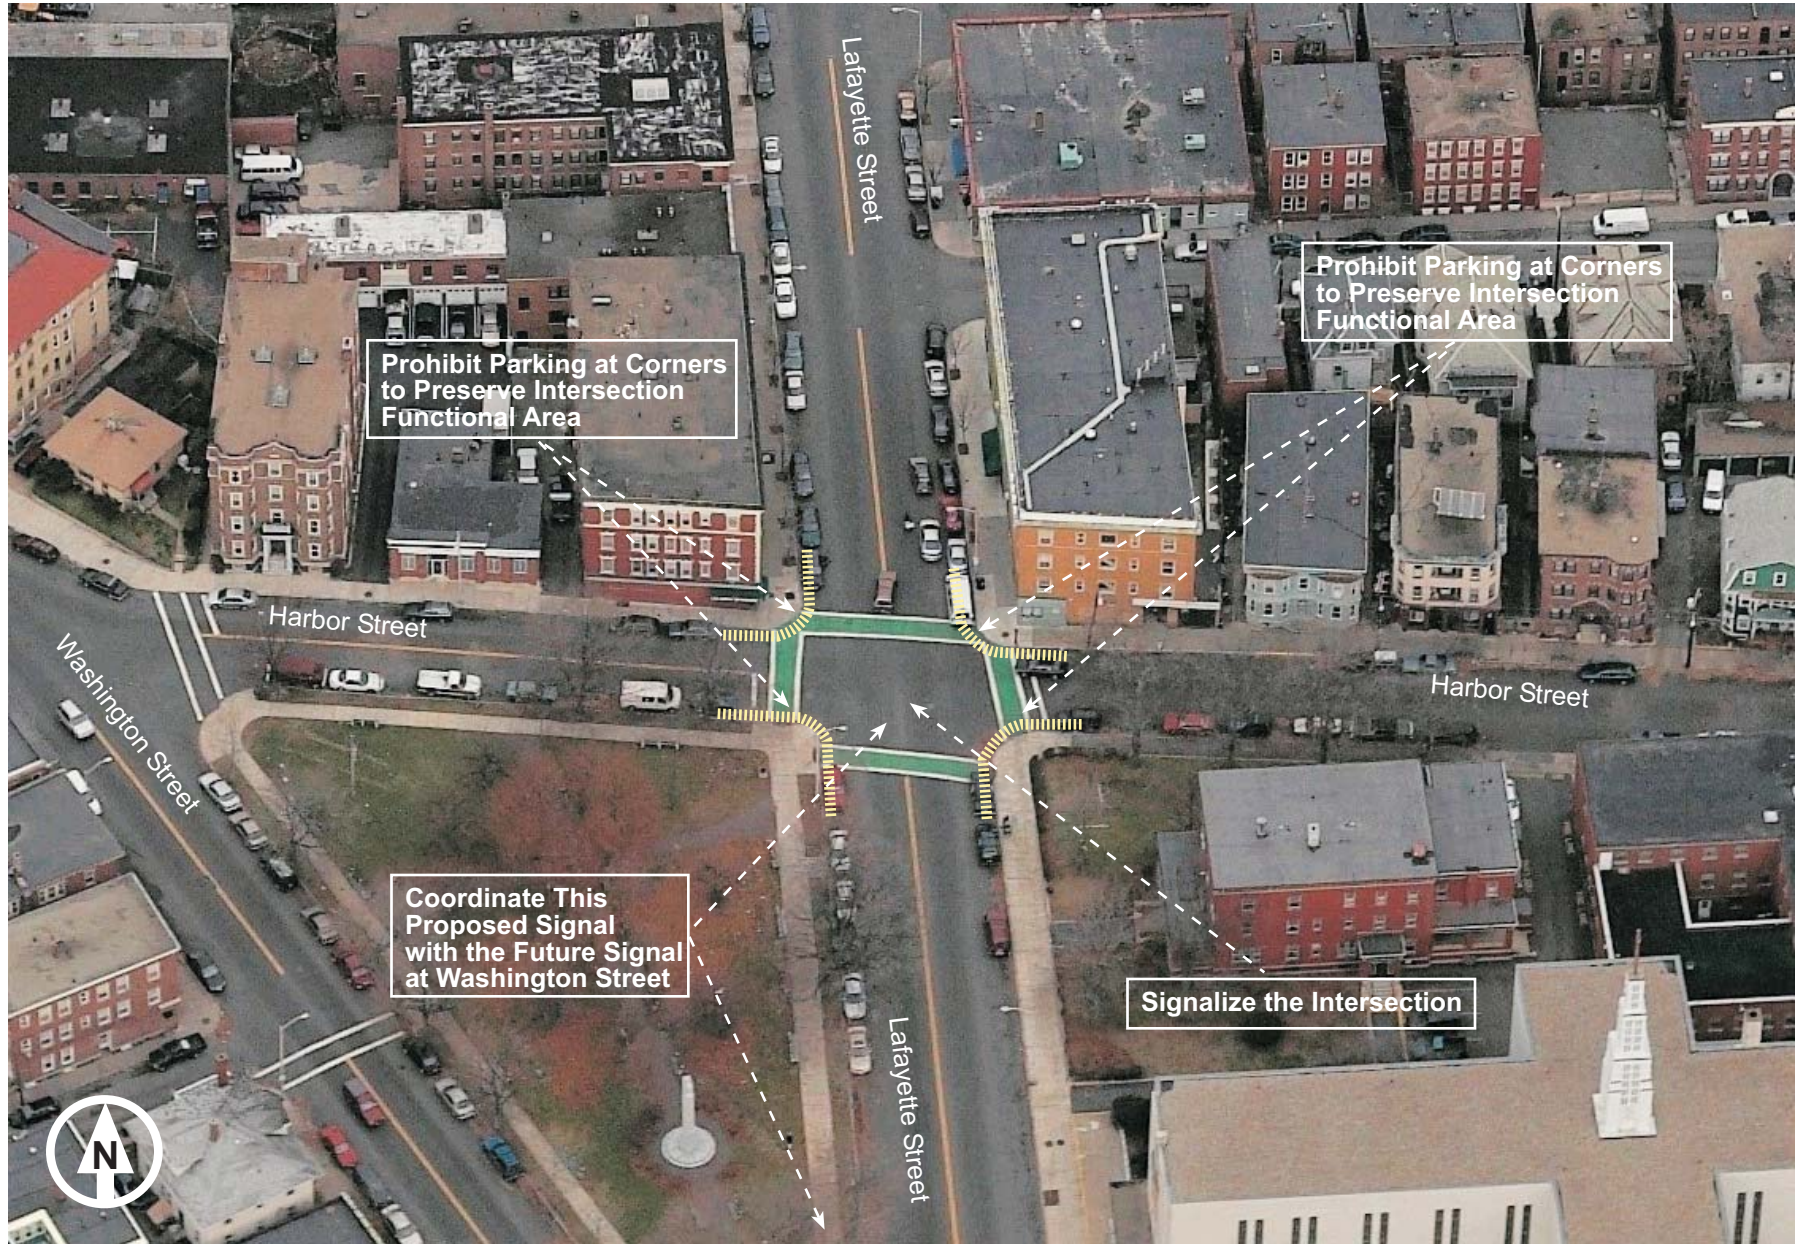
**Figure 4-13 Proposed Intersection Improvements:
Lafayette Street at Harbor Street**

The proposed improvements are summarized below (see Figure 4-13 for locations of the proposed improvements).

- Install a traffic signal at the intersection. The signal can have a simple two-phase traffic operation with an exclusive pedestrian phase. The intersection capacity analyses show that traffic delay during peak hours on both approaches of Harbor Street would be significantly reduced with the proposed signalization (see Figures 4-2 and 4-3).
