Appendix B

Pedestrian and Bicycle Report Cards

Part 1: Pedestrian Report Card Assessment

Route 37 (Granite Street): Existing Conditions

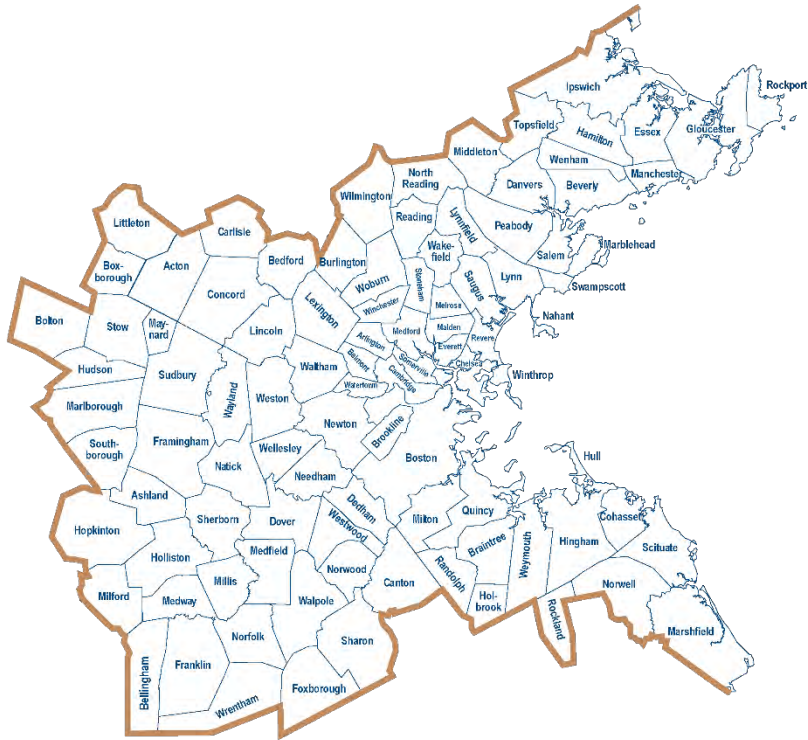
Roadway Segment Location

Grading Category	Performance Measure	Features of Analyzed Locations
Capacity Management and Mobility	Sidewalk Presence	Large gaps in sidewalk network(1)
	Crosswalk Presence	Seven crosswalk per mile (3)
	Walkway Width	Sidewalks measuring at least five feet wide on at least one side of the road (2)
Economic Vitality	Pedestrian Volumes	Roadway segment traversed by five to 60 pedestrians per hour (2)
	Adjacent Bicycle Accommodations	Roadway segments with between 5 and 60 bicycles per hour (2)
Safety	Pedestrian Crashes	Roadway segment with two pedestrian crashes (1)
	Pedestrian-Vehicle Buffer	Roadway segments without buffer (0)
	Vehicle Travel Speed	Roadway segments where average speeds between 25 and 35 mph (2)
System Preservation	Sidewalk Condition	Roadway segments with less than half of sidewalks in good condition (1)

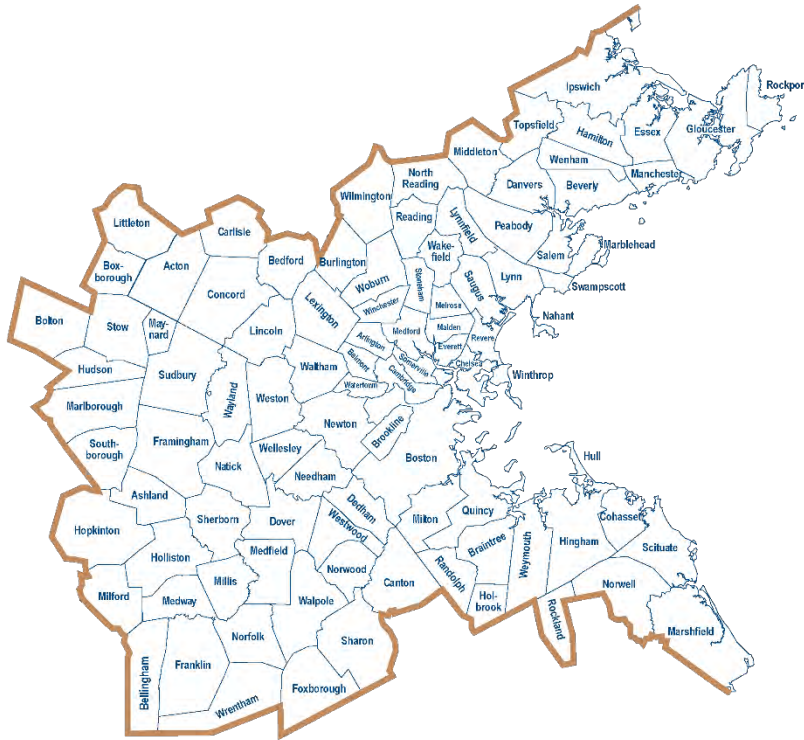
Roadway Segment Location

Route 37 (Franklin Street): Existing Conditions

Grading Category	Performance Measure	Features of Analyzed Locations
Capacity Management and Mobility	Sidewalk Presence	Large gaps in sidewalk network (2)
	Crosswalk Presence	Less than seven crosswalk per mile (1)
	Walkway Width	Sidewalks measuring at least five feet wide on at least one side of the road (3)
Economic Vitality	Pedestrian Volumes	Roadway segment traversed by five to 60 pedestrians per hour (2)
	Adjacent Bicycle Accommodations	Roadway segments with between 5 and 60 bicycles per hour (2)
Safety	Pedestrian Crashes	Roadway segment with no pedestrian crashes (2)
	Pedestrian-Vehicle Buffer	Roadway segments without buffer (1)
	Vehicle Travel Speed	Roadway segments where average speeds of 35 mph (1)
System Preservation	Sidewalk Condition	Roadway segments with less than half of sidewalks in good condition (1)

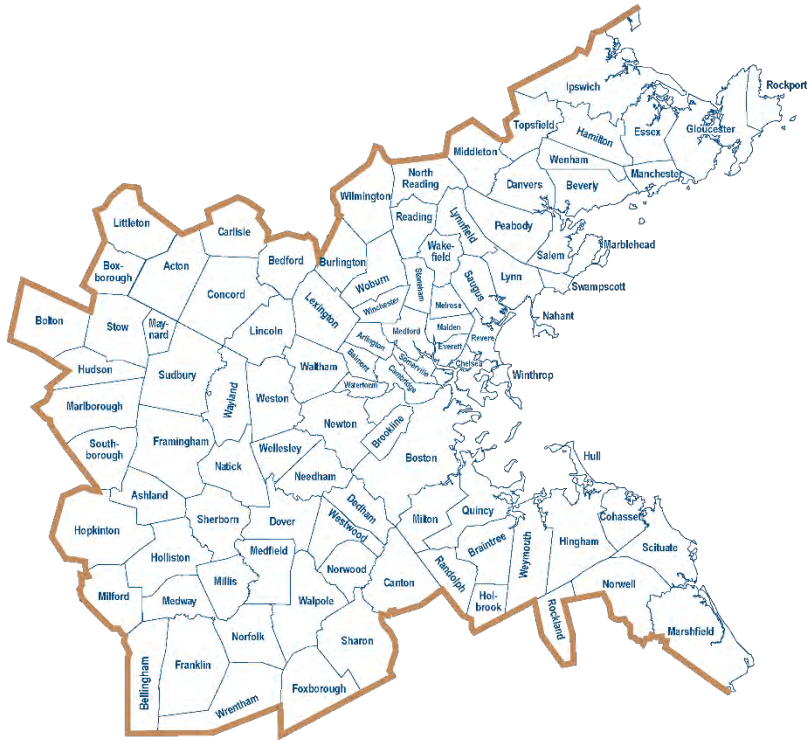
Roadway Segment Location

Route 37 (Washington Street): Existing Conditions

Grading Category	Performance Measure	Features of Analyzed Locations
Capacity Management and Mobility	Sidewalk Presence	Large gaps in sidewalk network (2)
	Crosswalk Presence	Less than 7 crosswalk per mile (1)
	Walkway Width	Sidewalks measuring at least five feet wide on at least one side of the road (3)
Economic Vitality	Pedestrian Volumes	Roadway segment traversed by five to 60 pedestrians per hour (2)
	Adjacent Bicycle Accommodations	Roadway segments with between 5 and 60 bicycles per hour (2)
Safety	Pedestrian Crashes	Roadway segment with no pedestrian crashes (3)
	Pedestrian-Vehicle Buffer	Roadway segments without buffer (1)
	Vehicle Travel Speed	Roadway segments where average speeds between 25 and 35 mph (2)
System Preservation	Sidewalk Condition	Roadway segments with less than half of sidewalks in good condition (1)

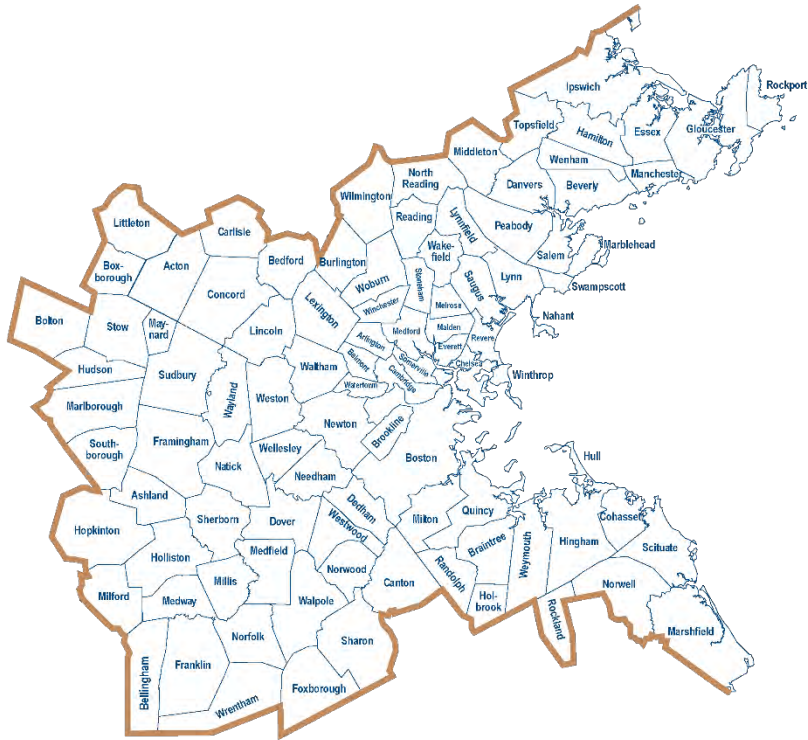
Roadway Segment Location

Route 37 (Granite Street): With Improvements

Grading Category	Performance Measure	Features of Analyzed Locations
Capacity Management and Mobility	Sidewalk Presence	Continuous sidewalk network (3)
	Crosswalk Presence	Seven crosswalk per mile (3)
	Walkway Width	Sidewalks measuring at least five feet wide on both sides of the road (3)
Economic Vitality	Pedestrian Volumes	Roadway segment traversed by five to 60 pedestrians per hour (2)
	Adjacent Bicycle Accommodations	Roadway segments with between five and 60 bicycles per hour (2)
Safety	Pedestrian Crashes	Roadway segment with no pedestrian crashes (3)
	Pedestrian-Vehicle Buffer	Roadway segments without buffer (0)
	Vehicle Travel Speed	Roadway segments where average speeds between 25 and 35 mph (2)
System Preservation	Sidewalk Condition	Roadway segments with sidewalks in good condition (3)

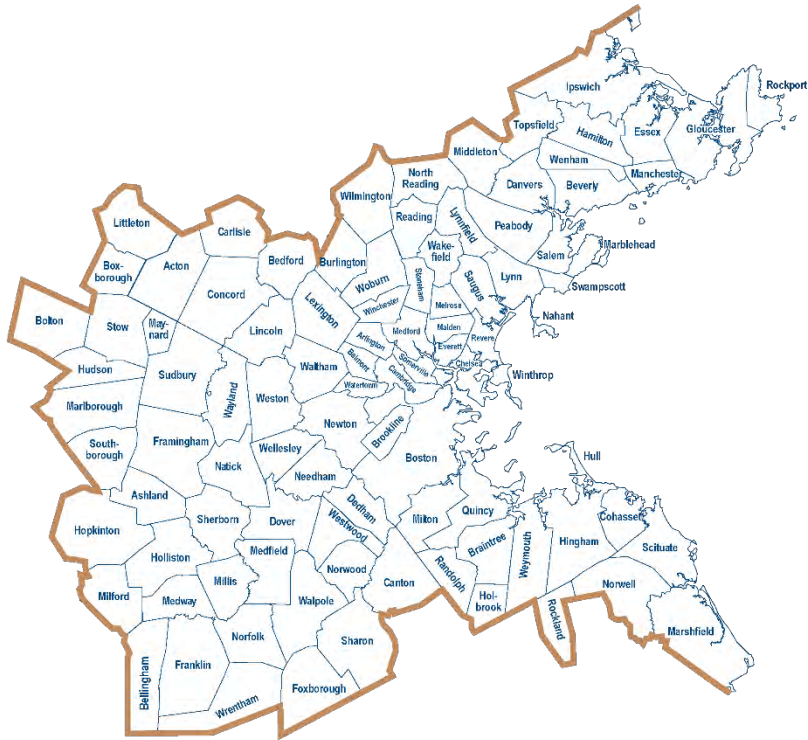
Roadway Segment Location

Route 37 (Franklin Street): With Improvements

Grading Category	Performance Measure	Features of Analyzed Locations
Capacity Management and Mobility	Sidewalk Presence	No gap in sidewalk network(3)
	Crosswalk Presence	Less than seven crosswalk per mile (1)
	Walkway Width	Sidewalks measuring at least five feet wide on both sides of the road (3)
Economic Vitality	Pedestrian Volumes	Roadway segment traversed by five to 60 pedestrians per hour (2)
	Adjacent Bicycle Accommodations	Roadway segment with between 5 and 60 bicycles per hour (2)
Safety	Pedestrian Crashes	Roadway segment with no pedestrian crashes (3)
	Pedestrian-Vehicle Buffer	Roadway segment without buffer (1)
	Vehicle Travel Speed	Roadway segment where average speeds between 25 and 35 mph (2)
System Preservation	Sidewalk Condition	Roadway segment with sidewalks in good condition (3)

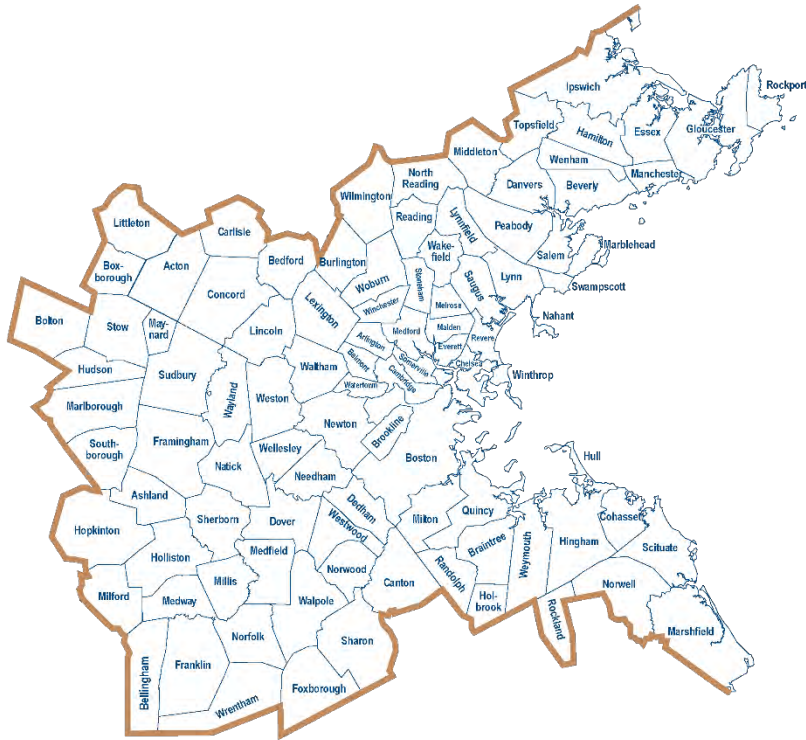
Roadway Segment Location

Route 37 (Granite Street) : Existing Conditions

Goal	Performance Measure	Features of Analyzed Locations
Capacity Management and Mobility	Bicycle Facility Presence	None in the corridor on Granite Street, people biking mostly share the road (0)
	Proximity to Bike Network	Yes, bicycle facility within one-quarter mile on West Street, which connects to Granite Street (100)
	Proximity to Transit	Yes, bus route 230, 236, and 238 operates on the corridor (100)
Economic Vitality	Bike Rack Presence	None in the corridor (0)
	Land Use	Land uses in the corridor, include commercial and retail, residential, and recreational, would support biking (100)
Safety	Bicycle Facility Presence	None in the corridor on Granite Street, people biking mostly share the road (0)
	Absence of Bicycle Crashes	Two bicycle crashes in five years (2016–20) (50%)
	Bicyclist Operating Space	People biking share lane with vehicles (0)
	Number of Travel Lanes	Two travel lanes each direction (75)

System Preservation	Bicycle Facility Continuity	No bicycle facility (0)
	Bicycle Facility Condition	No bicycle facility (0)

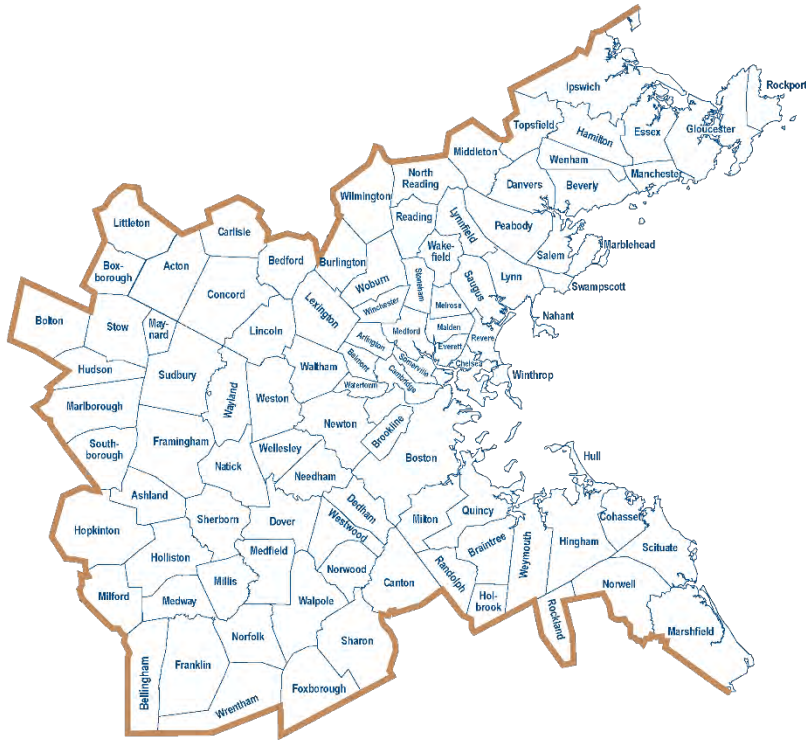
Roadway Segment Location

Route 37 (Franklin Street) : Existing Conditions

Goal	Performance Measure	Features of Analyzed Locations
Capacity Management and Mobility	Bicycle Facility Presence	None in the corridor on Granite Street, people biking mostly share the road (0)
	Proximity to Bike Network	Yes, bicycle facility within one-quarter mile on Hancock Street and West Street, which connects to Franklin Street (100)
	Proximity to Transit	Yes, bus route 230, 236, and 238 operates on the corridor (100)
Economic Vitality	Bike Rack Presence	None in the corridor (0)
	Land Use	Land uses in the corridor, include commercial and retail, residential, and recreational, would support biking (100)
Safety	Bicycle Facility Presence	None in the corridor on Granite Street, people biking mostly share the road (0)
	Absence of Bicycle Crashes	One bicycle crash in five years (2016–20) (70)
	Bicyclist Operating Space	People biking share lane with vehicles (0)
	Number of Travel Lanes	One travel lane each direction (100)

System Preservation	Bicycle Facility Continuity	No bicycle facility (0)
	Bicycle Facility Condition	No bicycle facility (0)

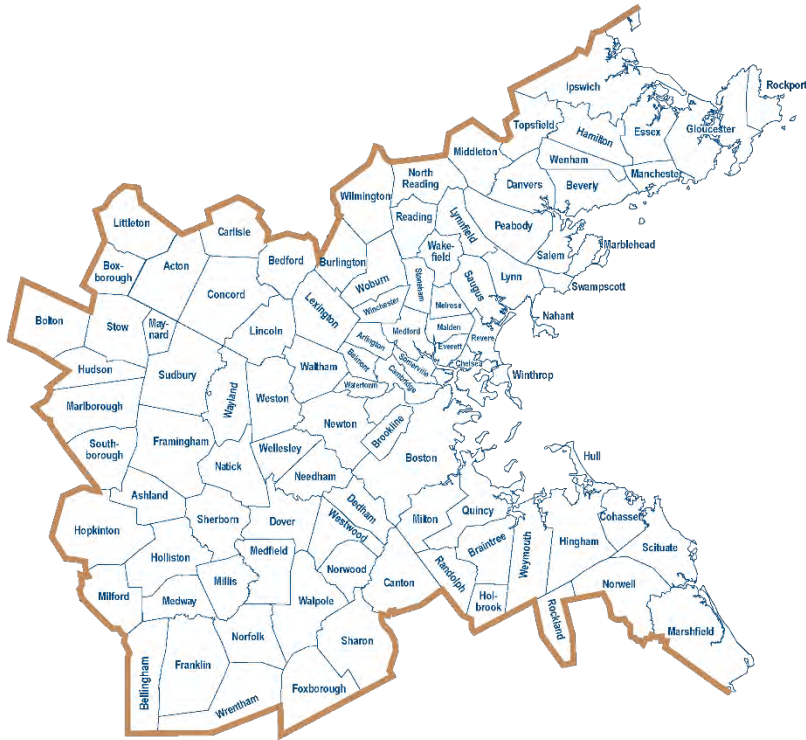
Roadway Segment Location

Route 37 (Washington Street) : Existing Conditions

Goal	Performance Measure	Features of Analyzed Locations
Capacity Management and Mobility	Bicycle Facility Presence	Yes, bike facility present in the corridor on Washington Street and shoulders in areas where there are no bike facilities. (70)
	Proximity to Bike Network	Yes, bicycle facility within the corridor south of South Street (100)
	Proximity to Transit	Yes, bus route 230, 236, and 238 operates on the corridor (100)
Economic Vitality	Bike Rack Presence	None in the corridor (0)
	Land Use	Land uses in the corridor, include commercial and retail, residential, and recreational, would support biking (100)
Safety	Bicycle Facility Presence	Yes, bike facility present in the corridor on Washington Street and shoulders in areas where there are no bike facilities (70)
	Absence of Bicycle Crashes	One bicycle crash in five years (2016–20) (70)
	Bicyclist Operating Space	Bicycle facility measures five feet wide for each direction of travel (70)

Number of Travel Lanes	One travel lane each direction (100)
System Preservation	Bicycle Facility Continuity	Bicycle facility present on one-half of the corridor (50)
	Bicycle Facility Condition	Bicycle facility is new and in good condition (100)
