# Technical Memorandum

**RE:** Intersection Study: US Route 1 and High Plain Street, Walpole

This memorandum summarizes the analyses and improvement strategies for the intersection of US Route 1 (Boston–Providence Highway) at Route 27 (High Plain Street) in the Town of Walpole.

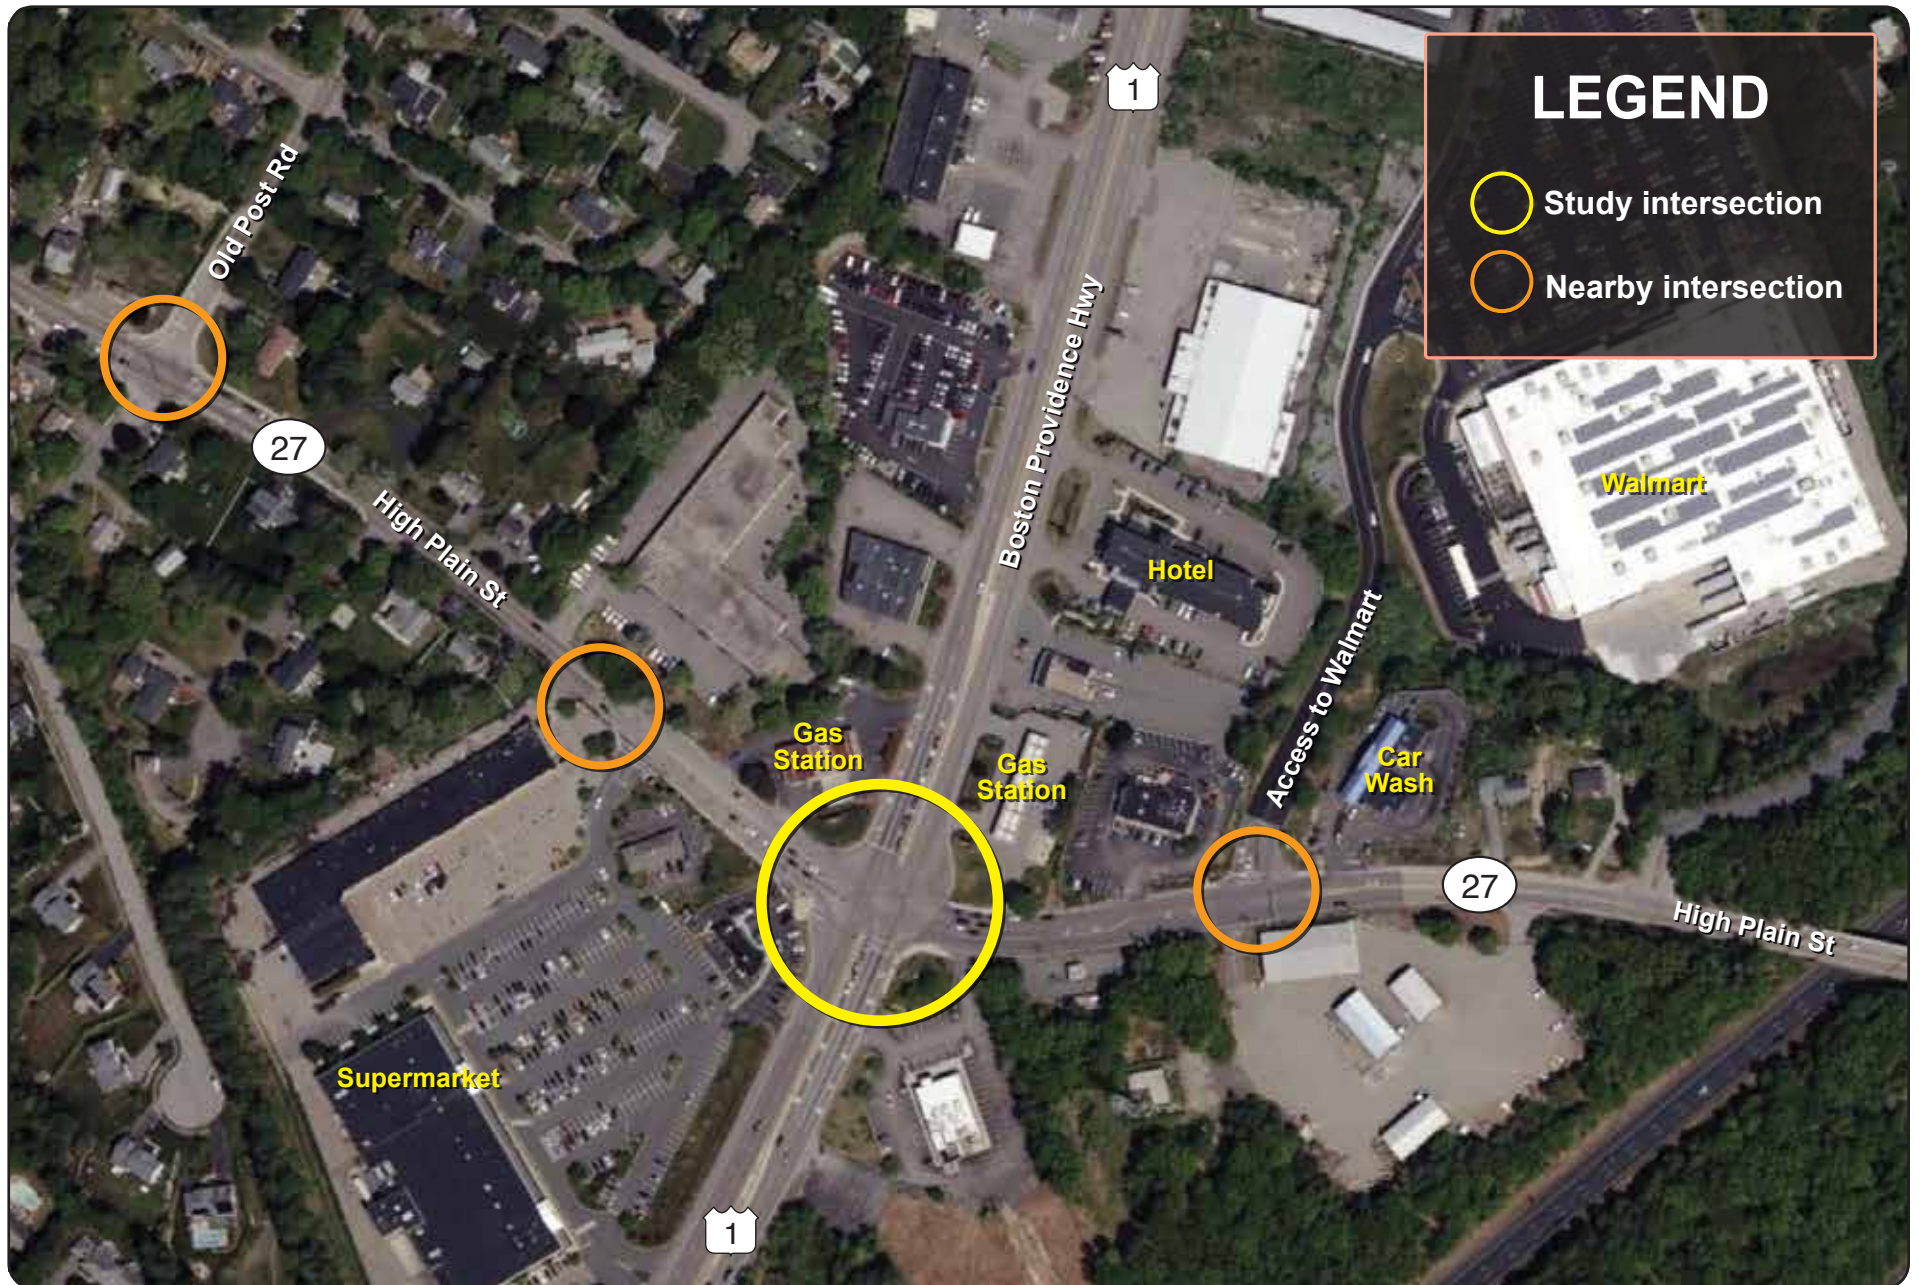
**Figure 1**  
**Walpole-Study Area**

Figure 1 shows the intersections studied, which includes the primary (study intersection) and secondary (nearby) intersections within the study area. The study intersection is the intersection of Route 1 and High Plain Street.

- the intersection of High Plain Street and the Big Y supermarket driveway, located west of the study intersection;
- the intersection of High Plain Street and Old Post Road, also located west of the study intersection; and
- the intersection of High Plain Street and the Walmart supercenter driveway, located east of the study intersection.

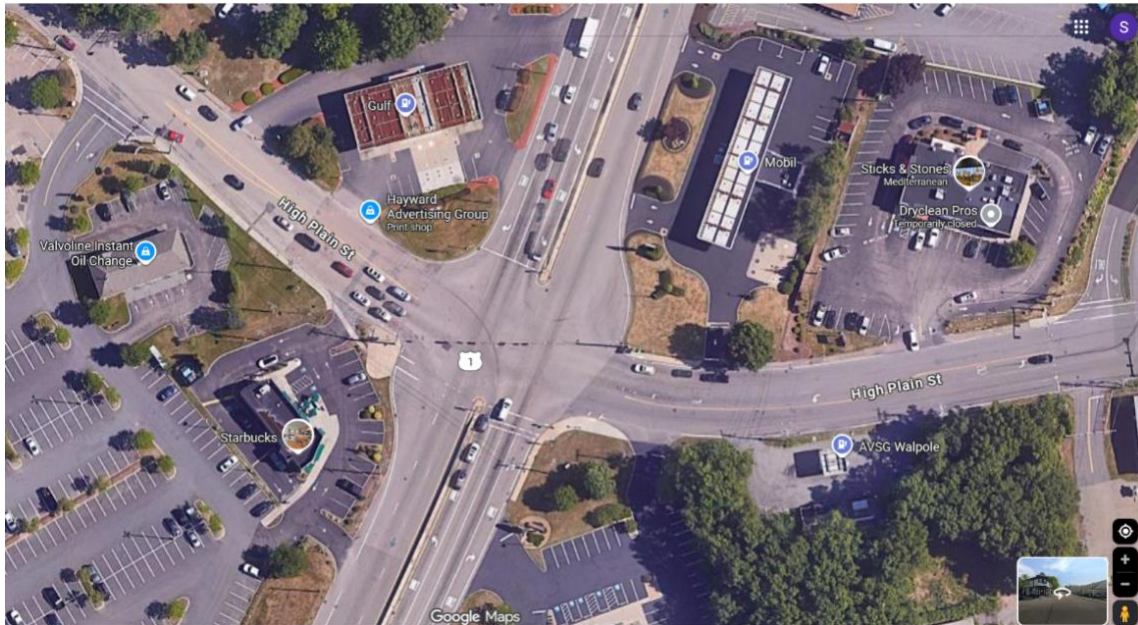
**Figure 2**  
**Existing Pavement Markings**

Respondents who drive through the intersection raised a range of operational and safety concerns. Those related to turning movements and lane markings are as follows (Figure 2):

- Drivers have difficulty turning left from the Gulf gas station across two lanes of traffic to get back onto High Plain Street eastbound.
- Left-turning vehicles yielding to traffic often remain in the intersection after the signal turns red.
- There is a lack of clear lane markings at the intersection.
- Faded lane markings are in the leftmost eastbound lane near Starbucks, and there is no signage indicating whether it is a left-turn-only lane. Additionally,

confusion arises where two eastbound through lanes near Starbucks merge into a single lane on the other side of the intersection and there is no signage or pavement markings to guide drivers.

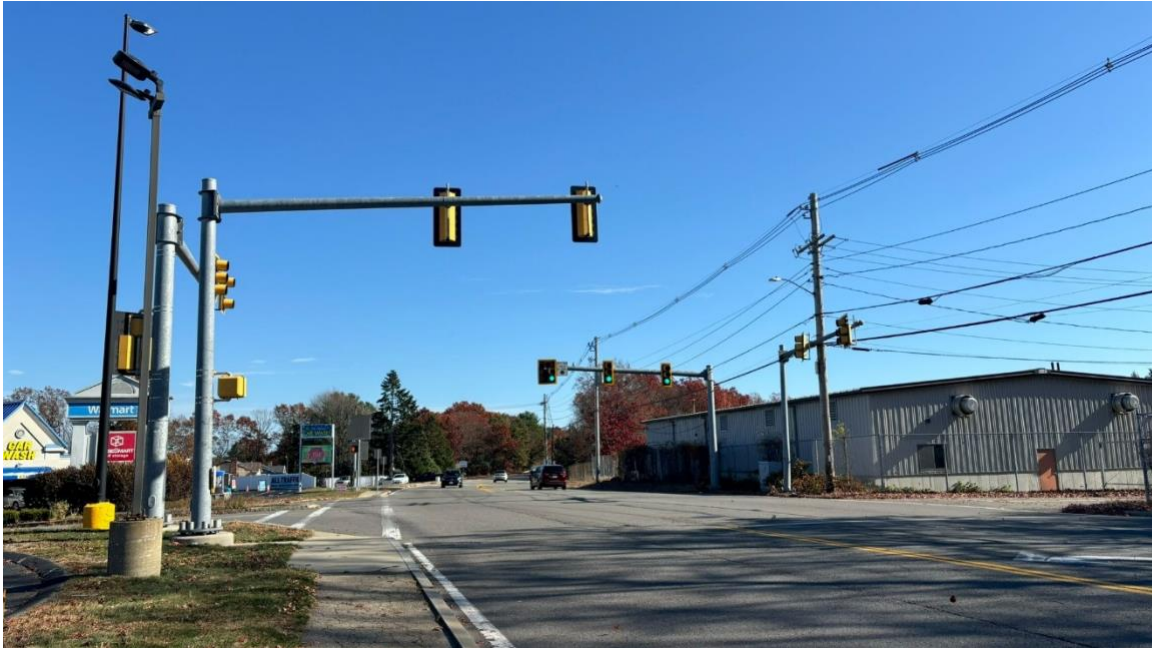
**Figure 3**  
**Signal at Walmart Entrance and High Plain Street Intersection**

Concerns related to signals, signal timing, and vehicle queuing are as follows (Figure 3):

- The signal at the Big Y complex entrance and High Plain Street is often overlooked due to focus on the approaching Route 1 signal.
- Backups occur on the westbound High Plain Street left-turn lane onto Route 1.
- Long signal cycles are perceived by drivers, especially at the intersection of High Plain Street and Old Post Road.
- The left-turn signal duration from Walmart onto High Plain Street is inadequate.

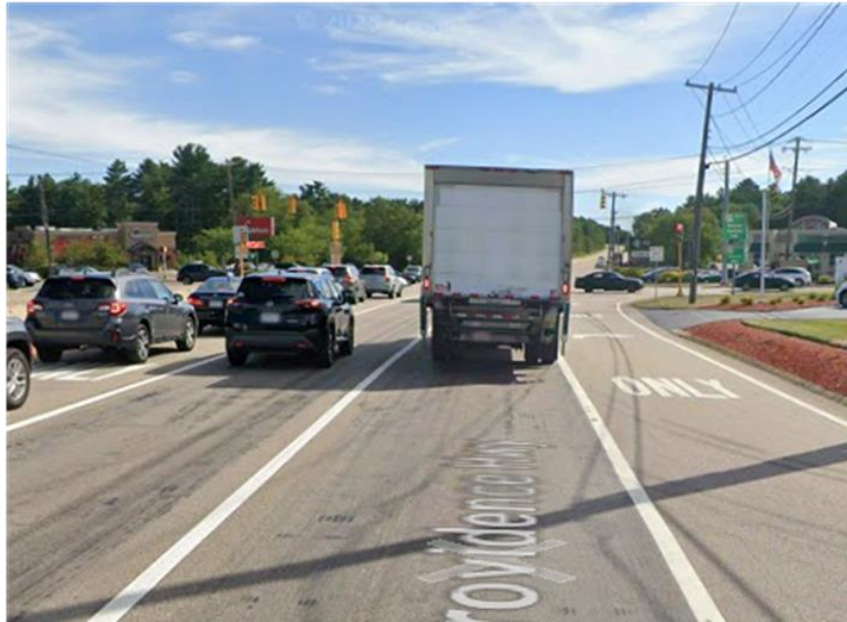
**Figure 4**  
**Signal Visibility behind Large Vehicles at US Route 1 Intersection**

- There is insufficient green time for all movements.
- There are long queues on Route 1 approaches.
- Queue storage for vehicles turning left onto Route 1 is inadequate.
- Signal heads are not well aligned with the approach lanes.

- Heights of the signal heads on Route 1 are low.
- There is a lack of advanced intersection lane control.
- Signal visibility is a key concern at this intersection. As shown in Figure 4, when a large vehicle is queued at the intersection in the lead position, it can obstruct the signal. Given the volume of heavy vehicles using this corridor, improvements are needed to enhance visibility.

- Assess the visibility of signal heads and consider raising signal head heights or installing additional signal heads on the approaches.
- Evaluate the potential for protected-only left-turn phasing on all approaches to the intersection to reduce conflicts between left-turning and opposing through vehicles, particularly given the relatively high number of angle crashes observed at the intersection. The evaluation should also consider any potential operational impacts, such as increased delay and queuing.

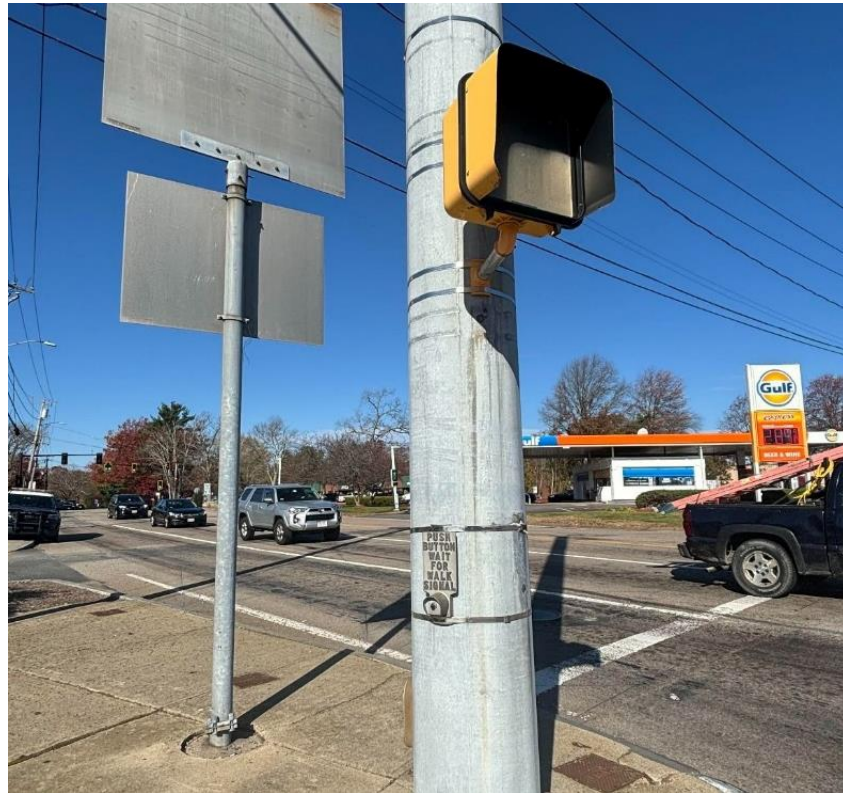
**Figure 5**  
**Push Button at US Route 1 and High Plain Street Intersection**

- The signals at the intersection are equipped with 12-inch LED signal lenses. While pedestrian countdown timers are present, they are not fully compliant with the Americans with Disabilities Act (ADA). In addition, the intersection signal heads lack signal backplates with retroreflective borders and require upgrades to fully meet MassDOT standards.
- Most pedestrian signal push buttons in the study area are outdated, except for one located on Old Post Road and another at the Walmart driveway on High Plane Street. However, the push button at the Walmart driveway (near Dunkin' Donuts) is not audible (Figure 5).

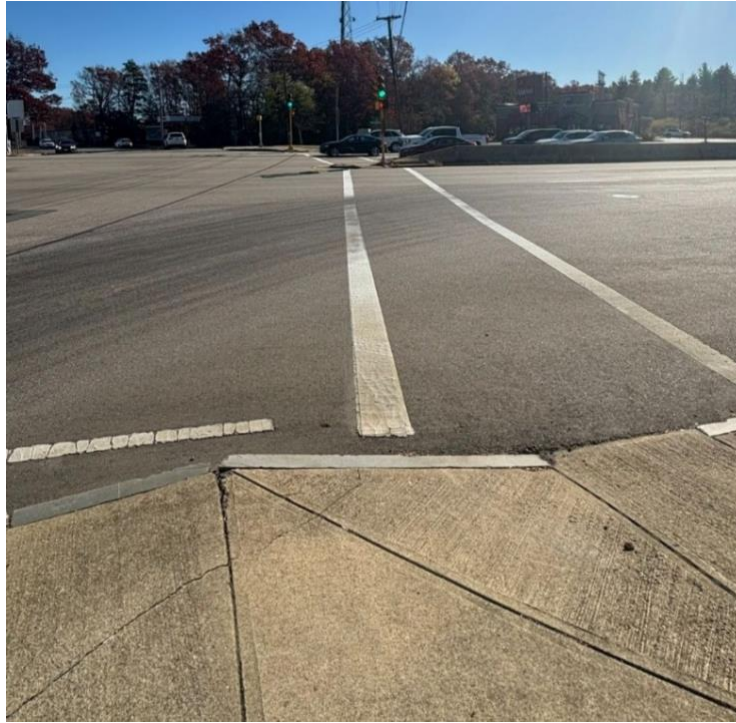
**Figure 6**  
**Crosswalk and Curb Ramp at the US Route 1 Intersection**

- The pedestrian crossing of Route 1 is split into two segments with a pedestrian refuge island in the center. The pedestrian phase is not programmed to provide sufficient crossing time. This may compromise pedestrian safety given the high volume and speed of traffic on Route 1. And not all pedestrian crossings are ADA-compliant (Figure 6).
- The pedestrian refuge island on Route 1 is narrow and unsafe.
- A crosswalk is missing on the north leg of Route 1.
- Gaps in sidewalk connectivity occur along the north side High Plain Street.
- Curb ramps and height of the pushbuttons are not ADA compliant.
- Utility poles obstruct sections of the sidewalk.
- Sidewalk surfaces at some locations are uneven.

- Evaluate and redesign truck turning areas on Route 1 approaches to reduce pedestrian crossing distances.
- Install bicycle parking near the intersection that is easily accessible from all intersection approaches. In addition, evaluate the intersection area for necessary bicycle infrastructure.

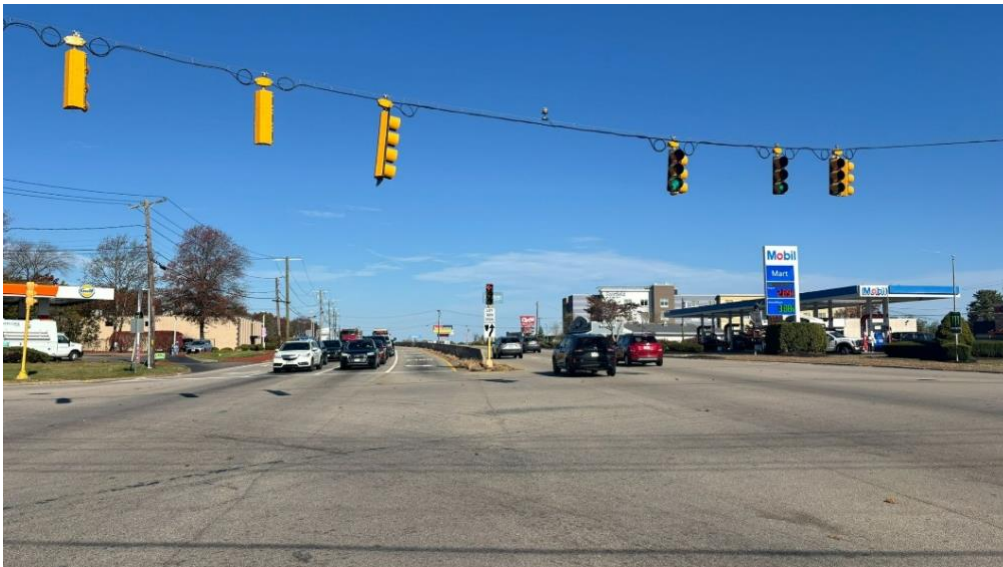
**Figure 7**  
**Lack of Turn Markings at the US Route 1 Intersection**

- Crosswalks and stop lines at secondary intersections are faded and need to be repaved.
- There is a lack of lane and lane-use arrow markings on High Plain Street.
- Pavement markings are fading and difficult to see.
- There are no turn markings within the Route 1 intersection to assist drivers (Figure 7).
- There is a lack of advanced intersection lane control markings.

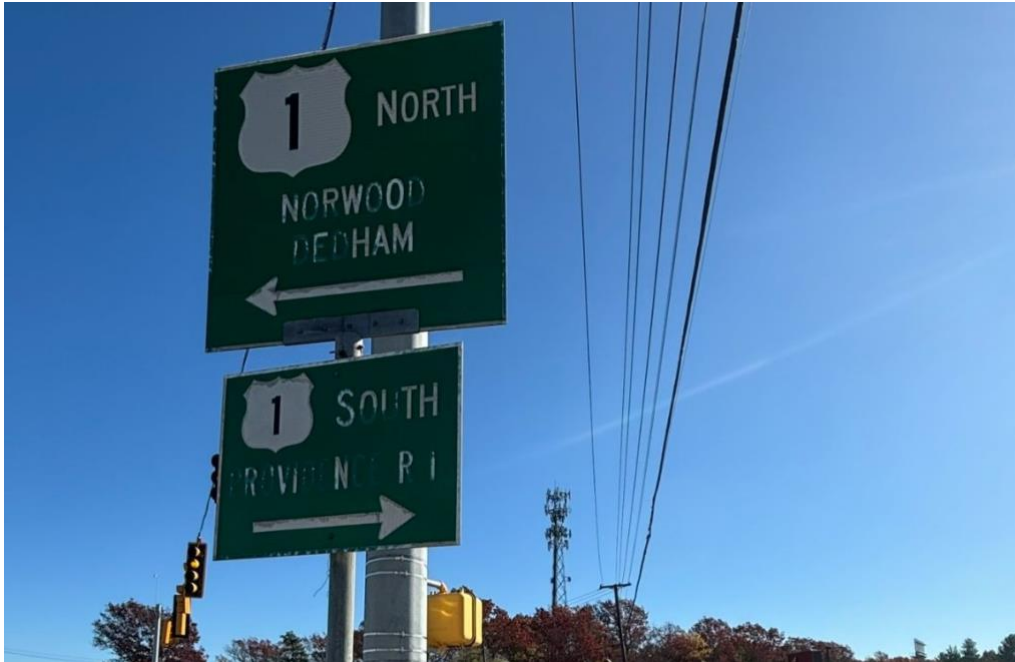
**Figure 8**  
**Condition of Signage in the Study Area**

- There is no signage indicating the presence of a through lane and a left-turn lane before the signal at the Big Y complex entrance and High Plain Street while travelling westbound.
- Eastbound from the Walmart signal, there is no signage alerting drivers to a lane merge.
- Most signage is in good condition. Most of the signage placement, height, and conditions are good. Some signs would benefit from refreshing or replacement (Figure 8).

- Replace faded Route 1 North and South directional guide signs and evaluate other signs near the intersection for replacement.
- Reorient Route 27 North and South signage near the Gulf gas station to improve visibility for southbound traffic on Route 1.

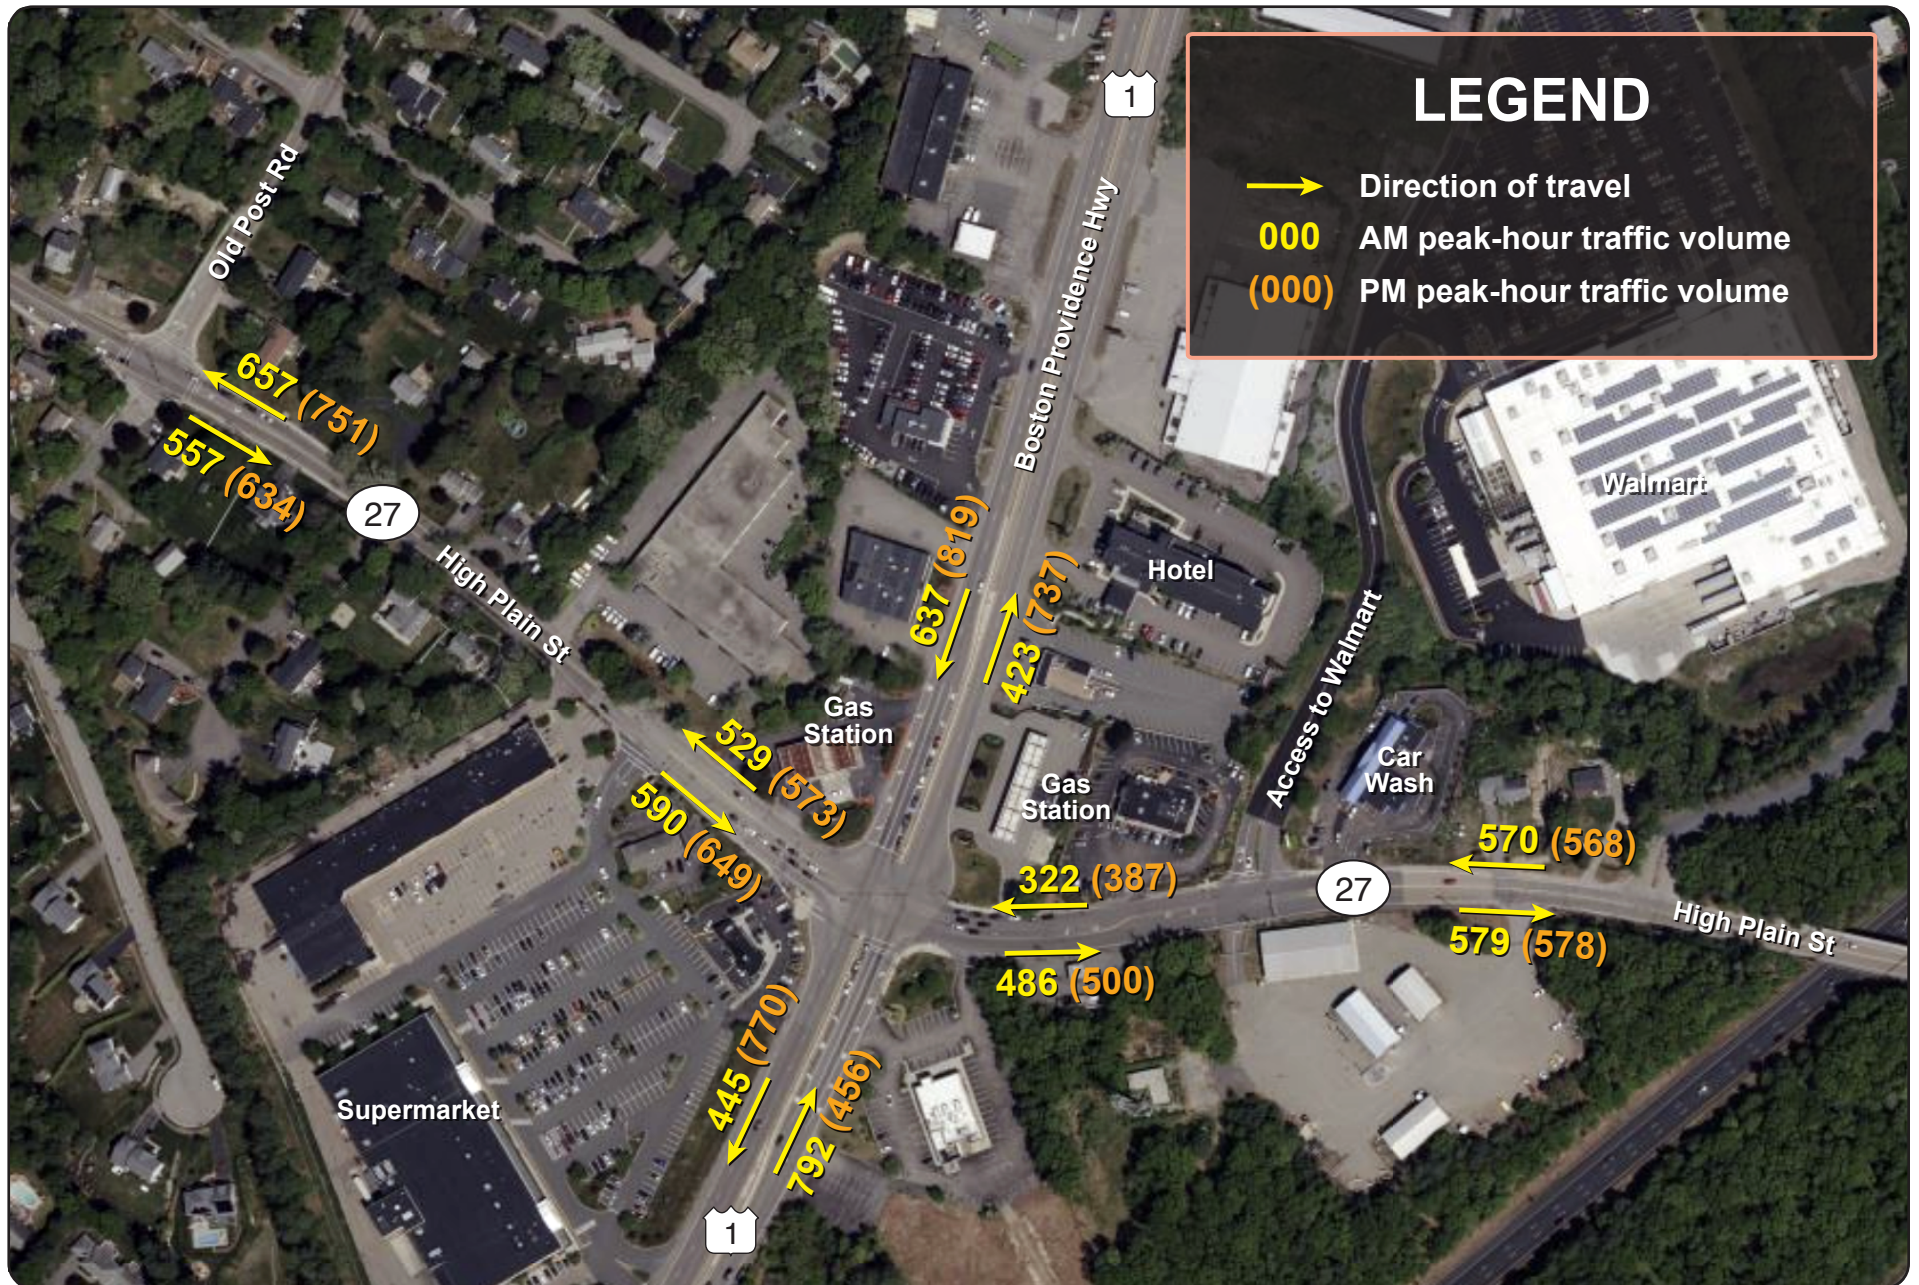
**Figure 10**  
**Walpole–Weekday Peak-hour Average Traffic Volume**

Based on the data, staff estimated the average weekday traffic volumes in roadway sections near the intersection as follows and as shown in Figure 10:

- At AM peak, 657 (54 percent) are westbound vehicles and 557 (46 percent) are eastbound vehicles.
- At PM peak, 751 (54 percent) are westbound vehicles and 634 (46 percent) are eastbound vehicles.

- At AM peak, 529 (47 percent) are westbound vehicles and 590 (53 percent) are eastbound vehicles.
- At PM peak, 573 (47 percent) are westbound vehicles and 649 (53 percent) are eastbound vehicles.

- At AM peak, 322 (40 percent) are westbound vehicles and 486 (60 percent) are eastbound vehicles.
- At PM peak, 387 (44 percent) are westbound vehicles and 500 (56 percent) are eastbound vehicles.

- At AM peak, 570 (50 percent) are westbound vehicles and 579 (50 percent) are eastbound vehicles.
- At PM peak, 568 (50 percent) are westbound vehicles and 578 (50 percent) are eastbound vehicles.

- At AM peak, 445 (36 percent) are southbound vehicles and 792 (64 percent) are northbound vehicles.
- At PM peak, 770 (63 percent) are southbound vehicles and 456 (37 percent) are northbound vehicles.

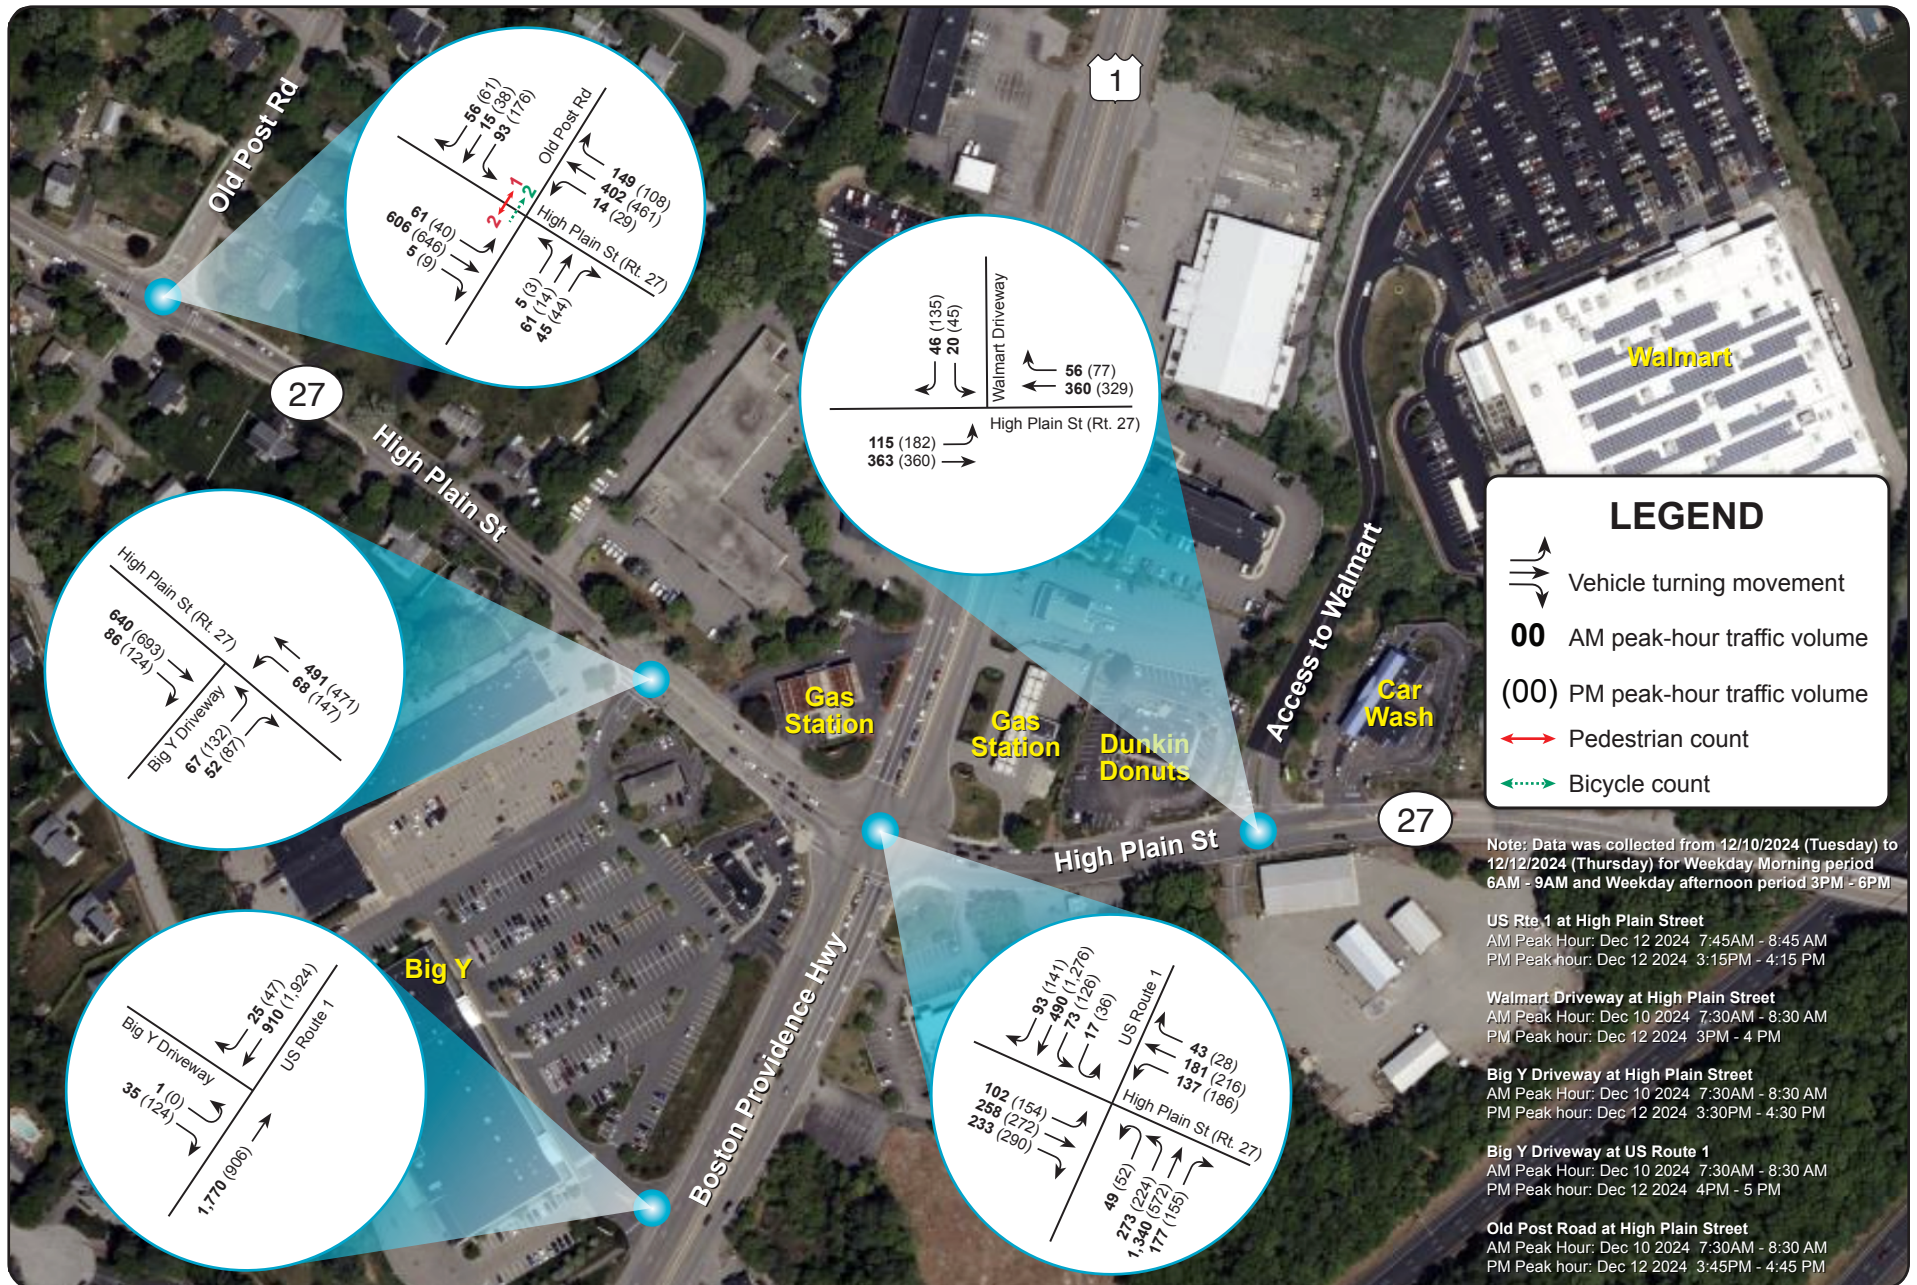
**Figure 11**  
**Walpole–Turning Movement Counts**

MassDOT collected turning movement counts at the study intersection on Tuesday, December 10, 2024, and Thursday, December 12, 2024, during the weekday morning peak period (6:00 AM–9:00 AM) and the weekday evening peak period (3:00 PM–6:00 PM). Figure 11 summarizes the 2024 AM and PM peak-hour traffic turning volumes by approach at intersections. A detailed weekly volume summary from the data collection is included in Appendix I.

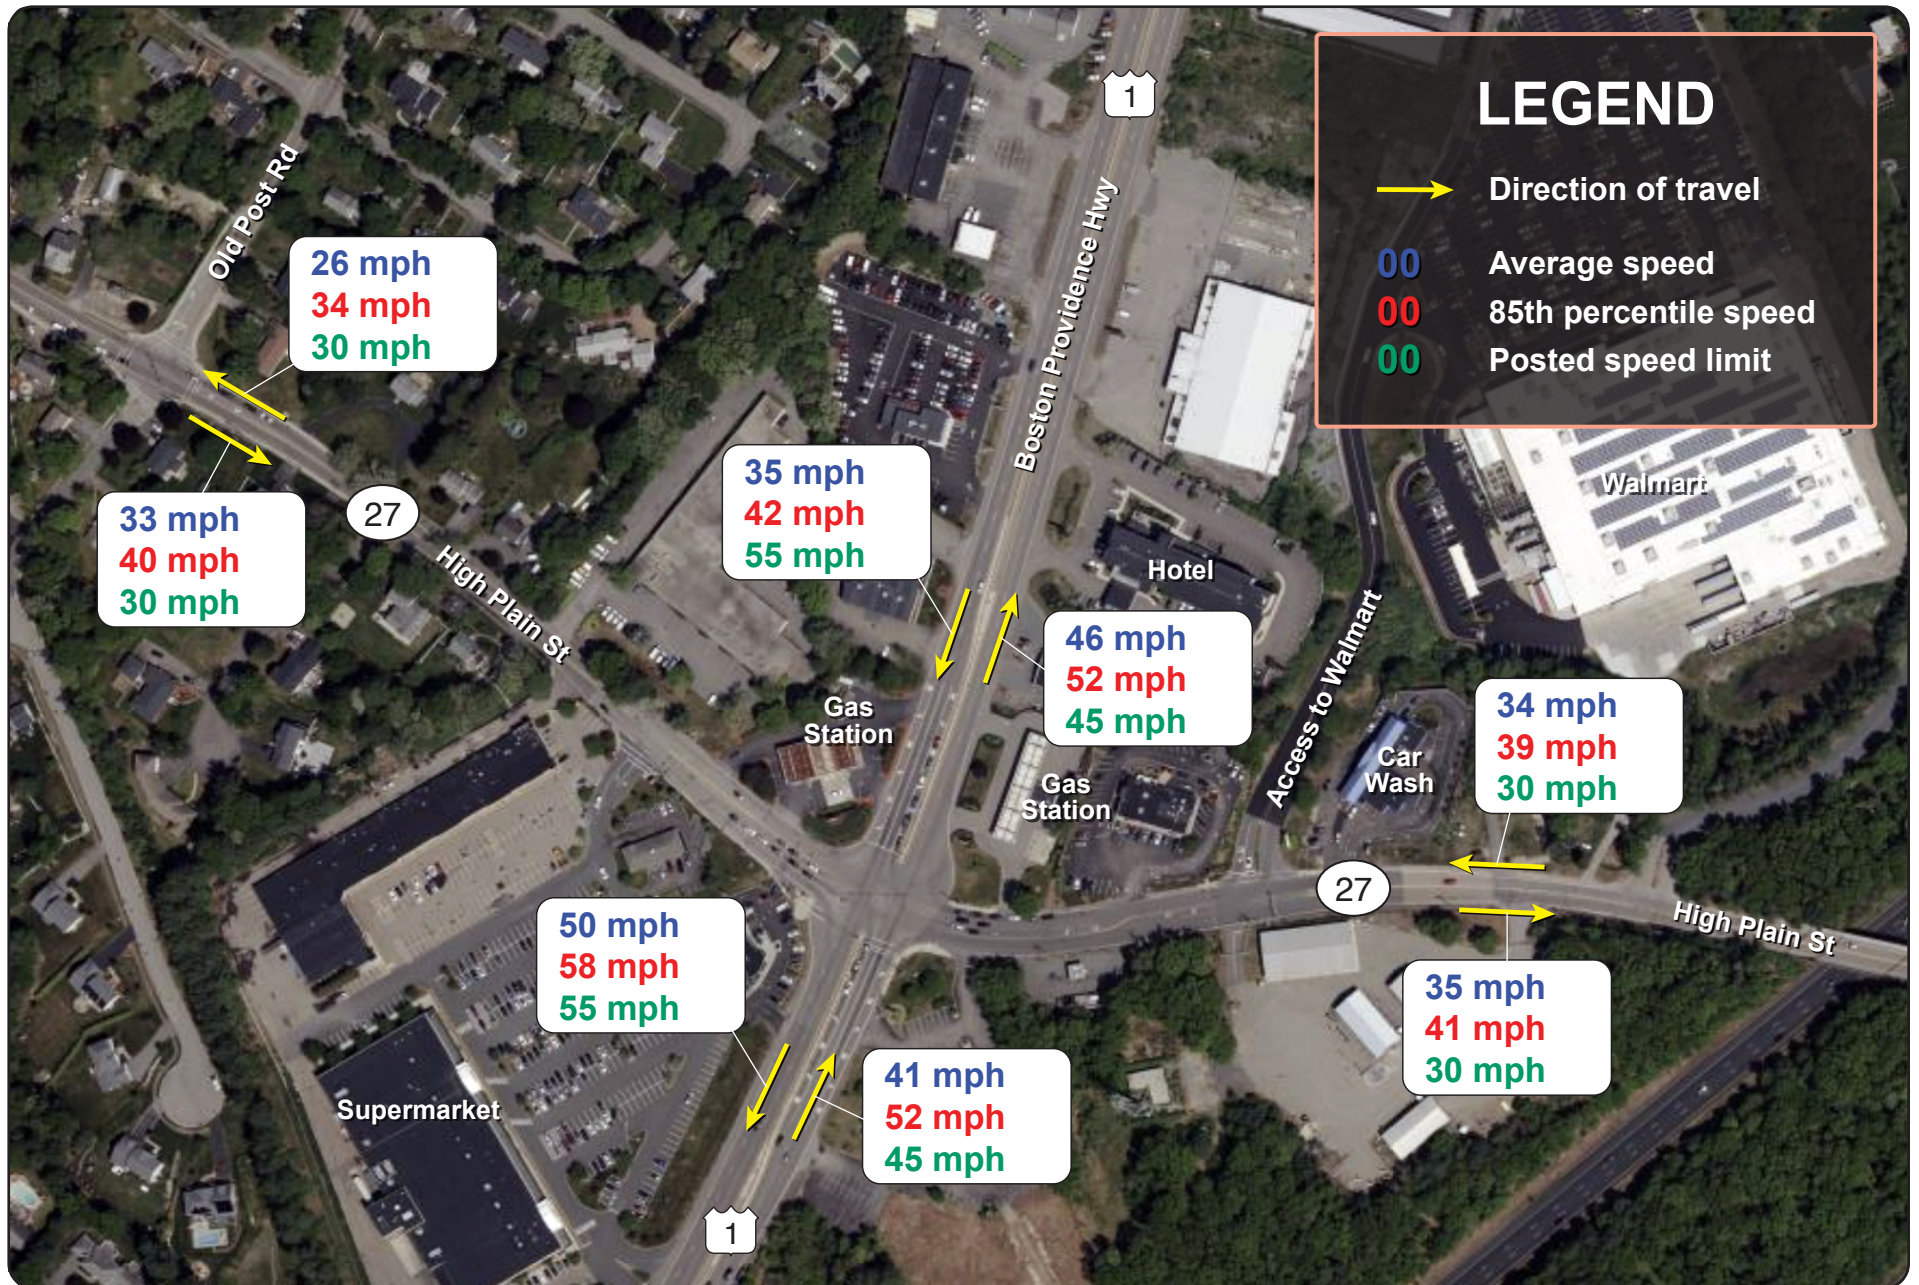
**Figure 12**  
**Walpole—Speed**

Speeding was mentioned as a concern in the study area. As mentioned above, the speed limit along Route 1 changes from 55 mph to 45 mph closer to the intersection, while the speed limit along High Plain Street is 30 mph. Speed data were also collected between Tuesday, December 10, 2024, and Thursday, December 12, 2024. Figure 12 below shows the average speed and 85th percentile speed along High Plain Street and Route 1. The Route 1 speed data were collected within the 45 mph posted speed limit. Overall, data indicate that vehicles are speeding along High Plain Street and traveling at speeds slightly above the posted speed limit along Route 1. A detailed speed summary from the data collection is included in Appendix J. Also, a detailed vehicle classification summary is available in Appendix K.

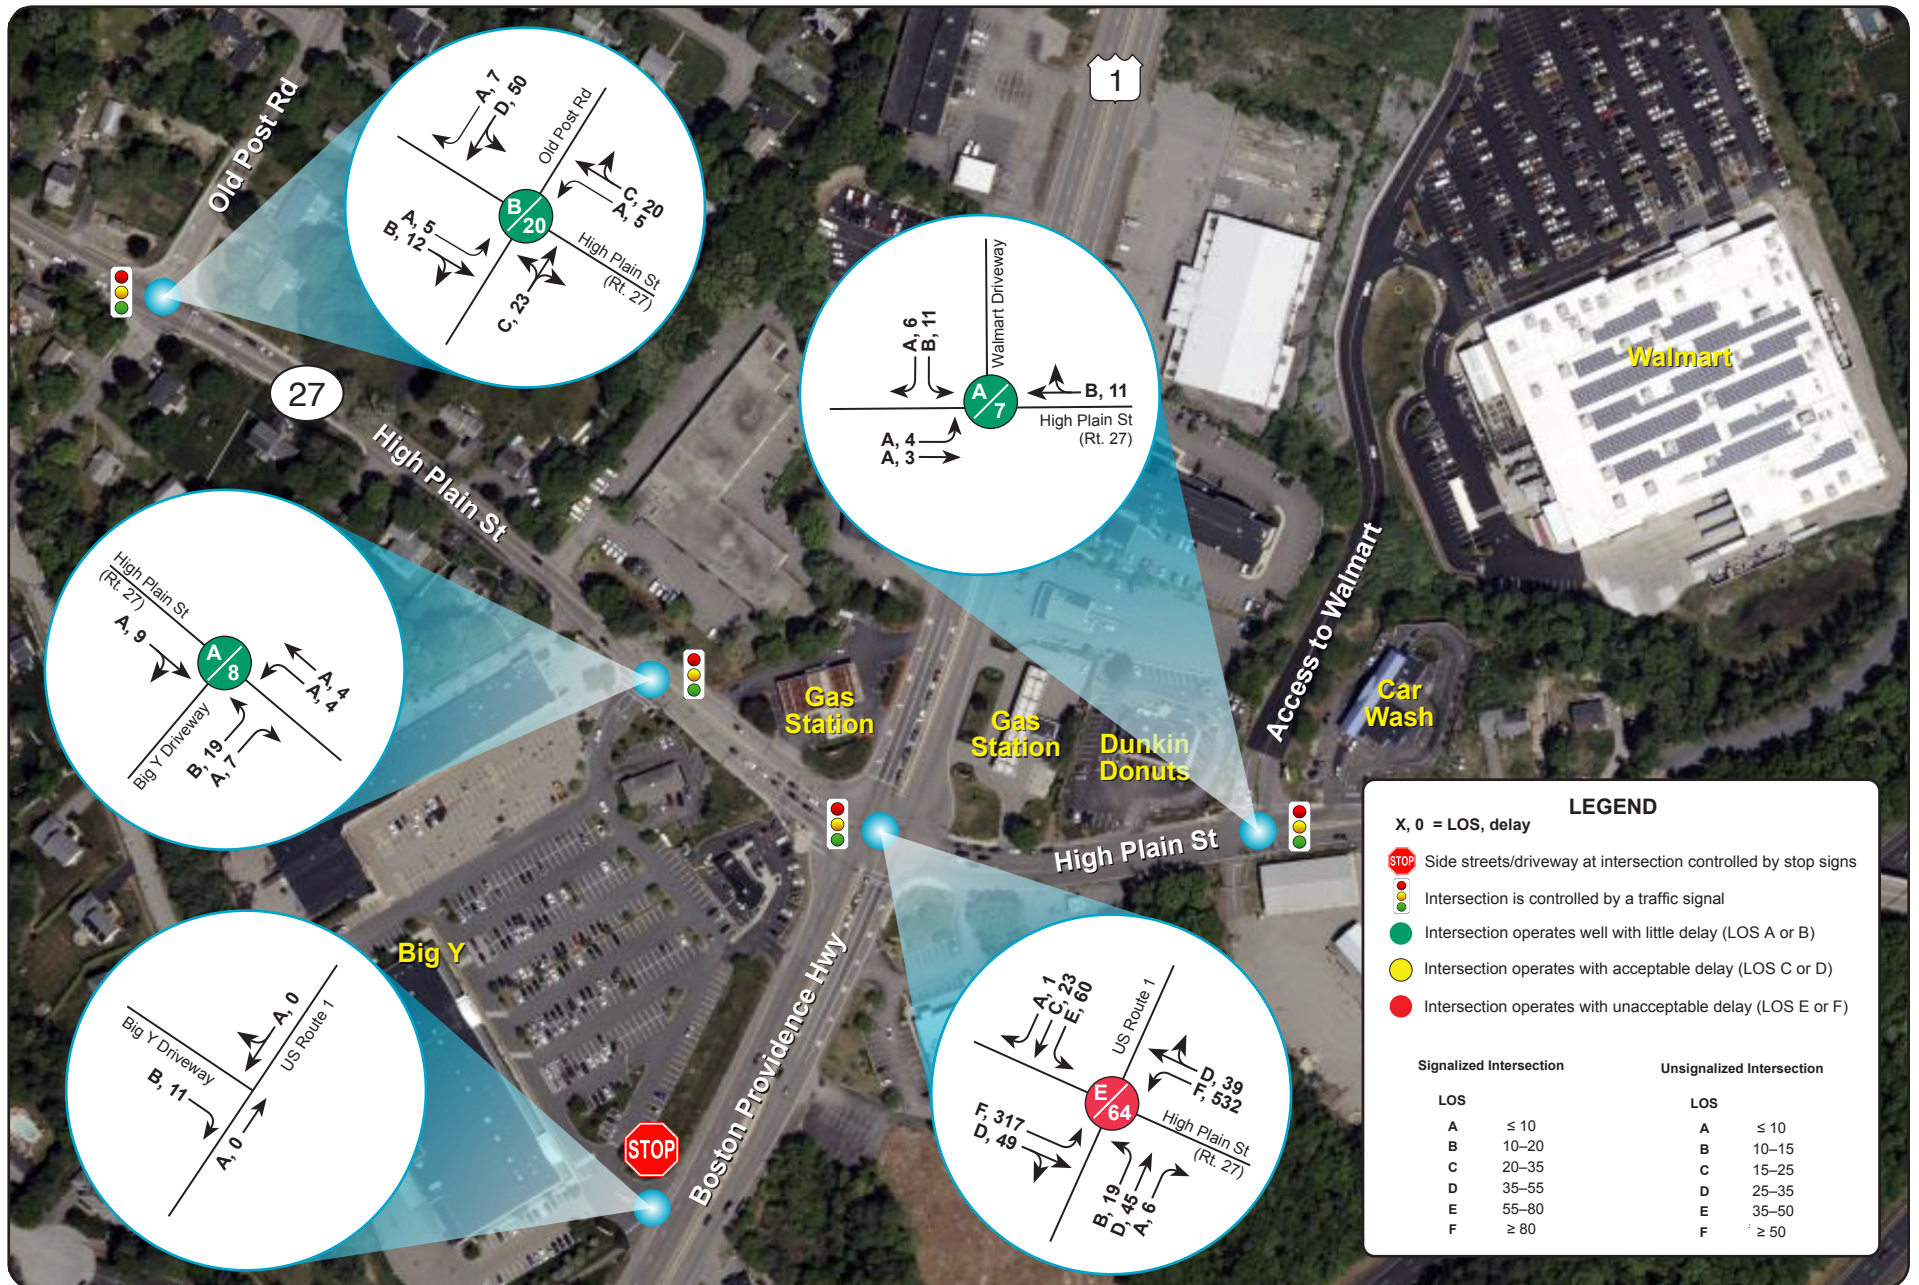
**Figure 13**  
**Walpole—Existing Conditions**  
**Weekday AM Peak-Hour LOS and Delays**

As shown in Figures 13 and 14, most intersections in the study area operate acceptably at both peak periods, with little delay during both the AM and PM peak periods. The intersections of High Plain Street with Old Post Road, the Walmart driveway, and the Big Y driveway all operate at either LOS A or B during both weekday peak periods.

The primary operational deficiency in the study area occurs at the signalized intersection of Route 1 and High Plain Street. The intersection operates at LOS E during the weekday AM peak hour and LOS F during the weekday PM peak hour, and delays increase from approximately 64 seconds in the AM peak periods to approximately 91 seconds in the PM peak periods. The weekday PM peak period experiences the highest delays. Intersections experiencing the highest delays and lower LOS highlight areas where congestion and operational issues are most pronounced during the peak hours. Table 2 summarizes the delays and LOS for the existing conditions.

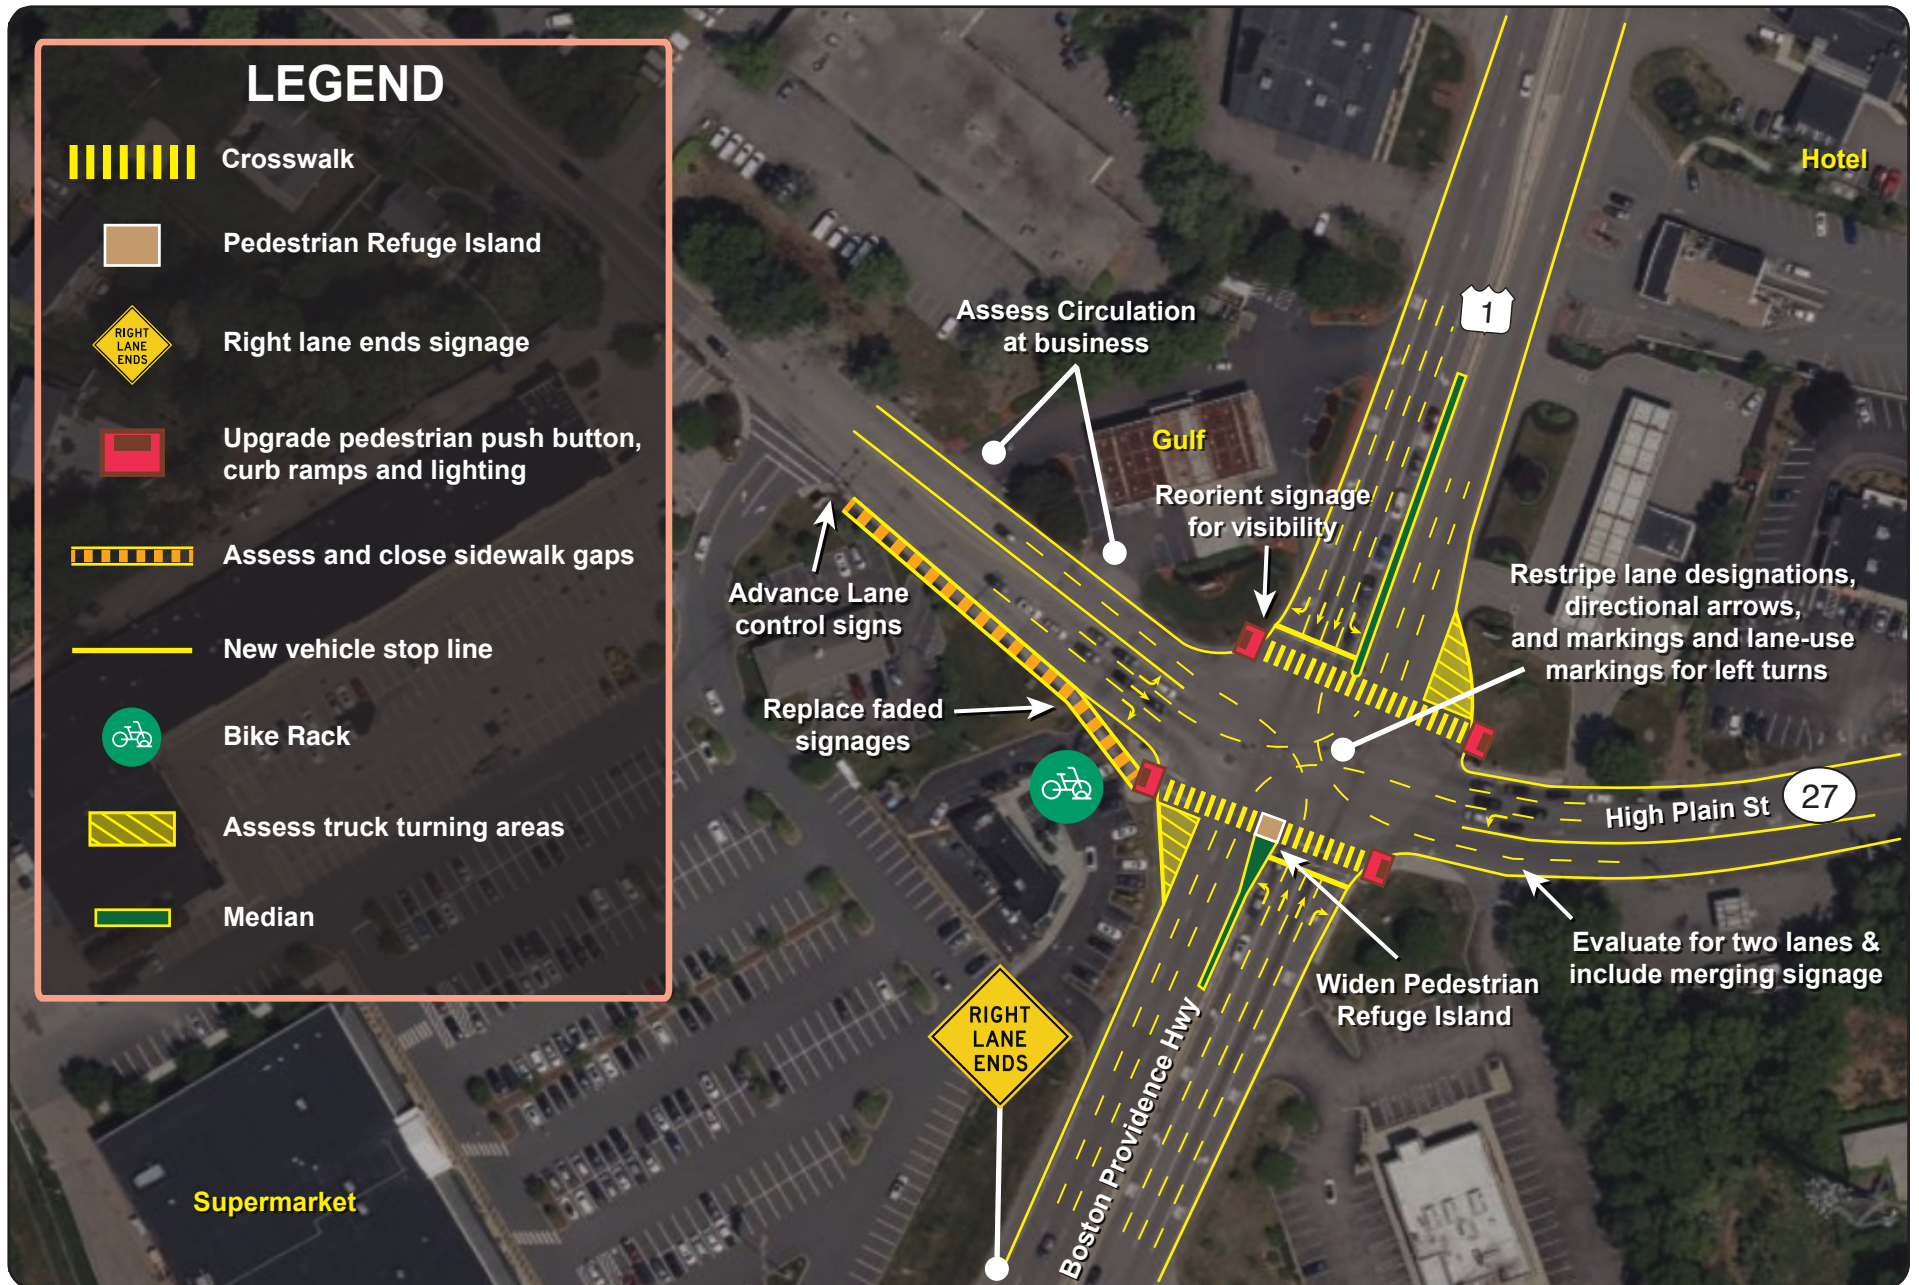
**Figure 15**  
**Walpole–Short & Long-Term Improvements**  
**US Route 1 at High Plain Street**

- Evaluate and align signal heads with their respective travel lanes.
- Improve lighting conditions at the intersection.
