# Technical Memorandum

**RE:** Intersection Study: US Route 1 and High Plain Street, Walpole

This memorandum summarizes the analyses and improvement strategies for the intersection of US Route 1 (Boston–Providence Highway) at Route 27 (High Plain Street) in the Town of Walpole.

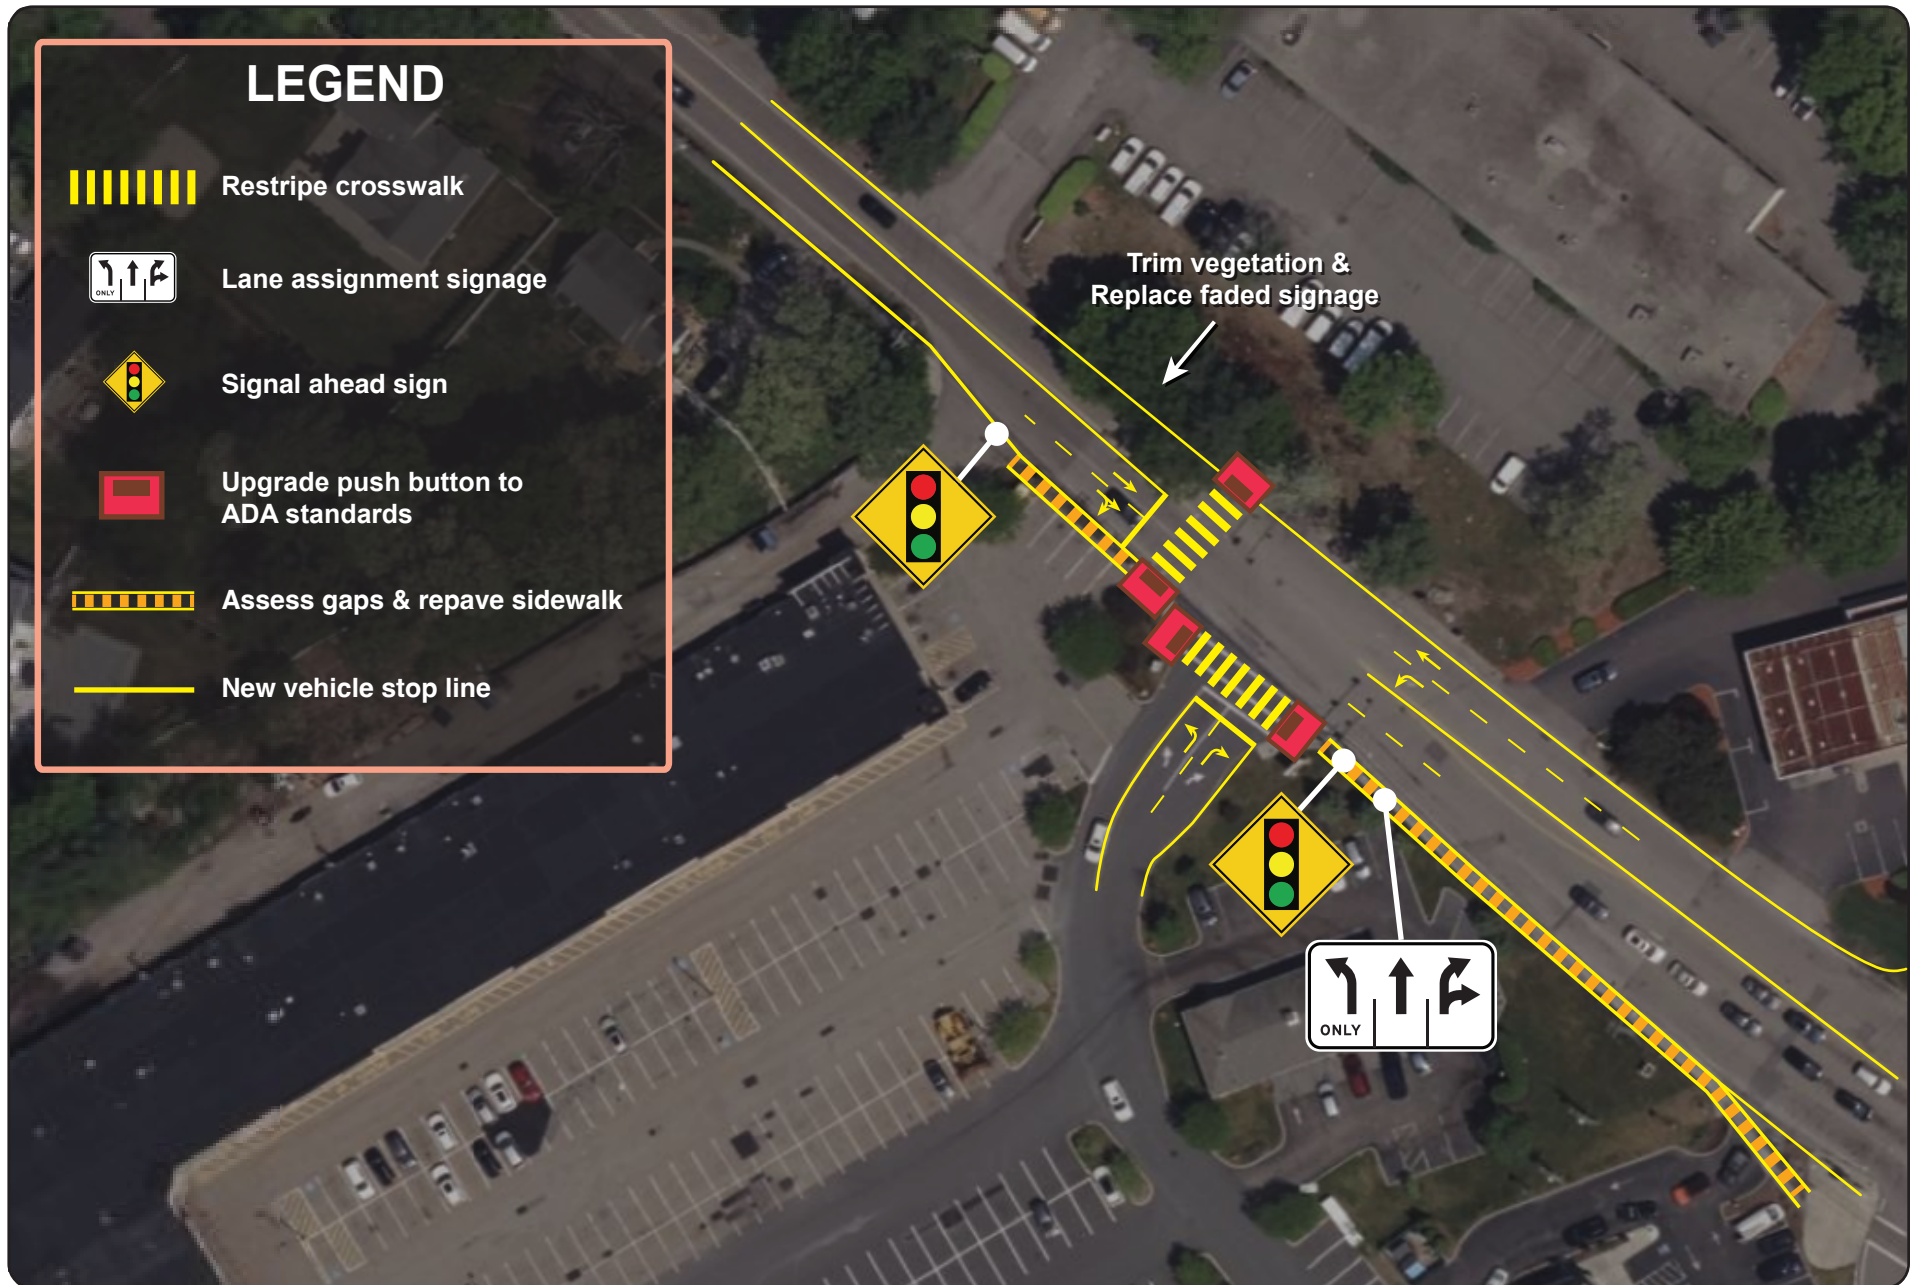
**Figure 16**  
**Walpole–Short & Long-Term Improvements**  
**Big Y Complex at High Plain Street**

- Restripe stop bars farther from crosswalks at Big Y Complex entrance.
- Evaluate sidewalk pavement condition and repave sidewalks.
- Evaluate for consistent lane designations, directional arrows, and lane markings at the intersection, and restripe faded lane-use markings.
- Install signage indicating lane assignments and the upcoming signalized intersection to improve visibility of traffic signals and related signage at the Big Y complex entrance and the High Plain Street intersection.
- Replace faded and damaged existing signage on the sidewalk along the westbound side of High Plain Street.
- Trim and maintain vegetation to improve visibility of signs and vehicles.

- Evaluate and align signal heads with their respective lanes.
- Improve lighting conditions at the intersection.
- Evaluate and upgrade pedestrian push buttons and curb ramps to comply with ADA standards at all intersection approaches.
- Assess and close gaps in the sidewalk network between nearby intersections.

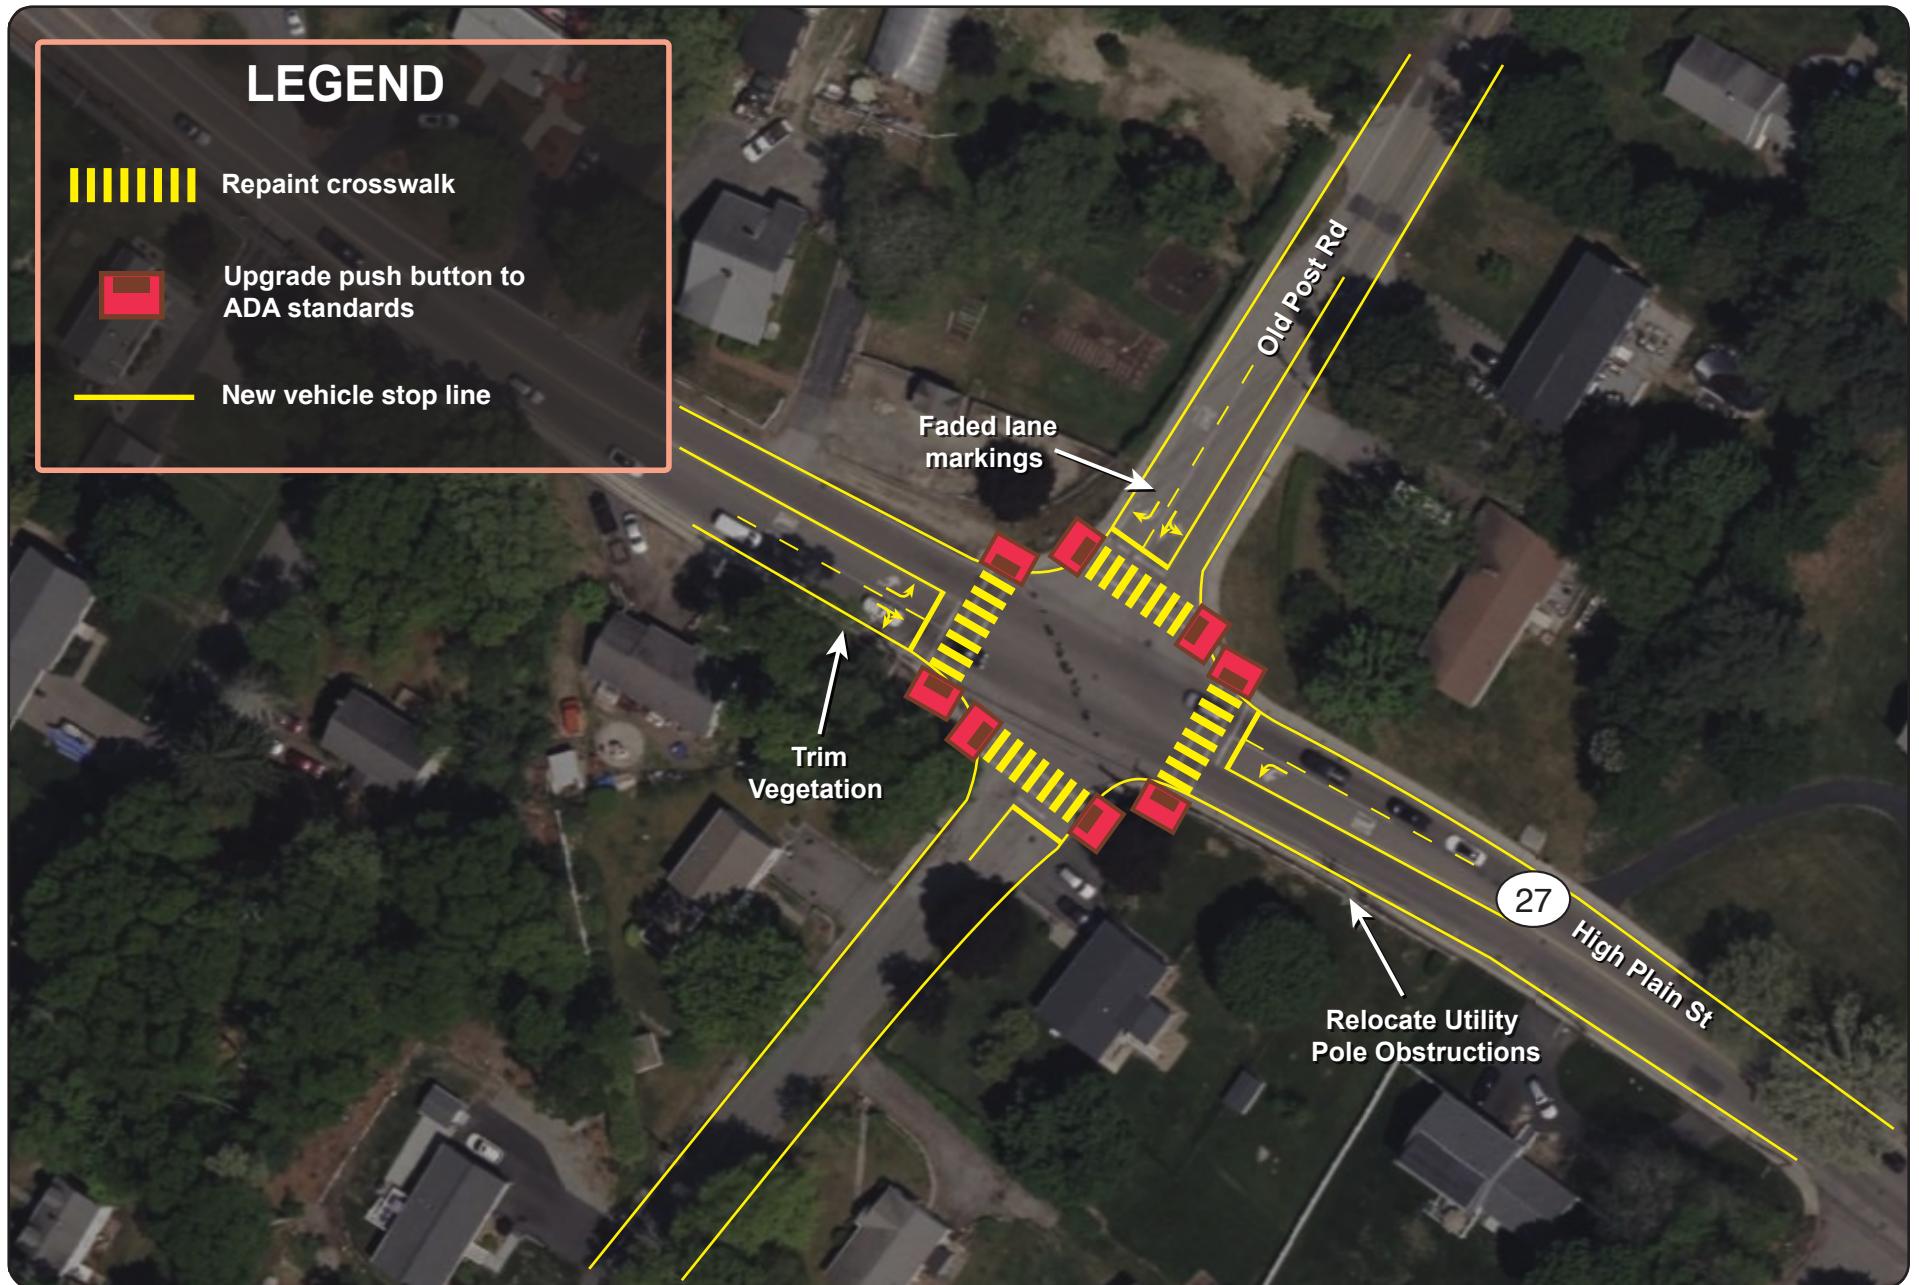
**Figure 17**  
**Walpole–Short & Long-Term Improvements**  
**Old Post Road at High Plain Street**

- Evaluate sidewalk pavement condition and repave sidewalks.
- Restripe stop bars farther from crosswalk at all intersection approaches to improve pedestrian safety and visibility.
- Evaluate for consistent lane designations, directional arrows, and lane markings, and restripe faded lane markings.
- Trim and maintain vegetation to improve visibility of signs and vehicles.

- Upgrade pedestrian push buttons and curb ramps to comply with ADA standards at all intersection approaches.
- Evaluate and align signal heads with their respective lanes.
- Relocate or modify utility pole obstructions affecting pedestrian access to sidewalks along the eastbound side of High Plain Street.
- Improve lighting conditions at the intersection.

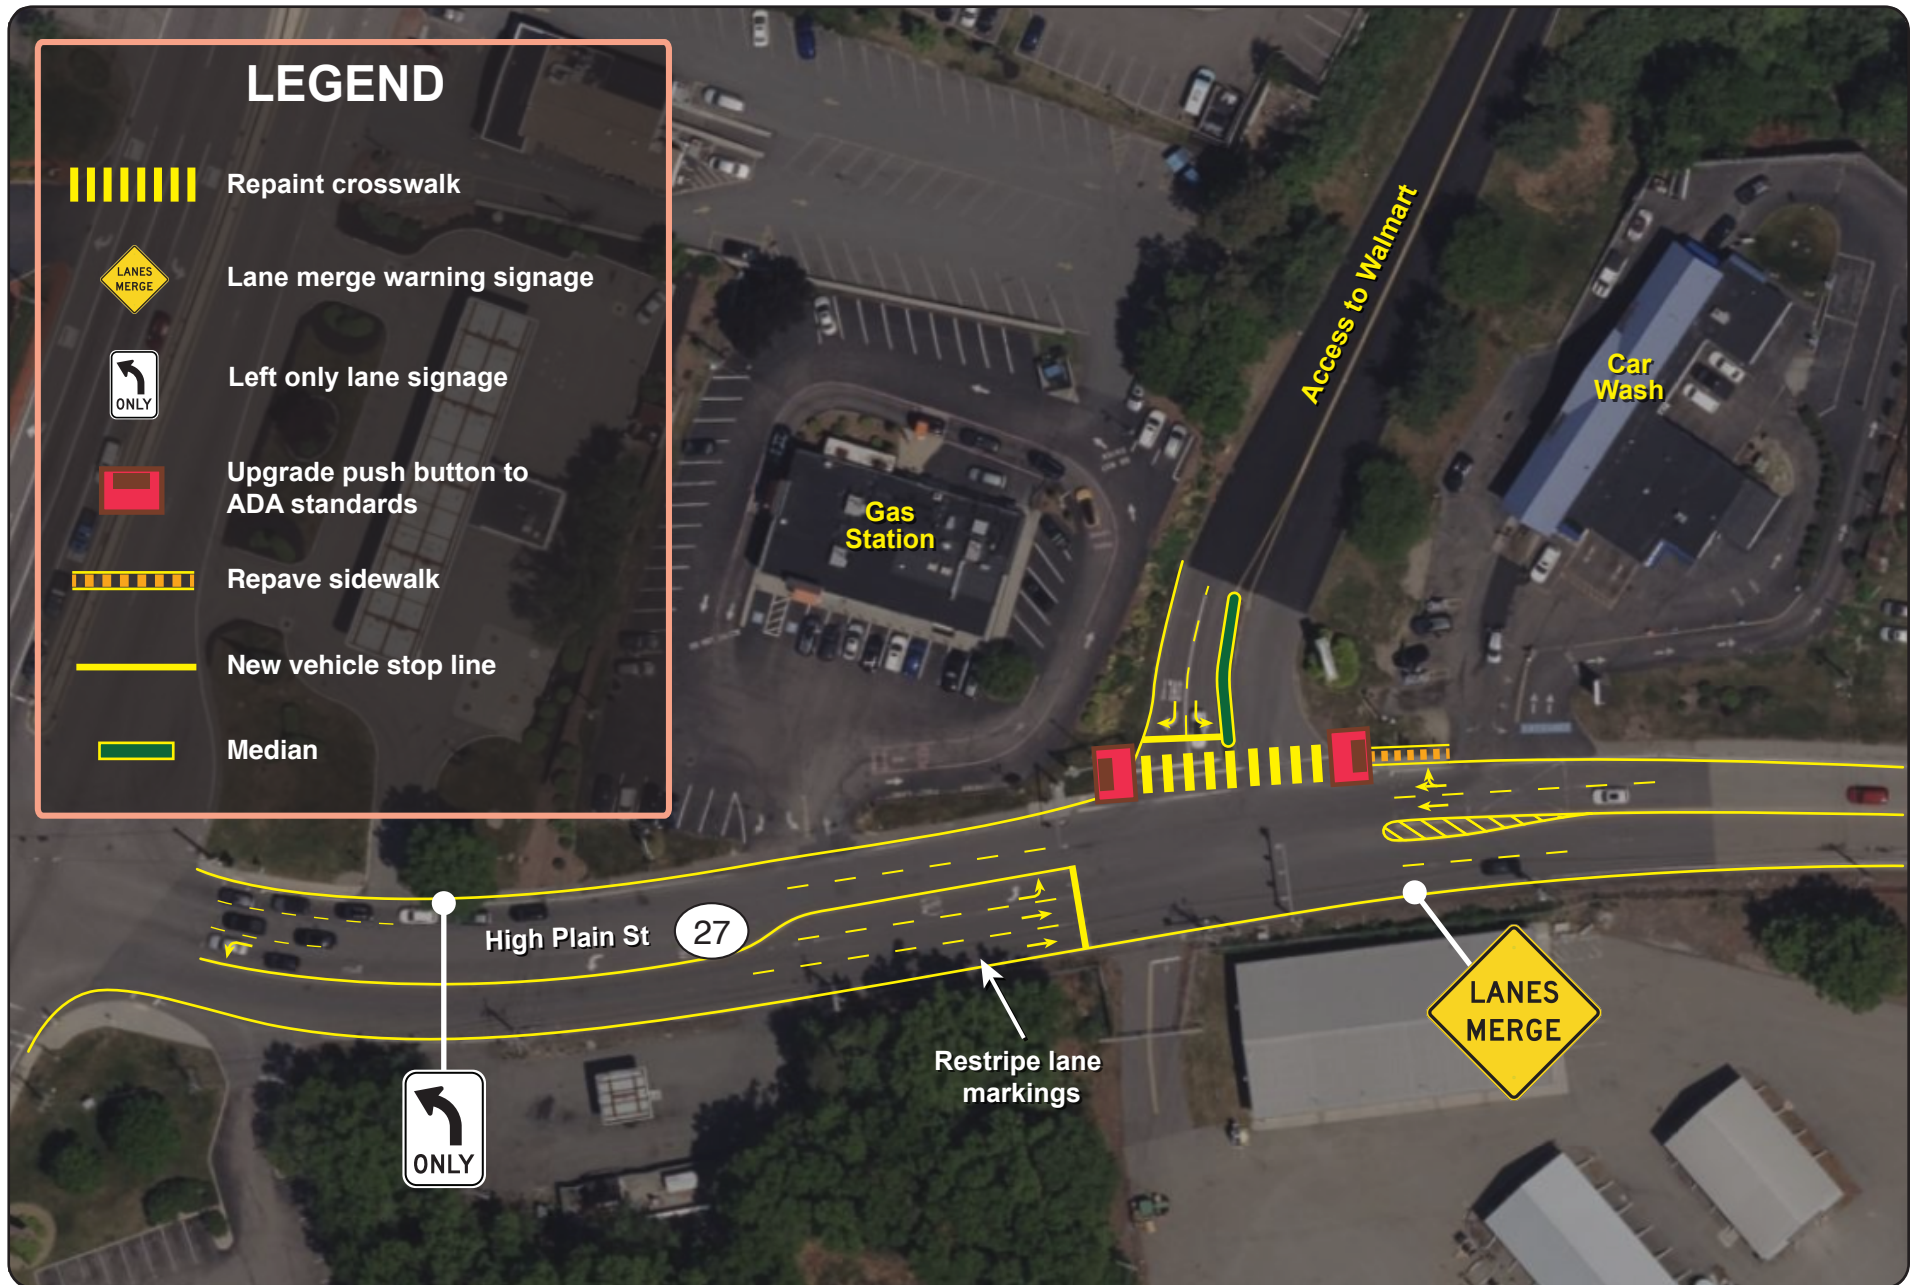
**Figure 18**  
**Walpole-Short & Long-Term Improvements**  
**Walmart Entrance at High Plain Street**

- Assess and upgrade pedestrian push buttons to include accessible pedestrian signal features and ensure compliance with ADA standards.
- Evaluate and align signal heads with their respective travel lanes.
- Improve lighting conditions at the intersection.
